ECO INSPECTION REPORT

Order ID : 10317

Ordered by : POONAM RANI | Inspection Date : 25/04/2017

Maruti Suzuki Eeco 5 STR WITH AC PLUSHTR, 2011

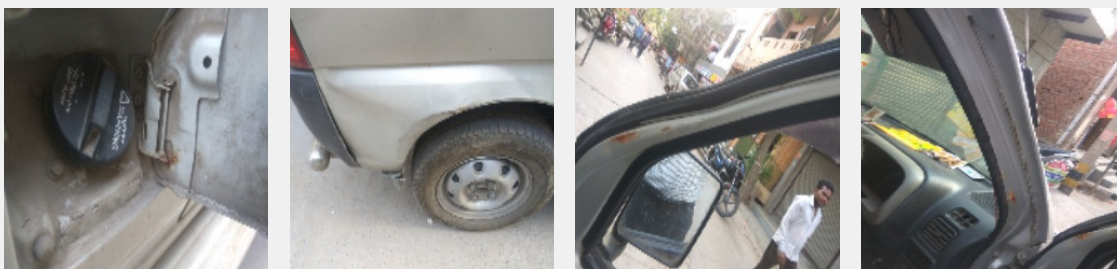
DAMAGE IMAGES

INSPECTION CHECKPOINTS	SCORE(X/10)	REMARKS/COMMENTS	OPTIONAL SPEND EST(RS)
REAR BUMPER	6		0
TRUNK LID/TAIL GATE	6		0
RH RUNNING BOARD	6		0
RH REAR DOOR	6		0
RH FRONT DOOR	6	DENTED	2500
RH FENDER	6		0
BODY RUST	6		0
ROOF (REGULAR)	6		0
PAINT CONDITION	6		0
FOG LAMPS	0		0
PILLAR	3	RHS A-PILLAR HAS BEEN REPAIRED.	2500
FUEL LID	4	BROKEN	1000
TAIL LIGHT	5	RHS TAIL LIGHT MINOR CRACK	1000
LUGGAGE COMPARTMENT LIGHT	0		0
RH QUARTER PANEL	4	DENTED	5000
