ECO INSPECTION REPORT

Order ID : 20893

Mahindra Kuv100 Nxt K8 6 Str, 2018

VEHICLE INFORMATION			
MAKE	MAHINDRA	TRANSMISSION TYPE	MANUAL
MODEL	KUV100 NXT	REGISTRATION NO.	KA02MN3228
YEAR	2018	VIN/CHASIS NUMBER	88797
TRIM	K8 6 STR	KMS RUN	3837
COLOR	SILVER	INSURANCE EXPIRY	2019-3-2
BODY TYPE	SEDAN	LOCATION	BANGALORE
FUEL TYPE	DIESEL	ENGINE SOUND LINK	NIL

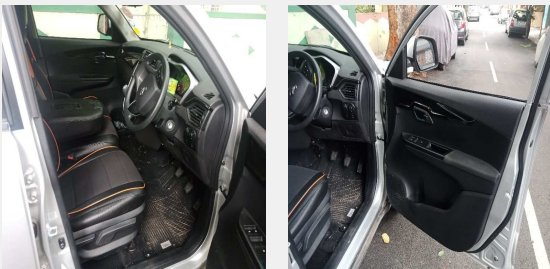
INTERIOR

INSPECTION CHECKPOINTS	SCORE(X/10)	REMARKS/COMMENTS	OPTIONAL SPEND EST. (RS)
DOOR PANEL	9		0
DOOR HINGES	8		0
CARPET & FLOOR MAT	8		0
SEAT & SEAT BELT	8		0
DASHBOARD & INSTRUMENT PANEL	8		0
HORN	8		0
SPEAKERS & MUSIC SYSTEM	8		0
HANDBRAKE	8		0
STEERING-MOUNTED CONTROLS	8		0
PEDALS	8		0
CENTRAL LOCK	8		0
A/C VENTS & HEATER	8		0
CUP HOLDERS	8		0
NAVIGATION	8		0
ODOMETER	8		0
POWER WINDOWS (YES)	9		0
HAZARD LIGHT	8		0

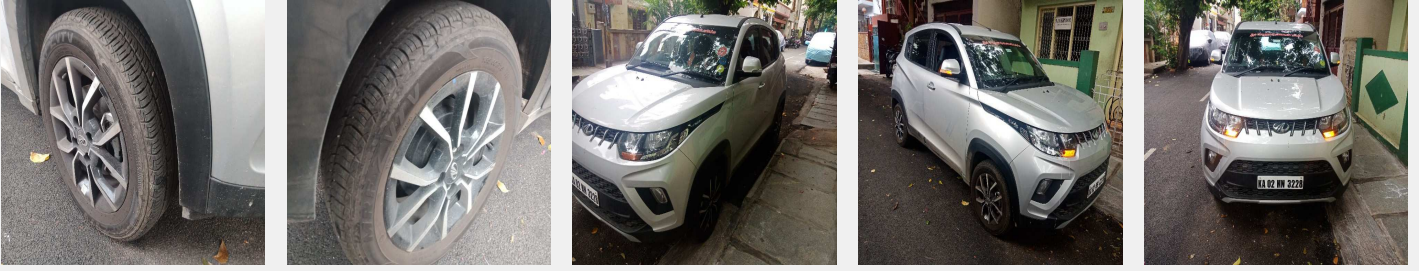
INSPECTION CHECKPOINTS	SCORE(X/10)	REMARKS/COMMENTS	OPTIONAL SPEND EST. (RS)
TYRES	8		0
SPARE TYRE	8		0
WHEEL ASSEMBLY (STEEL RIM)	8		0

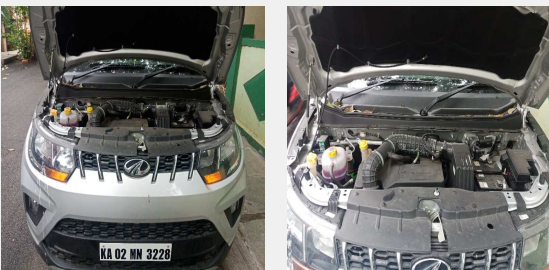
HOOD

INSPECTION CHECKPOINTS	SCORE(X/10)	REMARKS/COMMENTS	OPTIONAL SPEND EST. (RS)
LH APRON	8		0
RH APRON	8		0
RADIATOR	8		0
WIRING	8		0
BATTERY	8		0
BRAKE FLUID LEVEL	8		0
ENGINE OIL	8		0
COOLANT LEVEL	8		0
BRAKE & COOLANT HOSE PIPES	8		0
UNDERCARRIAGE	8		0
EXHAUST SYSTEM	8		0
