ECO INSPECTION REPORT

Order ID : 20380

Maruti Suzuki Alto 800 Lxi, 2017

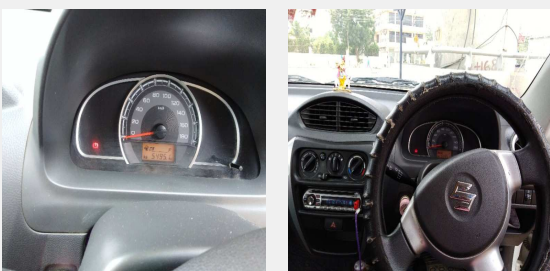
IMAGES

INSPECTION CHECKPOINTS	SCORE(X/10)	REMARKS/COMMENTS	OPTIONAL SPEND EST. (RS)
STEERING PERFORMANCE	7		0
BRAKE PERFORMANCE	7		0
CLUTCH PERFORMANCE	7		0
ENGINE NOISE	7		0
IGNITION SYSTEM	7		0
SUSPENSION PERFORMANCE	7		0
SUSPENSION FRONT SHOCKS	7		0
SUSPENSION REAR SHOCKS	7		0
TRANSMISSION ENGAGE	7		0
CRUISE CONTROL	7		0
REAR PARKING SENSORS	7		0
REAR VIEW CAMERA	7		0

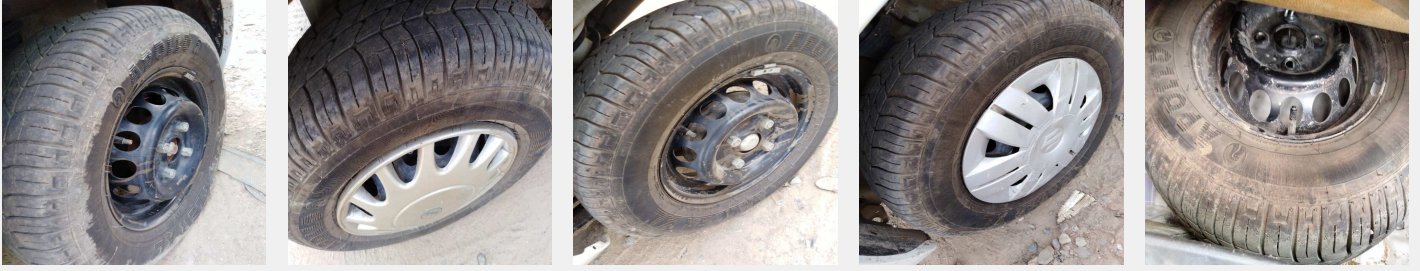
IMAGES

INSPECTION CHECKPOINTS	SCORE(X/10)	REMARKS/COMMENTS	OPTIONAL SPEND EST. (RS)
TYRES	7		0
SPARE TYRE	7		0
WHEEL ASSEMBLY (STEEL RIM)	7		0

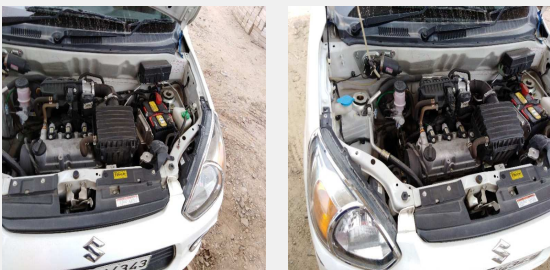
IMAGES

INSPECTION CHECKPOINTS	SCORE(X/10)	REMARKS/COMMENTS	OPTIONAL SPEND EST. (RS)
LH APRON	7		0
RH APRON	7		0
RADIATOR	7		0
WIRING	7		0
BATTERY	7		0
BRAKE FLUID LEVEL	7		0
ENGINE OIL	7		0
COOLANT LEVEL	7		0
BRAKE & COOLANT HOSE PIPES	7		0
UNDERCARRIAGE	7		0
EXHAUST SYSTEM	7		0

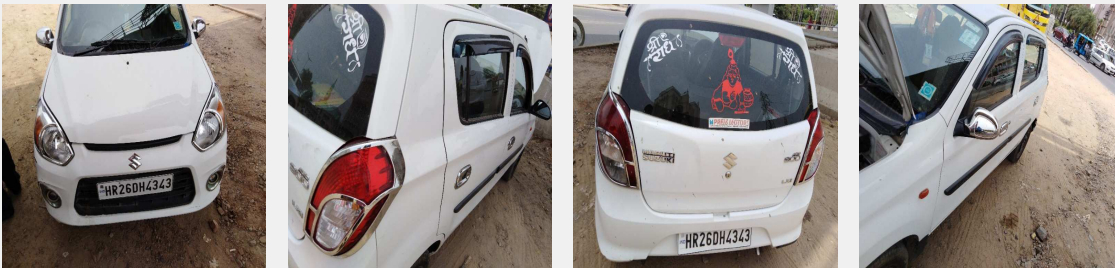
IMAGES

INSPECTION CHECKPOINTS	SCORE(X/10)	REMARKS/COMMENTS	OPTIONAL SPEND EST. (RS)
RH FRONT DOOR	7		0
RH FENDER	7		0
BODY RUST	7		0
ROOF (REGULAR)	7		0
PAINT CONDITION	7		0
