# ECO INSPECTION REPORT Premium

Order ID : 21919

## Audi A4 35 Tdi Technology, 2017

VEHICLE INFORMATION			
MAKE	AUDI	TRANSMISSION TYPE	AUTOMATIC
MODEL	A4	REGISTRATION NO.	HR26DH4514
YEAR	2017	VIN/CHASIS NUMBER	702005
TRIM	35 TDI TECHNOLOGY	KMS RUN	9457
COLOR	BLACK	INSURANCE EXPIRY	2018-9-20
BODY TYPE	SEDAN	LOCATION	GURGOW
FUEL TYPE	DIESEL	ENGINE SOUND LINK	NIL

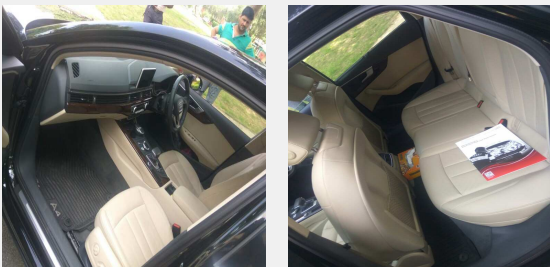
## IMAGES

INSPECTION CHECKPOINTS	SCORE(X/10)	REMARKS/COMMENTS	OPTIONAL SPEND EST. (RS)
DOOR PANEL	6	GOOD	0
DOOR HINGES	6	FAIR	0
CARPET & FLOOR MAT	6	FAIR	0
SEAT & SEAT BELT	6	GOOD	0
DASHBOARD & INSTRUMENT PANEL	6	GOOD	0
HORN	6	GOOD	0
SPEAKERS & MUSIC SYSTEM	6	GOOD	0
HANDBRAKE	6	GOOD	0
STEERING-MOUNTED CONTROLS	6	GOOD	0
PEDALS	6	GOOD	0
CENTRAL LOCK	6	GOOD	0
A/C VENTS & HEATER	6	GOOD	0
CUP HOLDERS	6	GOOD	0
NAVIGATION (YES)	6		0
ODOMETER	6	GOOD	0
POWER WINDOWS (YES)	6		0
HAZARD LIGHT	6		0

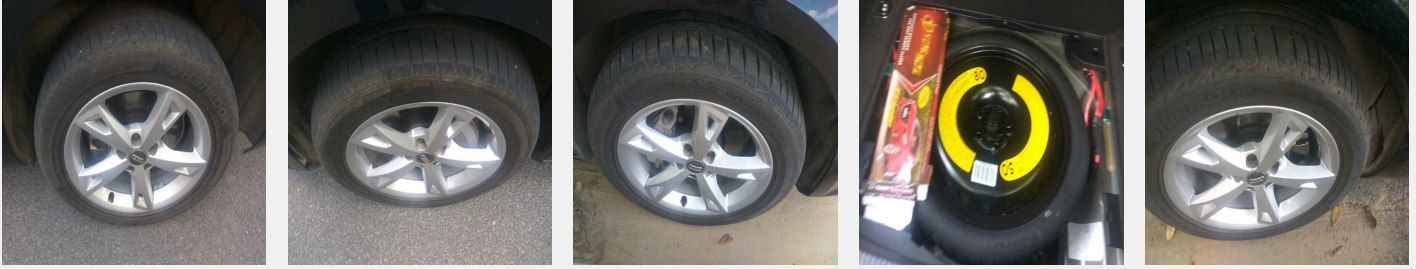
IMAGES

INSPECTION CHECKPOINTS	SCORE(X/10)	REMARKS/COMMENTS	OPTIONAL SPEND EST. (RS)
TYRES	6	AVERAGE	0
SPARE TYRE (YES)	6		0
WHEEL ASSEMBLY	6		0

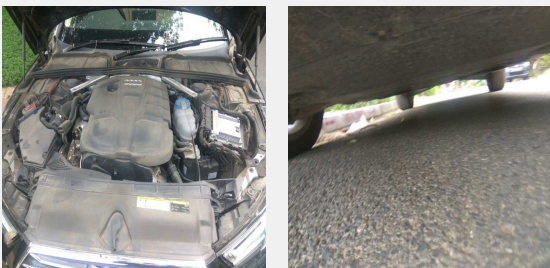
IMAGES

INSPECTION CHECKPOINTS	SCORE(X/10)	REMARKS/COMMENTS	OPTIONAL SPEND EST. (RS)
LH APRON	6	FAIR	0
RH APRON	6	FAIR	0
RADIATOR	6	GOOD	0
WIRING	6	GOOD	0
BATTERY	6	GOOD	0
BRAKE FLUID LEVEL	6	TOP	0
ENGINE OIL	6	AVERAGE	0
COOLANT LEVEL	6	TOP	0
BRAKE & COOLANT HOSE PIPES	6	GOOD	0
UNDERCARRIAGE	6	FAIR	0
EXHAUST SYSTEM	6	FAIR	0
