ECO INSPECTION REPORT

Order ID : 20873

Mahindra Xuv500 W4, 2017

VEHICLE INFORMATION			
MAKE	MAHINDRA	TRANSMISSION TYPE	MANUAL
MODEL	XUV500	REGISTRATION NO.	MH14GH5007
YEAR	2017	VIN/CHASIS NUMBER	G15018
TRIM	W4	KMS RUN	14412
COLOR	OTHER	INSURANCE EXPIRY	2018-7-20
BODY TYPE	SEDAN	LOCATION	BILLEKAHALLI
FUEL TYPE	DIESEL	ENGINE SOUND LINK	LISTEN ENGINE SOUND

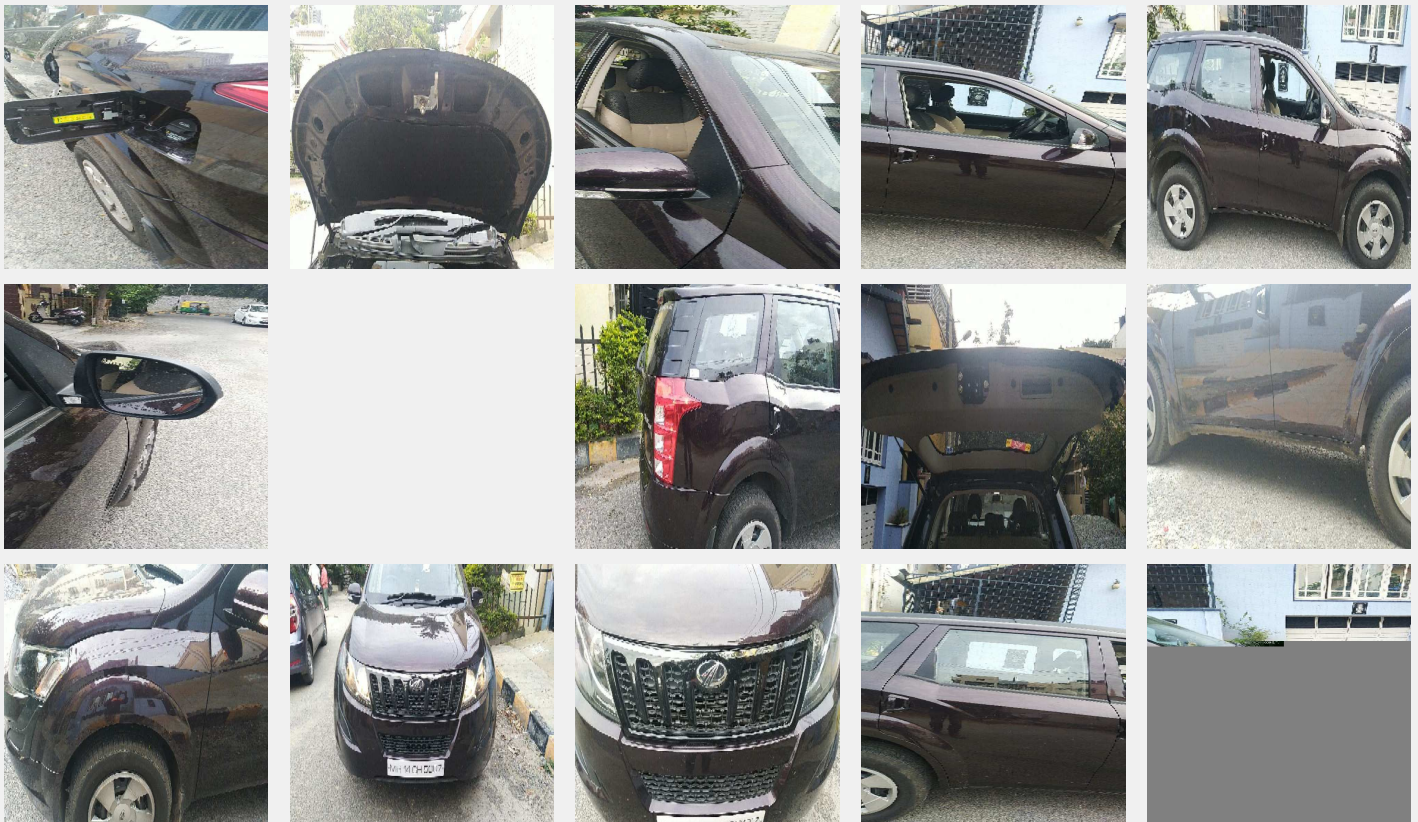
INSPECTION CHECKPOINTS	SCORE(X/10)	REMARKS/COMMENTS	OPTIONAL SPEND EST. (RS)
RH FRONT DOOR	10		0
RH FENDER	10		0
BODY RUST	10		0
ROOF (REGULAR)	10		0
PAINT CONDITION	10		0

all good condition
