ECO INSPECTION REPORT

Order ID : 24782

Ordered By : Anurag | Inspection Date : 2018-09-30 | Valid Till : 2018-12-30

Fiat Linea Emotion 1.3, 2010

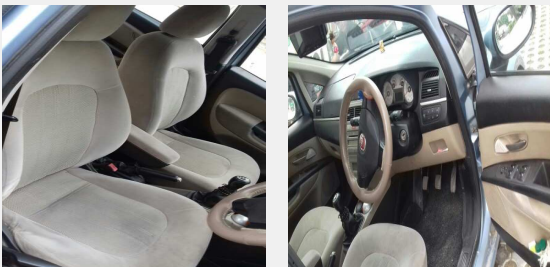
| INSPECTION CHECKPOINTS | SCORE(X/10) | REMARKS/COMMENTS | OPTIONAL SPEND EST. (RS) |
|---|---|---|---|
| SEAT & SEAT BELT | 5 | NEED TO BE DRYCLEANING | 1500 |

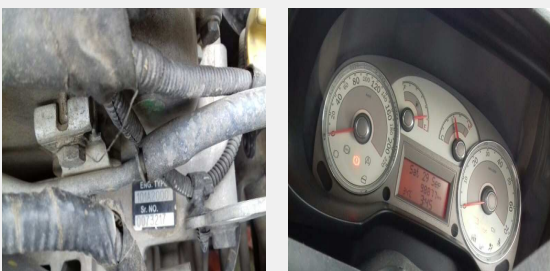
| INSPECTION CHECKPOINTS | SCORE(X/10) | REMARKS/COMMENTS | OPTIONAL SPEND EST. (RS) |
|---|---|---|---|
| ENGINE NOISE | 5 | AVERAGE CANDITION | 0 |

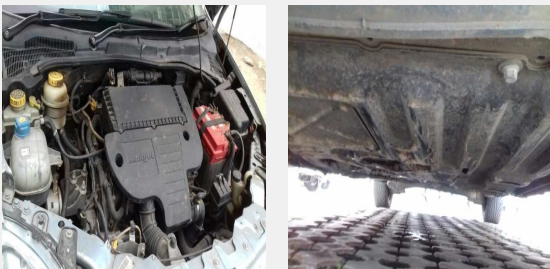
| INSPECTION CHECKPOINTS | SCORE(X/10) | REMARKS/COMMENTS | OPTIONAL SPEND EST. (RS) |
|---|---|---|---|
| ENGINE OIL | 3 | BAD | 2000 |
| COOLANT LEVEL | 4 | BAD | 500 |
| EXHAUST SYSTEM | 5 | BLACK SMOKE | 10000 |

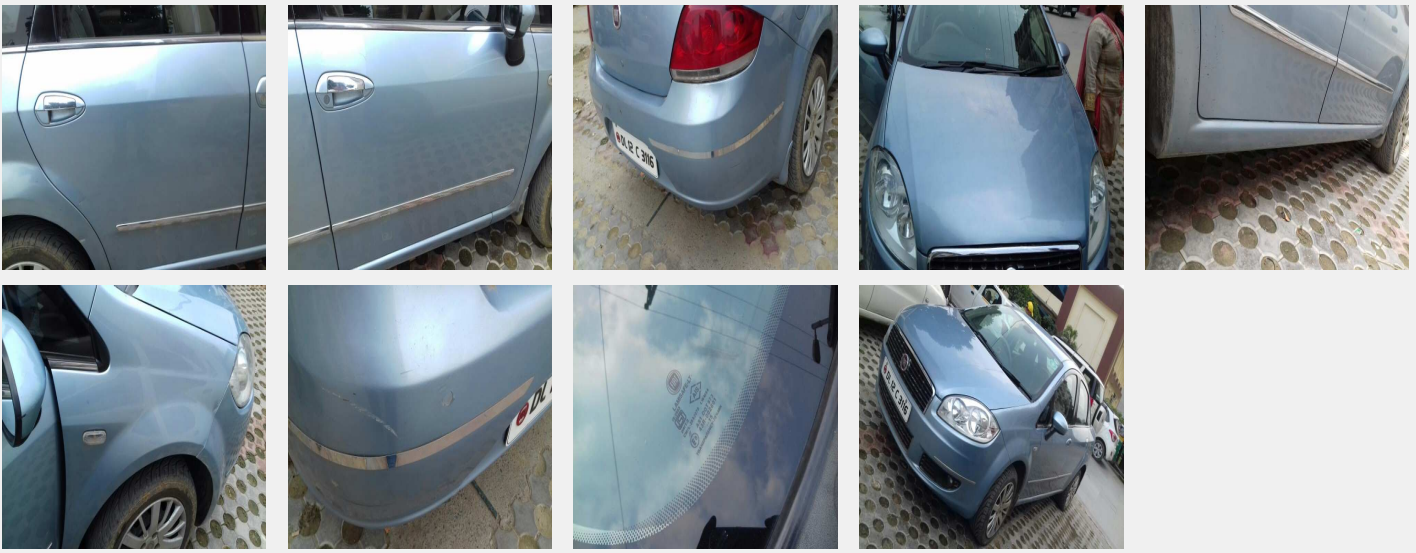
NEED ATTENTION

| INSPECTION CHECKPOINTS | SCORE(X/10) | REMARKS/COMMENTS | OPTIONAL SPEND EST. (RS) |
|---|---|---|---|
| FRONT BUMPER | 5 | PAINTED AND MINOR SCRATCH | 1000 |
| SIDE VIEW MIRRORS | 5 | PAINTED AND SCRATCH | 500 |
| TAIL LIGHT | 4 | BAD CANDITION | 1800 |
| TRUNK LID/TAIL GATE | 4 | PAINTED AND DENT | 0 |

all car is painted without roof rear camera is available frant windshield is all ready change smal
