ECO INSPECTION REPORT Premium

Order ID : 25056

Harley Davidson Iron 883 883cc, 2017

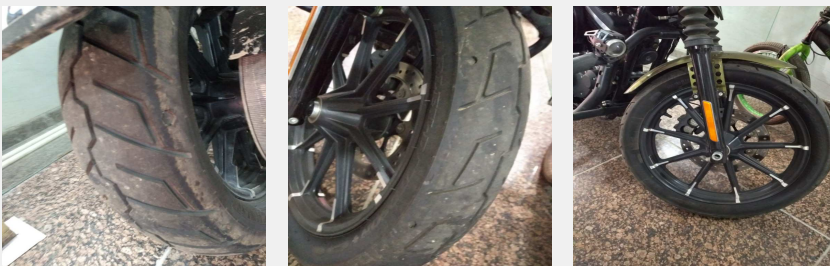
INSPECTION CHECKPOINTS	SCORE(X/10)	REMARKS/COMMENTS	OPTIONAL SPEND EST. (RS)
FRONT TYRE CONDITION & AIR PRESSURE	8		0
REAR TYRE CONDITION & AIR PRESSURE	8		0
WHEEL SPOKES FRONT	8		0
WHEEL SPOKES REAR	8		0
WHEEL RIM FRONT	8		0
WHEEL RIM REAR	8		0
WHEEL BEARINGS FRONT	8		0
WHEEL BEARINGS REAR	8		0
WHEEL SEALS FRONT	8		0
WHEEL SEALS REAR	8		0
BRAKE FUNCTION FRONT	8		0
BRAKE FUNCTION REAR	8		0
BRAKES CONDITION FRONT	8		0
BRAKES CONDITION REAR	8		0

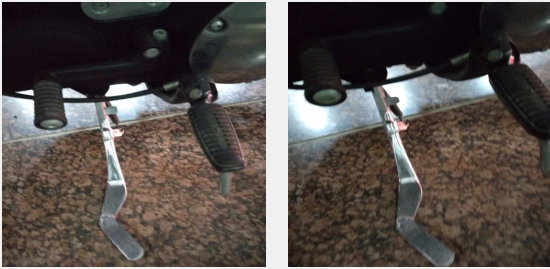
INSPECTION CHECKPOINTS	SCORE(X/10)	REMARKS/COMMENTS	OPTIONAL SPEND EST. (RS)
CENTRE STAND CONDITION	8		0
CENTRE STAND RETENTION	8		0
SIDE STAND CONDITION	8		0
SIDE STAND RETENTION	7		0
