ECO INSPECTION CERTIFICATE

Order ID : 28385

121 Points Vehicle Inspection Certificate

Land Rover Freelander 2 SD4 HSE, 2012

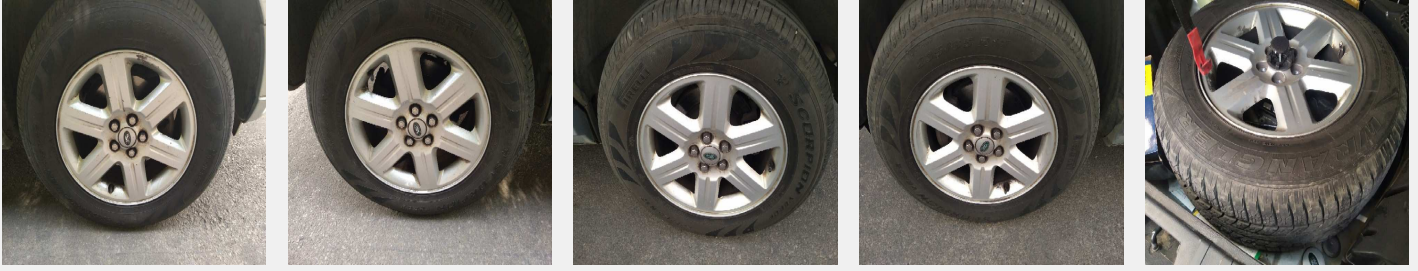
WHEEL

INSPECTION CHECKPOINTS	SCORE(X/10)	REMARKS/COMMENTS	OPTIONAL SPEND EST. (RS)
TYRES	8	GOOD	0

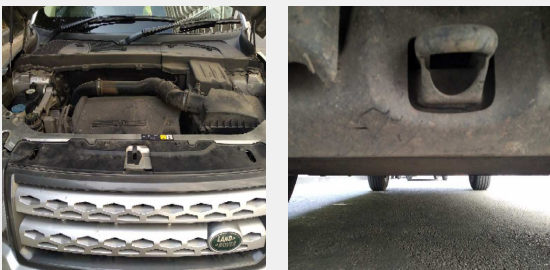
HOOD

INSPECTION CHECKPOINTS	SCORE(X/10)	REMARKS/COMMENTS	OPTIONAL SPEND EST. (RS)
LH APRON	8	GOOD	0
RH APRON	8	GOOD	0
RADIATOR	8	GOOD	0
WIRING	8	GOOD	0
BATTERY	8	GOOD	0
BRAKE FLUID LEVEL	8	GOOD	0
ENGINE OIL	8	GOOD	0
COOLANT LEVEL	8	GOOD	0
BRAKE & COOLANT HOSE PIPES	8	GOOD	0
UNDERCARRIAGE	8	GOOD	0
EXHAUST SYSTEM	8	GOOD	0

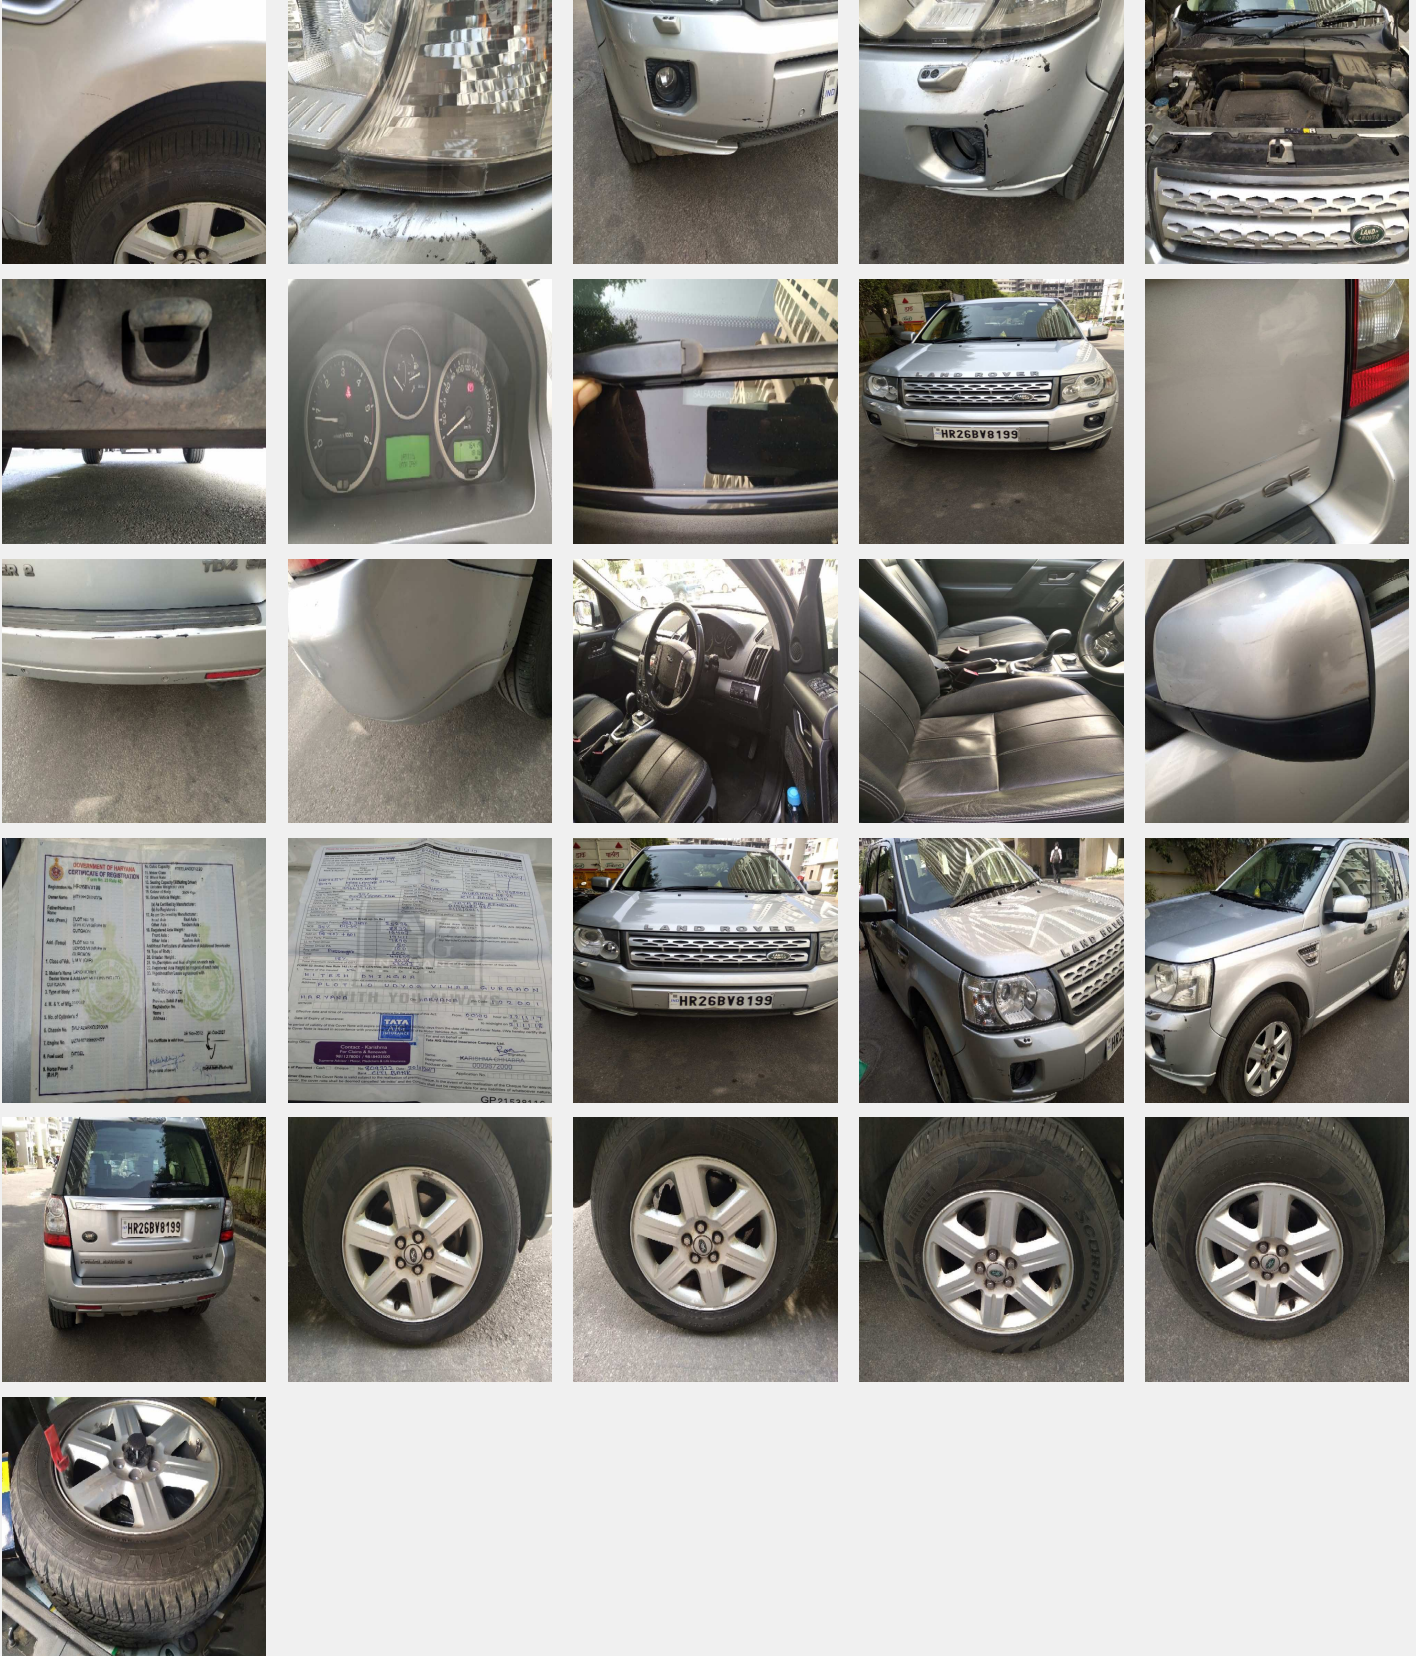
minor scratches all tyres are already changed dent on the fender and backdoor
