ECO INSPECTION CERTIFICATE

Order ID : 26554

121 Points Vehicle Inspection Certificate

Audi Q3 2.0 Tdi Base Grade, 2014

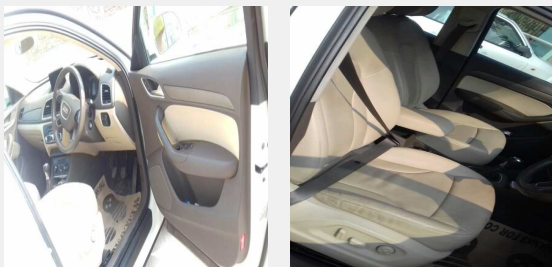
INTERIOR

INSPECTION CHECKPOINTS	SCORE(X/10)	REMARKS/COMMENTS	OPTIONAL SPEND EST. (RS)
DOOR PANEL	7	GOOD	0
DOOR HINGES	7	GOOD	0
CARPET & FLOOR MAT	7	GOOD	0
SEAT & SEAT BELT	7	GOOD	0
DASHBOARD & INSTRUMENT PANEL	7	GOOD	0
HORN	7	GOOD	0
SPEAKERS & MUSIC SYSTEM	7	GOOD	0
HANDBRAKE	7	GOOD	0
STEERING-MOUNTED CONTROLS	7	GOOD	0
PEDALS	7	GOOD	0
CENTRAL LOCK	7	GOOD	0
A/C VENTS & HEATER	7	GOOD	0
CUP HOLDERS	7	GOOD	0
ODOMETER	7	GOOD	0
HAZARD LIGHT	7	GOOD	0

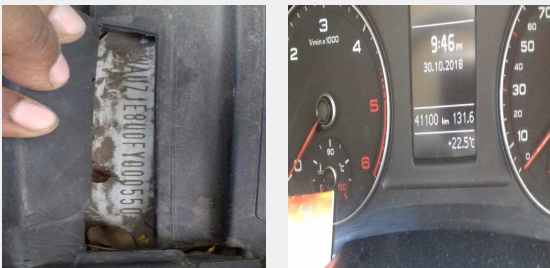
TEST DRIVE

INSPECTION CHECKPOINTS	SCORE(X/10)	REMARKS/COMMENTS	OPTIONAL SPEND EST. (RS)
STEERING PERFORMANCE	7	GOOD	0
BRAKE PERFORMANCE	7	GOOD	0
CLUTCH PERFORMANCE	6	GOOD	0
ENGINE NOISE	7	GOOD	0
IGNITION SYSTEM	7	GOOD	0
SUSPENSION PERFORMANCE	7	GOOD	0
SUSPENSION FRONT SHOCKS	7	GOOD	0
SUSPENSION REAR SHOCKS	7	GOOD	0
TRANSMISSION ENGAGE	7	GOOD	0

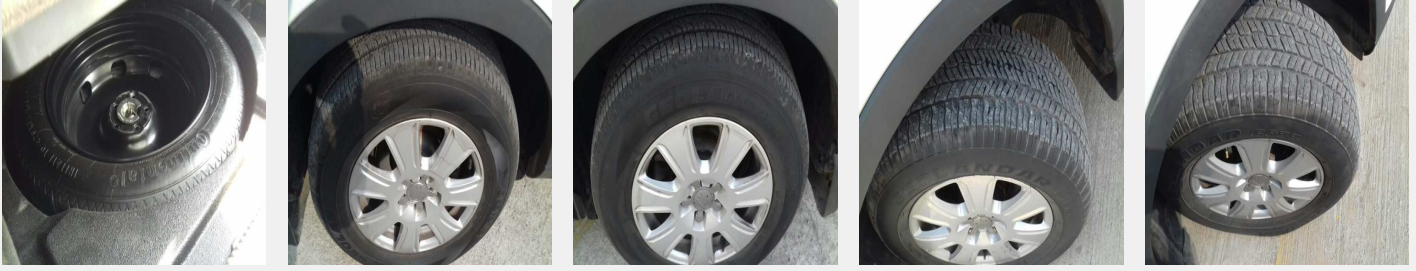
WHEEL

INSPECTION CHECKPOINTS	SCORE(X/10)	REMARKS/COMMENTS	OPTIONAL SPEND EST. (RS)
TYRES	7	GOOD	0

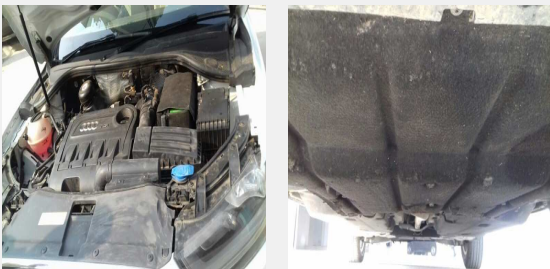
HOOD

INSPECTION CHECKPOINTS	SCORE(X/10)	REMARKS/COMMENTS	OPTIONAL SPEND EST. (RS)
LH APRON	7	GOOD	0
RH APRON	7	GOOD	0
RADIATOR	7	GOOD	0
WIRING	7	GOOD	0
BATTERY	6	GOOD	0
BRAKE FLUID LEVEL	7	GOOD	0
BRAKE & COOLANT HOSE PIPES	7	GOOD	0
UNDERCARRIAGE	7	GOOD	0
EXHAUST SYSTEM	7	GOOD	0
ENGINE OIL	3	BAD	8500
COOLANT LEVEL	3	BAD	1500

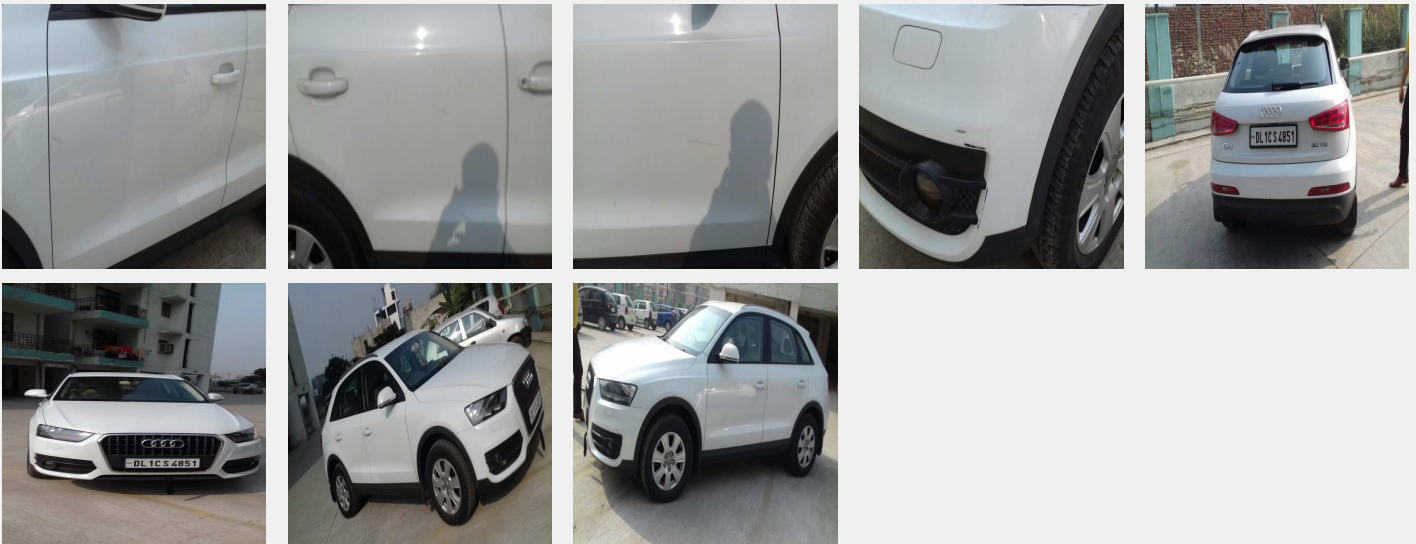
EXTERIOR (CONTINUED)

INSPECTION CHECKPOINTS	SCORE(X/10)	REMARKS/COMMENTS	OPTIONAL SPEND EST. (RS)
LICENSE PLATE	7	GOOD	0
FRONT BUMPER	6	MINOR SCRATCH	4000
HEAD LIGHTS	7	GOOD	0
GRILLE	7	GOOD	0
TURN SIGNAL	7	GOOD	0
FOG LAMPS	7	GOOD	0
HOOD	7	GOOD	0
PILLAR	7	GOOD	0
FRONT WINDSHIELD	7	GOOD	0
SIDE VIEW MIRRORS	7	GOOD	0
LH FENDER	7	GOOD	0
LH FRONT DOOR	6	MINOR SCRATCH	0
LH REAR DOOR	7	GOOD	0
LH RUNNING BOARD	7	GOOD	0
LH QUARTER PANEL	7	GOOD	0
FUEL LID	7	GOOD	0
REAR WINDSHIELD	7	GOOD	0
REAR BUMPER	7	GOOD	0
TAIL LIGHT	7	GOOD	0
TRUNK LID/TAIL GATE	7	GOOD	0
LUGGAGE COMPARTMENT LIGHT	7	GOOD	0
RH QUARTER PANEL	7	GOOD	0
RH RUNNING BOARD	7	GOOD	0
RH REAR DOOR	6	MINOR SCRATCH	0

INSPECTION CHECKPOINTS	SCORE(X/10)	REMARKS/COMMENTS	OPTIONAL SPEND EST. (RS)
RH FRONT DOOR	6	MINOR SCRATCH	3500
RH FENDER	7	GOOD	0
BODY RUST	7	GOOD	0
PAINT CONDITION	7	GOOD	0
