ECO INSPECTION CERTIFICATE

Order ID : 29730

121 Points Vehicle Inspection Certificate

Fiat Linea Active T-Jet, 2016

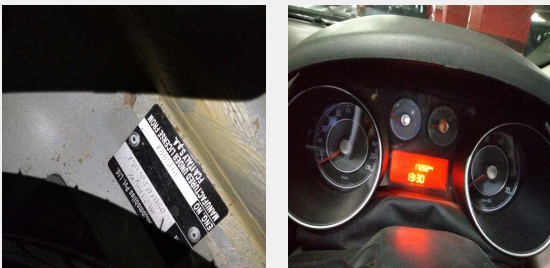
INSPECTION CHECKPOINTS	SCORE(X/10)	REMARKS/COMMENTS	OPTIONAL SPEND EST. (RS)
STEERING PERFORMANCE	8	GOOD	0
BRAKE PERFORMANCE	8	GOOD	0
CLUTCH PERFORMANCE	8	GOOD	0
ENGINE NOISE	8	GOOD	0
IGNITION SYSTEM	8	GOOD	0
SUSPENSION PERFORMANCE	8	GOOD	0
SUSPENSION FRONT SHOCKS	8	GOOD	0
SUSPENSION REAR SHOCKS	8	GOOD	0
TRANSMISSION ENGAGE	8	GOOD	0

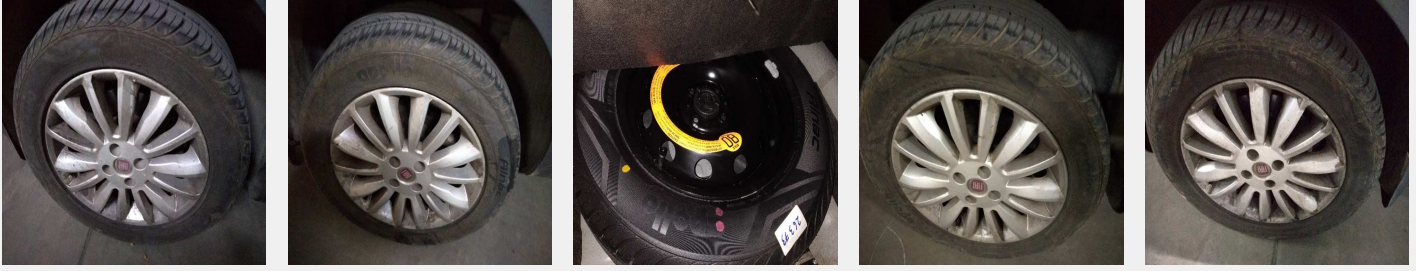
INSPECTION CHECKPOINTS	SCORE(X/10)	REMARKS/COMMENTS	OPTIONAL SPEND EST. (RS)
TYRES	8	GOOD	0

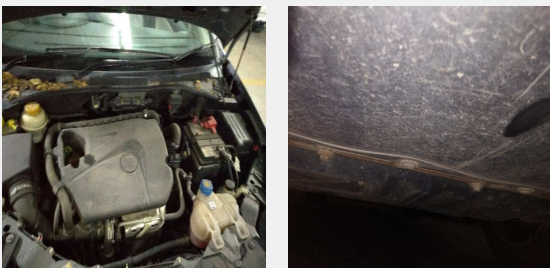
INSPECTION CHECKPOINTS	SCORE(X/10)	REMARKS/COMMENTS	OPTIONAL SPEND EST. (RS)
LH APRON	8	GOOD	0
RH APRON	8	GOOD	0
RADIATOR	8	GOOD	0
WIRING	8	GOOD	0
BATTERY	8	GOOD	0
BRAKE FLUID LEVEL	8	GOOD	0
ENGINE OIL	8	GOOD	0
COOLANT LEVEL	8	GOOD	0
BRAKE & COOLANT HOSE PIPES	8	GOOD	0
UNDERCARRIAGE	8	GOOD	0
EXHAUST SYSTEM	8	GOOD	0

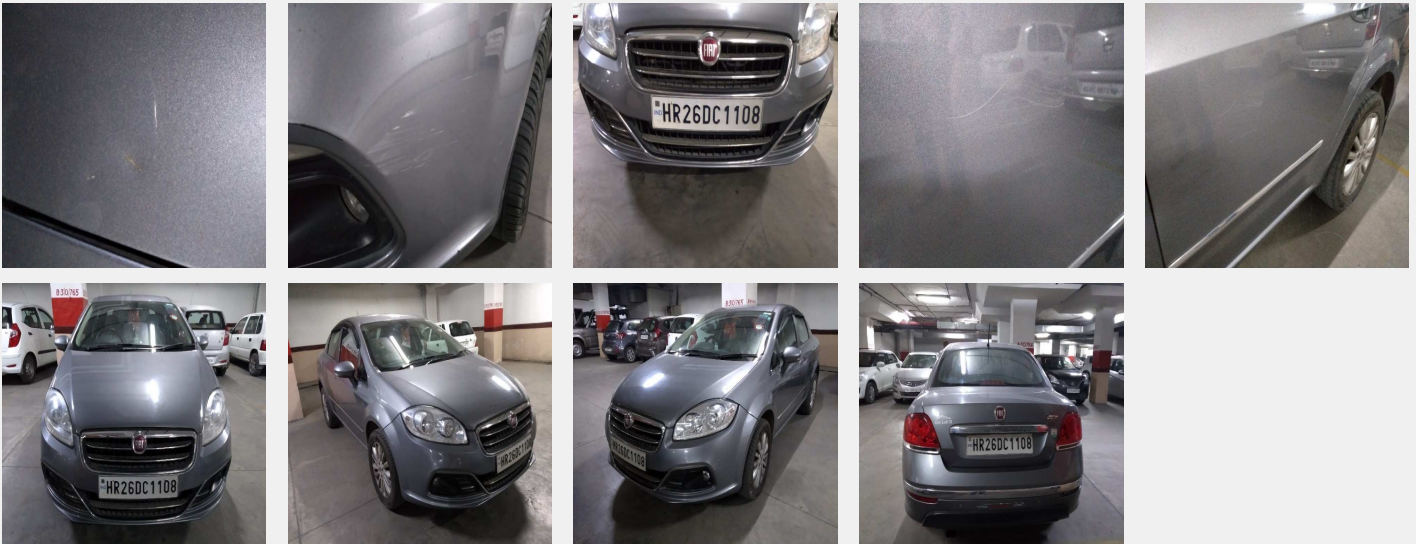
INSPECTION CHECKPOINTS	SCORE(X/10)	REMARKS/COMMENTS	OPTIONAL SPEND EST. (RS)
PAINT CONDITION	8	GOOD	0
FRONT BUMPER	2	NEED TO REPAIR	10000
HOOD	1	NEED TO REPAIR	10000
LH REAR DOOR	5	NEED TO REPAIR	10000

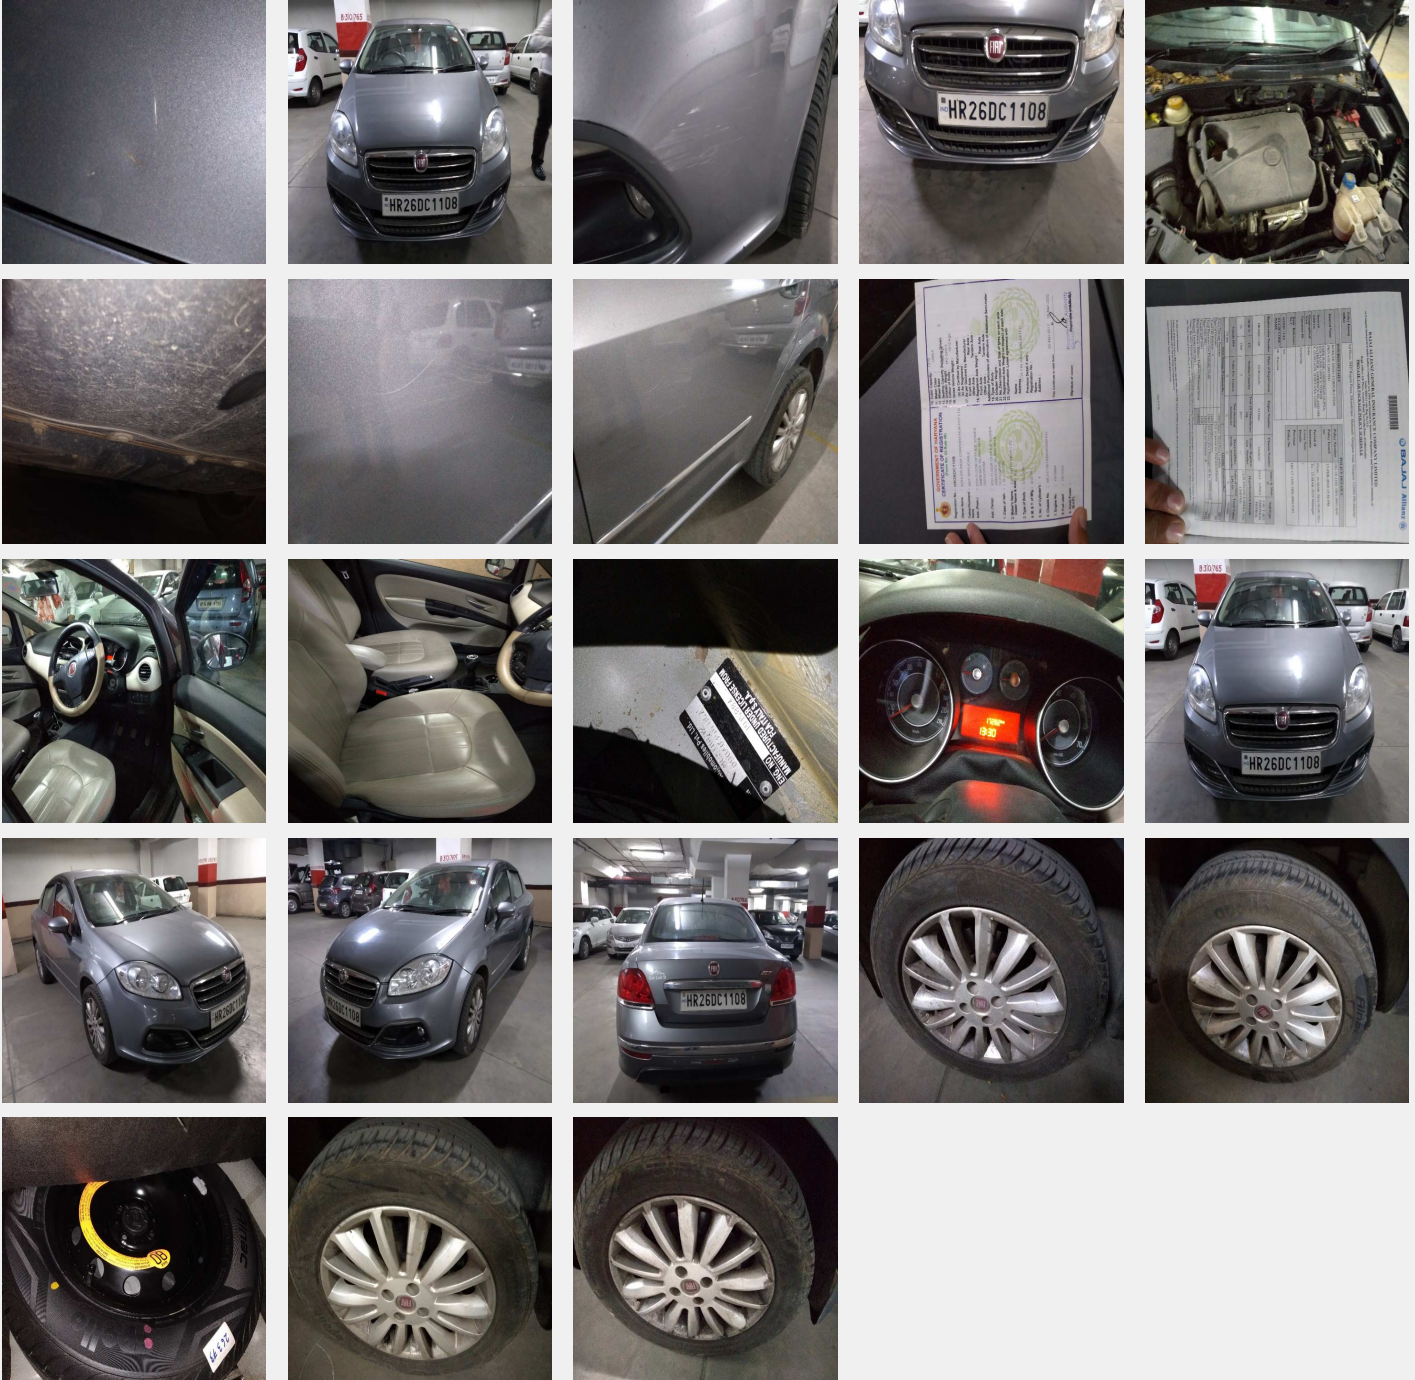
minor scratches minor dent
