ECO INSPECTION CERTIFICATE

Order ID : 30293

121 Points Vehicle Inspection Certificate

Bajaj Ct 100 100CC, 2004

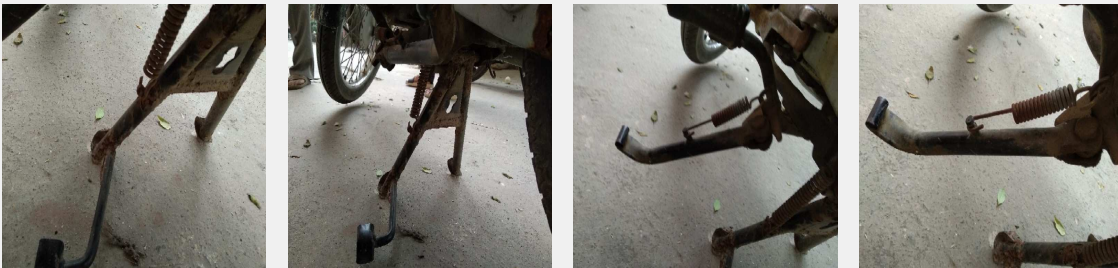
IMAGES

INSPECTION CHECKPOINTS	SCORE(X/10)	REMARKS/COMMENTS	OPTIONAL SPEND EST. (RS)
CENTRE STAND RETENTION	6	GOOD	0
SIDE STAND RETENTION	6	GOOD	0
CENTRE STAND CONDITION	3	RUSTED NEED TO BE CHANGE	500
SIDE STAND CONDITION	4	RUSTED NEED TO BE CHANGE	500

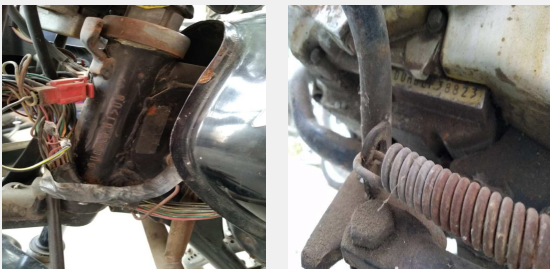
IMAGES

INSPECTION CHECKPOINTS	SCORE(X/10)	REMARKS/COMMENTS	OPTIONAL SPEND EST. (RS)
FRAME CONDITION	6	GOOD	0
FRAME STEERING-HEAD BEARINGS	6	GOOD	0
FRAME SWINGARM BUSHINGS	6	GOOD	0
SUSPENSION FRONT FORKS LEFT	6	GOOD	0
SUSPENSION FRONT FORKS RIGHT	6	GOOD	0
SUSPENSION REAR SHOCKS LEFT	6	GOOD	0
SUSPENSION REAR SHOCKS RIGHT	6	GOOD	0
CHAIN/BELT TENSION	6	GOOD	0
CHAIN/BELT LUBRICATION	6	GOOD	0
CHAIN/BELT SPROCKETS	6	GOOD	0
FASTENERS THREADED	6	GOOD	0
FASTENERS CLIPS & COTTER PINS	6	GOOD	0
ENGINE	6	GOOD	0
TRANSMISSION	6	GOOD	0

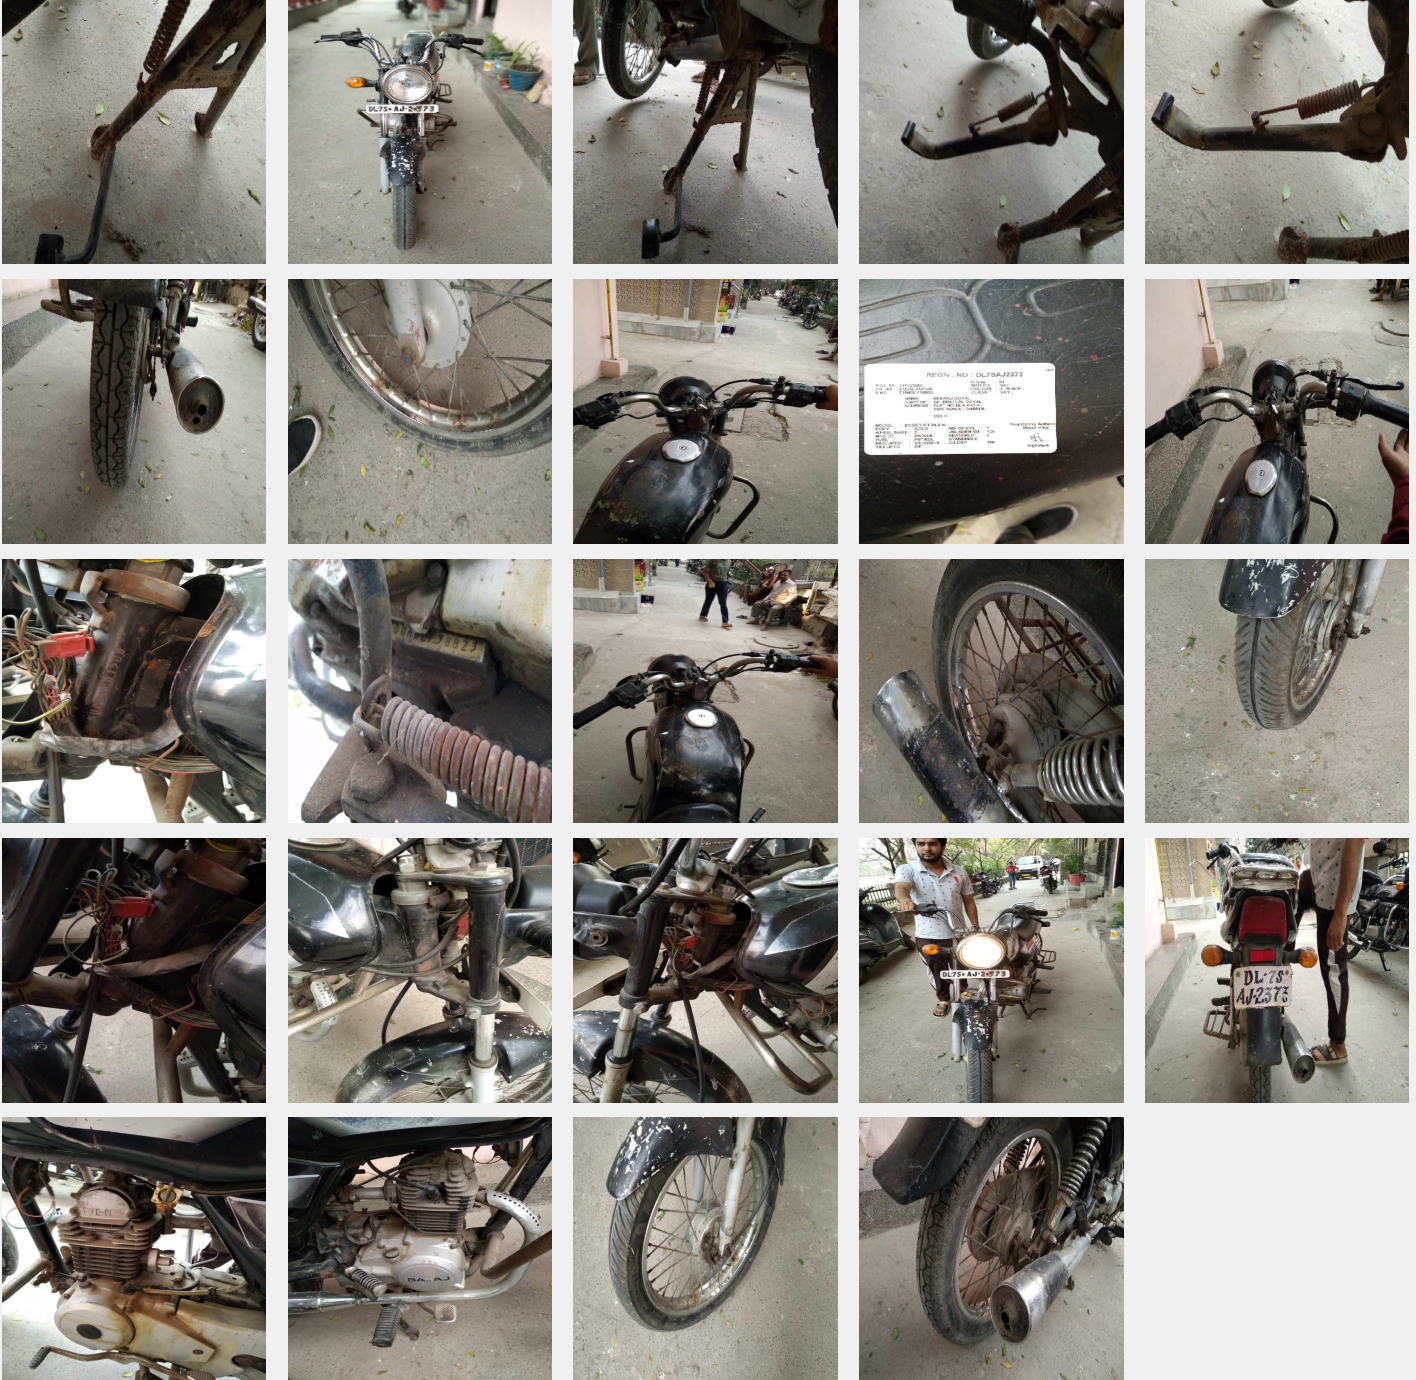
IMAGES

front Rim registered all wire open all indicator not working rear break light not working fuel t
