ECO INSPECTION CERTIFICATE

Order ID : 30595

121 Points Vehicle Inspection Certificate

Fiat Linea 1.4 T-JET EMOTION, 2014

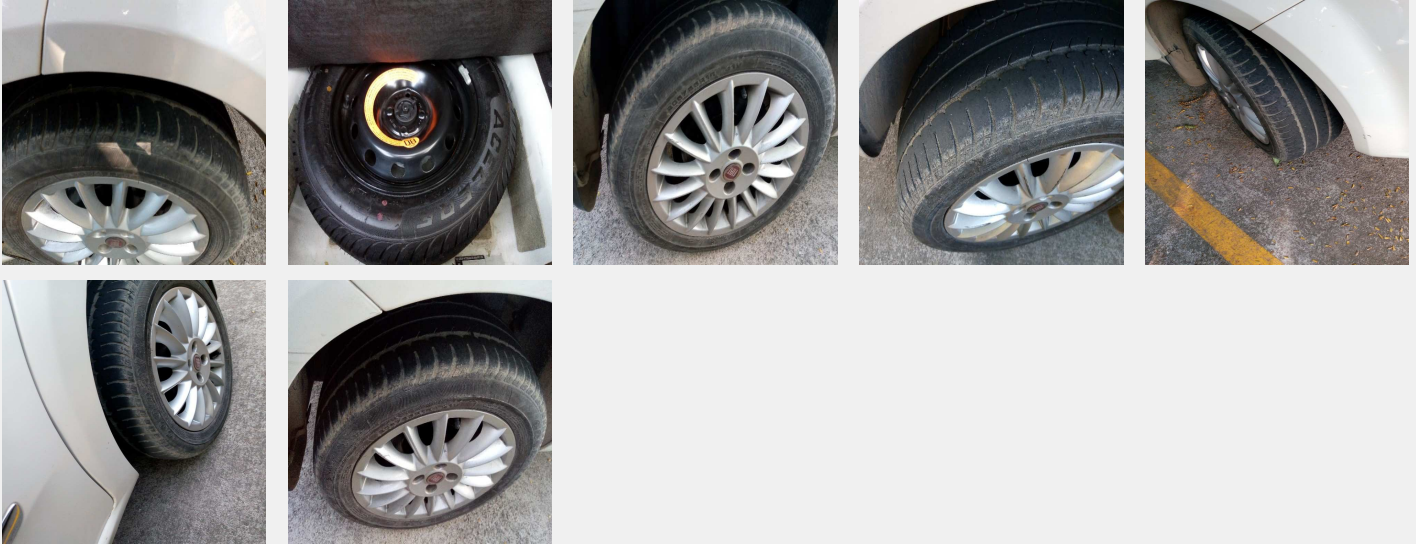
WHEEL

INSPECTION CHECKPOINTS	SCORE(X/10)	REMARKS/COMMENTS	OPTIONAL SPEND EST. (RS)
TYRES	7		0

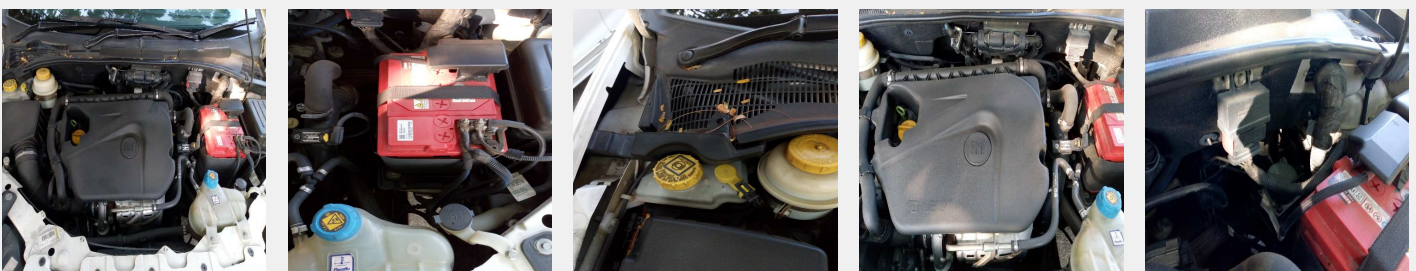
HOOD

INSPECTION CHECKPOINTS	SCORE(X/10)	REMARKS/COMMENTS	OPTIONAL SPEND EST. (RS)
LH APRON	9		0
RH APRON	10		0
RADIATOR	10	GOOD	0
WIRING	10	GOOD	0
BATTERY	10		0
BRAKE FLUID LEVEL	10	GOOD	0
ENGINE OIL	10	GOOD	0
COOLANT LEVEL	10	GOOD	0
BRAKE & COOLANT HOSE PIPES	10	GOOD	0
UNDERCARRIAGE	9	GOOD	0
EXHAUST SYSTEM	10	GOOD	0

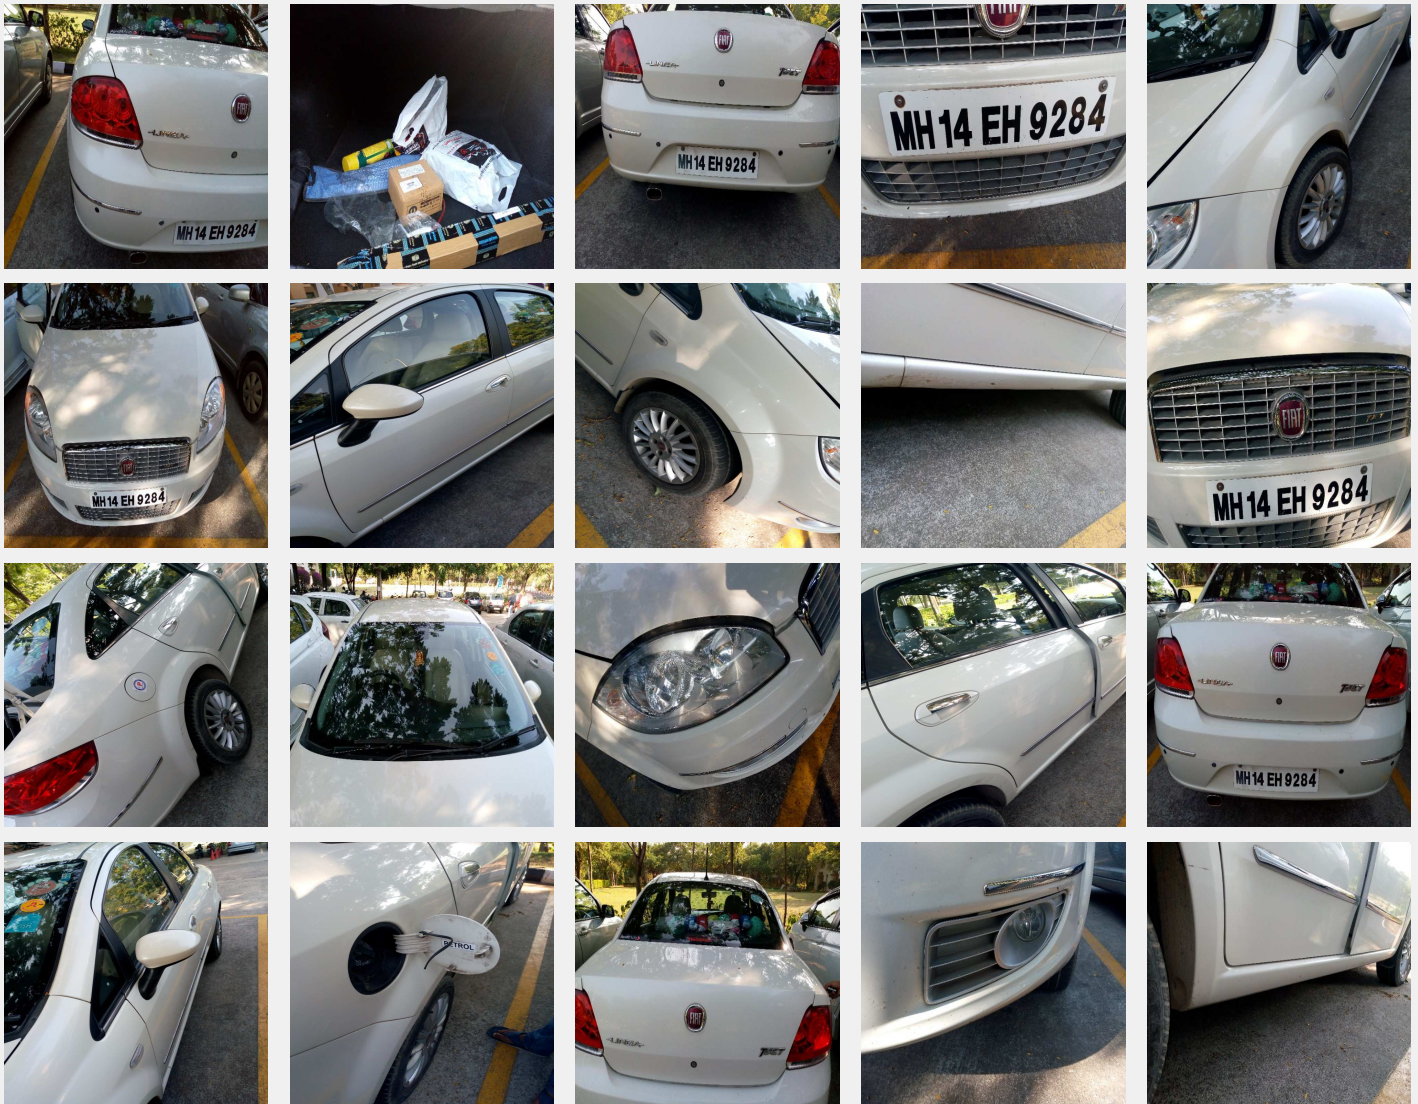
EXTERIOR (CONTINUED)

INSPECTION CHECKPOINTS	SCORE(X/10)	REMARKS/COMMENTS	OPTIONAL SPEND EST. (RS)
RH FRONT DOOR	10		0
RH FENDER	10		0
BODY RUST	10		0
PAINT CONDITION	9		0
