ECO INSPECTION CERTIFICATE

Order ID : 30825

121 Points Vehicle Inspection Certificate

Volkswagen Passat HIGHLINE DSG S, 2008

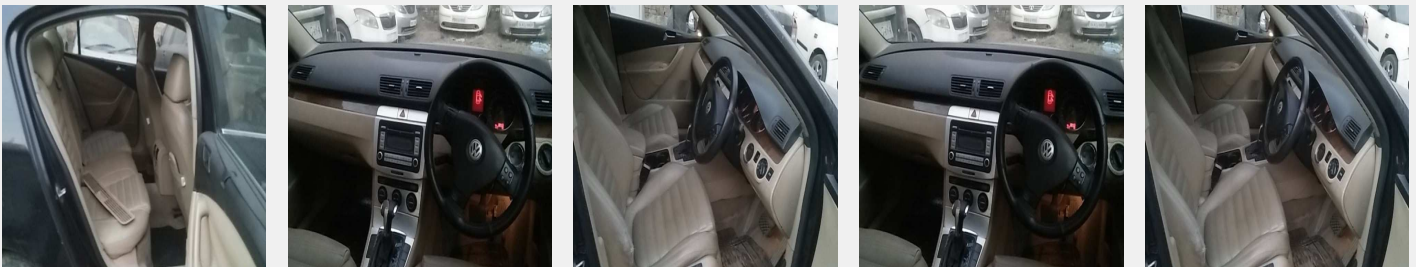
IMAGES

INSPECTION CHECKPOINTS	SCORE(X/10)	REMARKS/COMMENTS	OPTIONAL SPEND EST. (RS)
DOOR PANEL	6		0
DOOR HINGES	7		0
CARPET & FLOOR MAT	6		0
SEAT & SEAT BELT	7		0
DASHBOARD & INSTRUMENT PANEL	6		0
HORN	7		0
SPEAKERS & MUSIC SYSTEM	7		0
HANDBRAKE	6		0
STEERING-MOUNTED CONTROLS	7		0
PEDALS	6		0
CENTRAL LOCK	7		0
A/C VENTS & HEATER	7		0
CUP HOLDERS	7		0
NAVIGATION (NO)	10		0
ODOMETER	7		0
POWER WINDOWS (YES)	7		0
HAZARD LIGHT	6		0

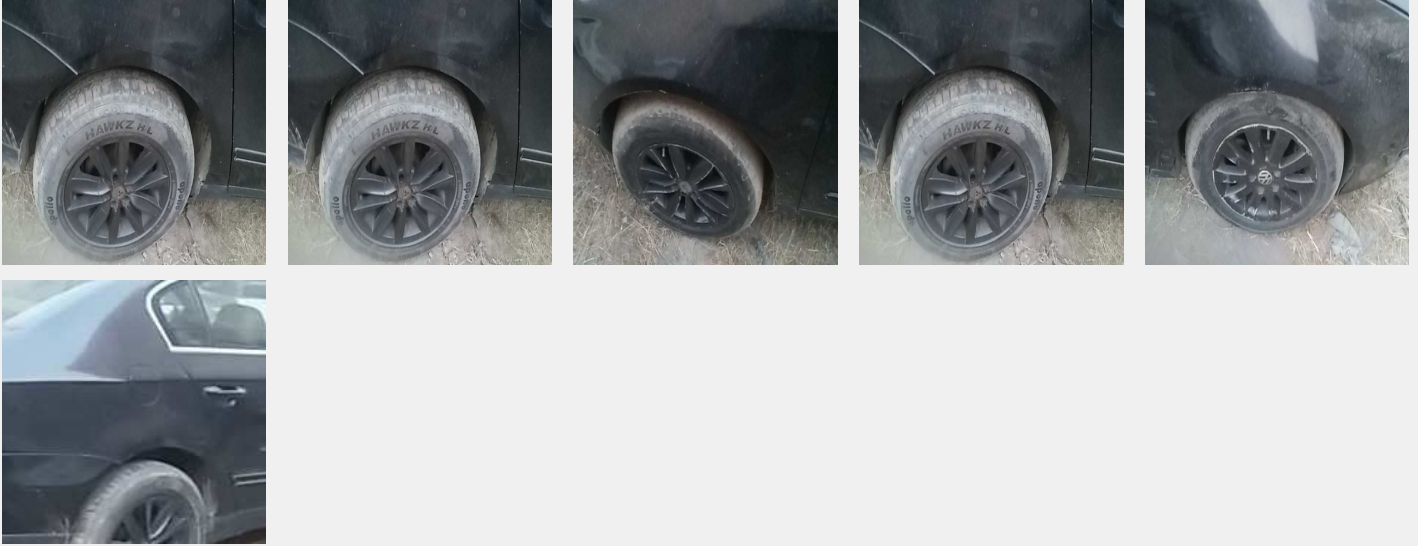
IMAGES

INSPECTION CHECKPOINTS	SCORE(X/10)	REMARKS/COMMENTS	OPTIONAL SPEND EST. (RS)
TYRES	6		0
SPARE TYRE (NO)	10		0
WHEEL ASSEMBLY	6		0

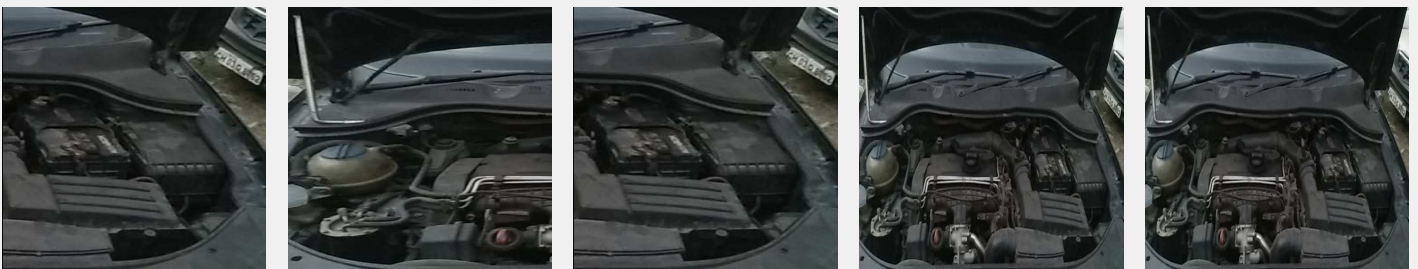
IMAGES

INSPECTION CHECKPOINTS	SCORE(X/10)	REMARKS/COMMENTS	OPTIONAL SPEND EST. (RS)
LH APRON	7		0
RH APRON	7		0
RADIATOR	6		0
WIRING	7		0
BATTERY	6		0
BRAKE FLUID LEVEL	6		0
ENGINE OIL	7		0
COOLANT LEVEL	6		0
BRAKE & COOLANT HOSE PIPES	7		0
UNDERCARRIAGE	7		0
EXHAUST SYSTEM	6		0

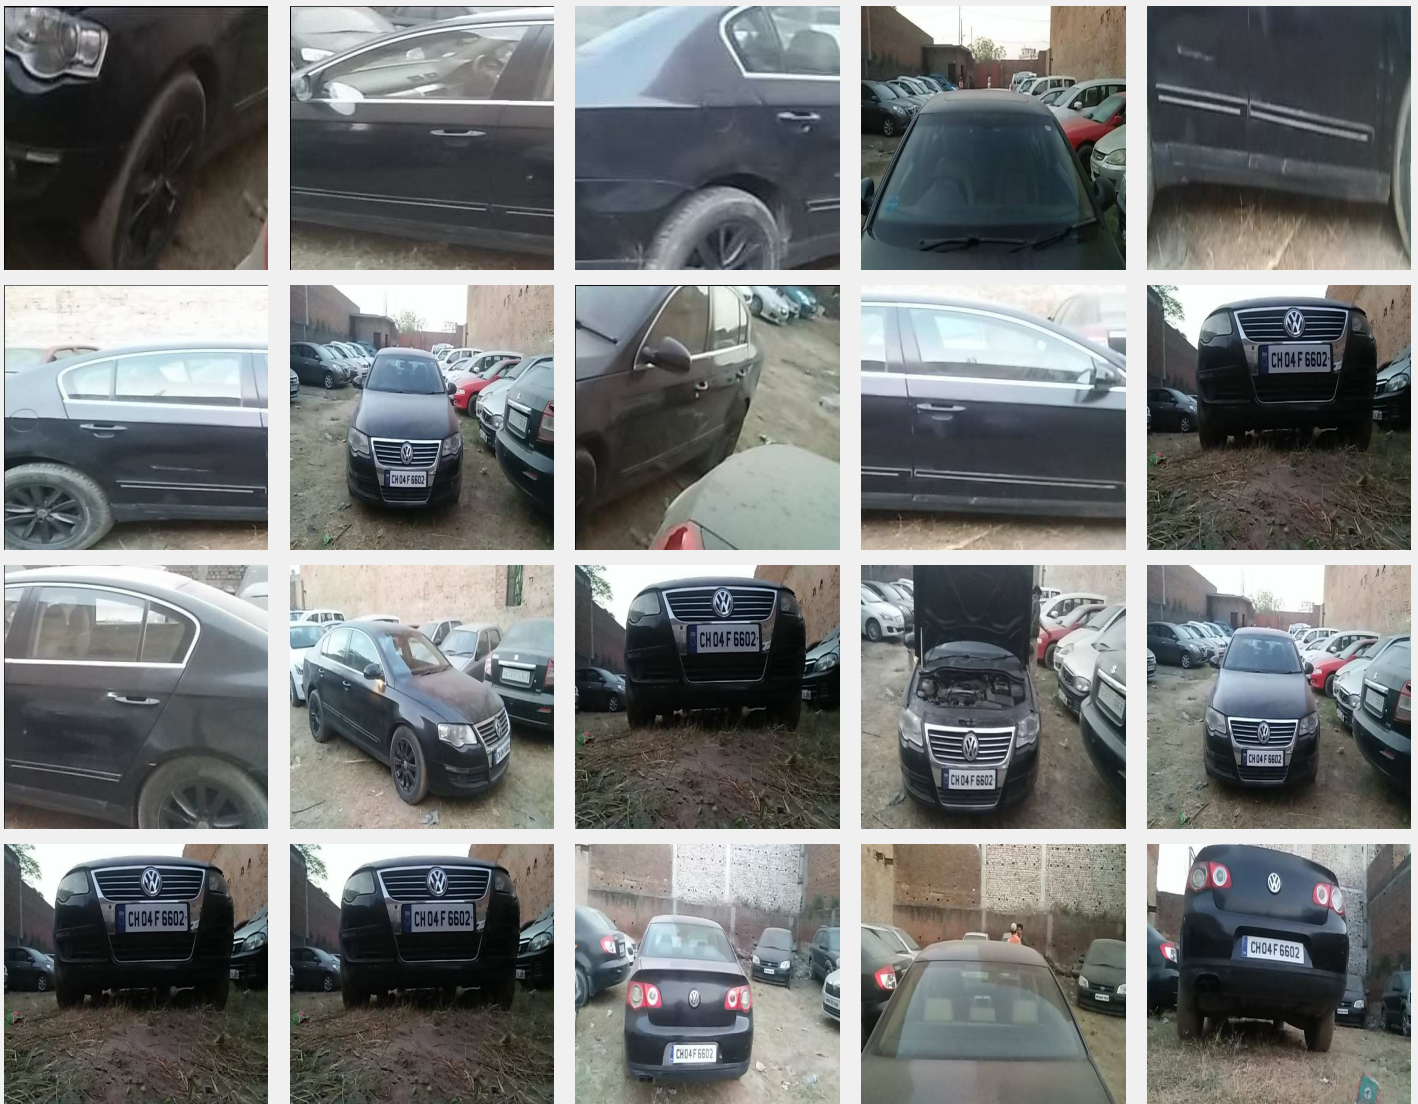
IMAGES

INSPECTION CHECKPOINTS	SCORE(X/10)	REMARKS/COMMENTS	OPTIONAL SPEND EST. (RS)
LICENSE PLATE	7		0
FRONT BUMPER	7		0
HEAD LIGHTS	7		0
GRILLE	7		0
TURN SIGNAL	6		0
HOOD	6		0
PILLAR	6		0
FRONT WINDSHIELD	7		0
SIDE VIEW MIRRORS	6		0
LH FENDER	7		0
LH FRONT DOOR	6		0
LH REAR DOOR	6		0
LH RUNNING BOARD	7		0
LH QUARTER PANEL	6		0
FUEL LID	7		0
REAR WINDSHIELD	7		0
REAR BUMPER	7		0
TAIL LIGHT	6		0
TRUNK LID/TAIL GATE	6		0
LUGGAGE COMPARTMENT LIGHT	6		0
RH QUARTER PANEL	6		0
RH FRONT DOOR	6	MINOR SCRATHES	0
RH FENDER	6		0
BODY RUST	7		0

INSPECTION CHECKPOINTS	SCORE(X/10)	REMARKS/COMMENTS	OPTIONAL SPEND EST. (RS)
ROOF (REGULAR)	6		0
PAINT CONDITION	6		0
FOG LAMPS	0	NOT FITTED	5000
RH RUNNING BOARD	5	SCRATHES AND DENTS	5000
RH REAR DOOR	5	SCRATHES	2000
