ECO INSPECTION CERTIFICATE

121 Points Vehicle Inspection Certificate

Tvs Wego 110CC, 2013

MAKE	TVS	LOCATION	NAJAFGARH
MODEL	WEGO	REGISTRATION NO.	DL4SCE4264
YEAR	2013	VIN/CHASIS NUMBER	5698
TRIM	110CC	KMS RUN	26796
COLOR	WHITE	INSURANCE EXPIRY	2018-9-11
FUEL TYPE	PETROL	ENGINE SOUND LINK	LISTEN ENGINE SOUND

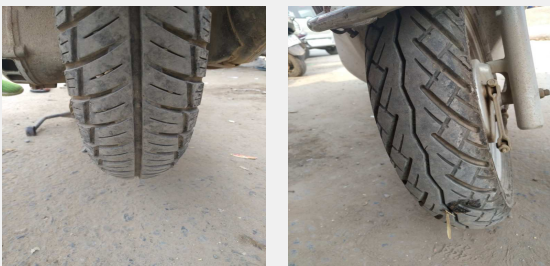
INSPECTION CHECKPOINTS	SCORE(X/10)	REMARKS/COMMENTS	OPTIONAL SPEND EST. (RS)
FRONT TYRE CONDITION & AIR PRESSURE	6		0
REAR TYRE CONDITION & AIR PRESSURE	6		0
WHEEL SPOKES FRONT	6		0
WHEEL SPOKES REAR	6		0
WHEEL RIM FRONT	6		0
WHEEL RIM REAR	6		0
WHEEL BEARINGS FRONT	6		0
WHEEL BEARINGS REAR	6		0
WHEEL SEALS FRONT	6		0
WHEEL SEALS REAR	6		0
BRAKE FUNCTION FRONT	6		0
BRAKE FUNCTION REAR	6		0
BRAKES CONDITION FRONT	6		0
BRAKES CONDITION REAR	6		0

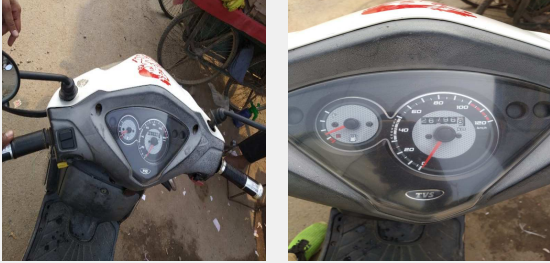
CONTROL

INSPECTION CHECKPOINTS	SCORE(X/10)	REMARKS/COMMENTS	OPTIONAL SPEND EST. (RS)
HANDLEBARS CONDITION	6		0
LEVERS & PEDAL CONDITION	6		0
PIVOTS	6		0
CABLES CONDITION	6		0
CABLES ROUTING	6		0
HOSES CONDITION	6		0
HOSES ROUTING	6		0
THROTTLE OPERATION	6		0

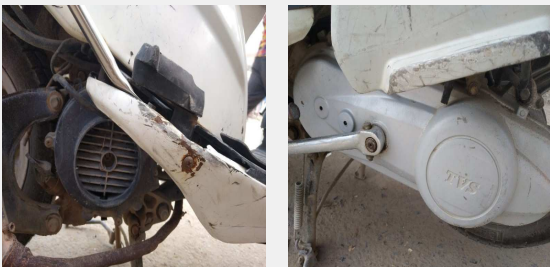
INSPECTION CHECKPOINTS	SCORE(X/10)	REMARKS/COMMENTS	OPTIONAL SPEND EST. (RS)
LEVELS - ENGINE OIL	6		0
LEVELS - GEAR OIL/SHAFT DRIVE (YES)	6		0
LEVELS - HYDRAULIC FLUID (YES)	6		0
LEVELS - COOLANT (YES)	6		0
LEVELS - FUEL	6		0
LEAKS - ENGINE OIL	6		0
LEAKS - GEAR OIL	6		0
LEAKS - HYDRAULIC FLUID	6		0
LEAKS - COOLANT	6		0
LEAKS - FUEL	6		0
