ECO INSPECTION CERTIFICATE

Order ID : 31828

121 Points Vehicle Inspection Certificate

Fiat Linea EMOTION 1.3, 2009

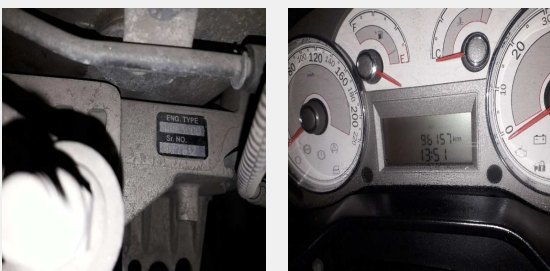
IMAGES

INSPECTION CHECKPOINTS	SCORE(X/10)	REMARKS/COMMENTS	OPTIONAL SPEND EST. (RS)
STEERING PERFORMANCE	6	GOOD	0
BRAKE PERFORMANCE	6	GOOD	0
CLUTCH PERFORMANCE	6	GOOD	0
IGNITION SYSTEM	6	GOOD	0
SUSPENSION FRONT SHOCKS	6	GOOD	0
SUSPENSION REAR SHOCKS	6	GOOD	0
TRANSMISSION ENGAGE	6	GOOD	0
CRUISE CONTROL (NO)	10		0
REAR PARKING SENSORS (NO)	10		0
REAR VIEW CAMERA (YES)	6	GOOD	0
ENGINE NOISE	5	GOOD	0
SUSPENSION PERFORMANCE	4	MINOR SOUND	6000

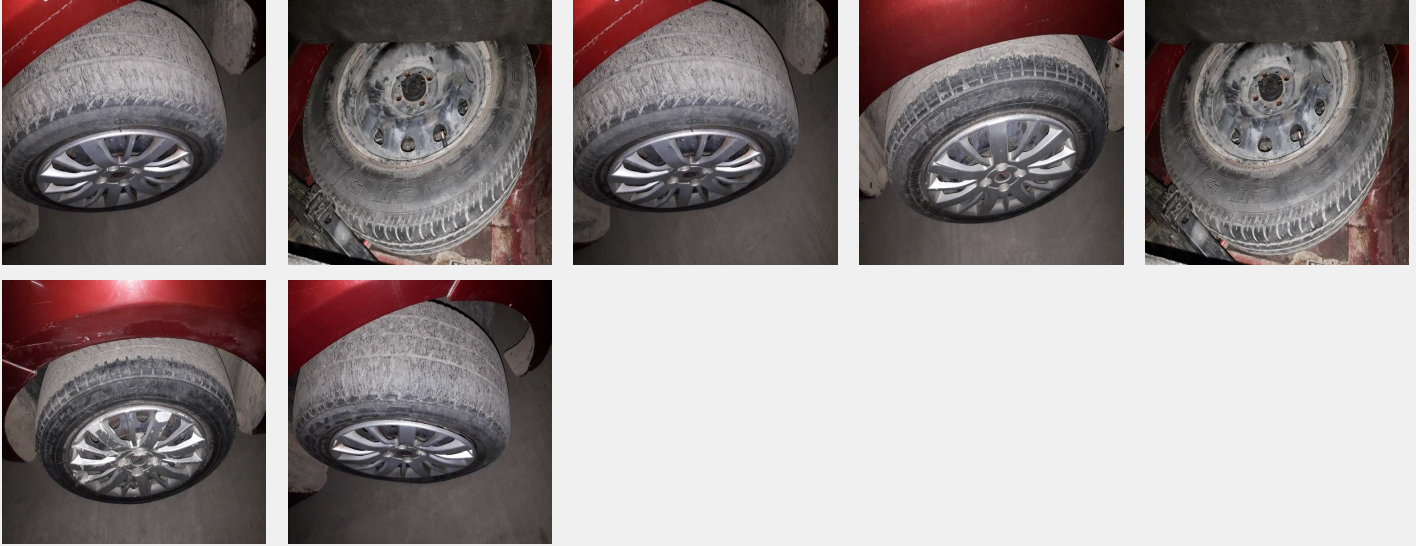
IMAGES

INSPECTION CHECKPOINTS	SCORE(X/10)	REMARKS/COMMENTS	OPTIONAL SPEND EST. (RS)
WHEEL ASSEMBLY (STEEL RIM)	6	GOOD	0
TYRES	3	BAD	16000
SPARE TYRE (YES)	3	BAD	4000

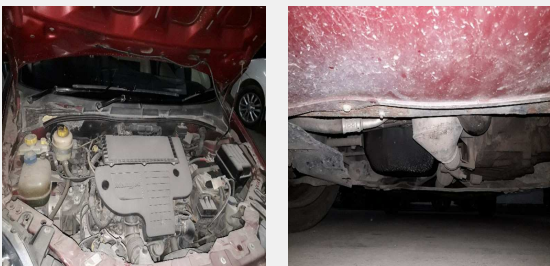
IMAGES

INSPECTION CHECKPOINTS	SCORE(X/10)	REMARKS/COMMENTS	OPTIONAL SPEND EST. (RS)
LH APRON	6	GOOD	0
RH APRON	6	GOOD	0
RADIATOR	6	GOOD	0
WIRING	6	GOOD	0
BATTERY	6	GOOD	0
BRAKE FLUID LEVEL	6	GOOD	0
BRAKE & COOLANT HOSE PIPES	6	GOOD	0
UNDERCARRIAGE	6	GOOD	0
ENGINE OIL	3	BAD	3000
COOLANT LEVEL	3	BAD	500
EXHAUST SYSTEM	5	MINOR BLACK SMOKE	5000

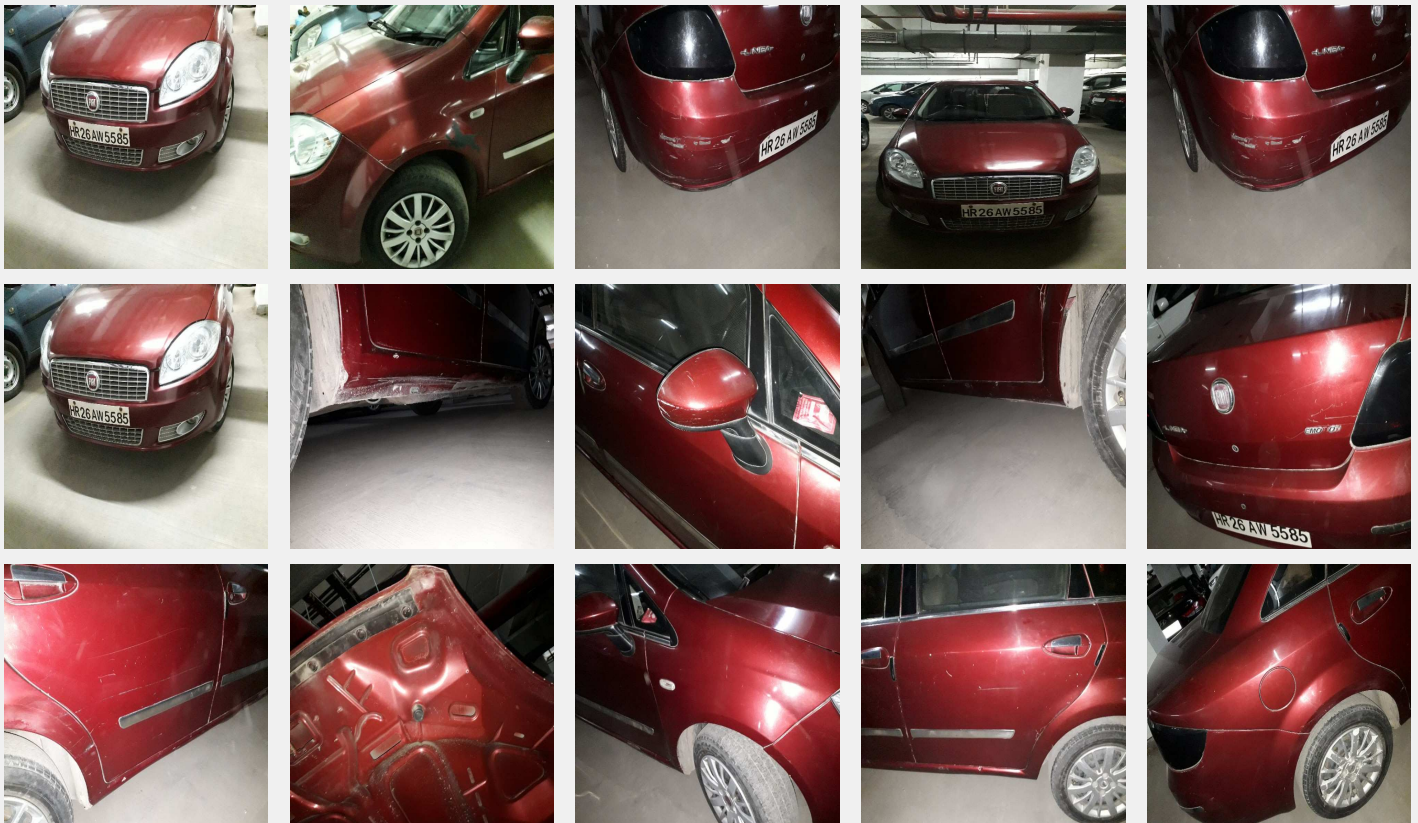
IMAGES

INSPECTION CHECKPOINTS	SCORE(X/10)	REMARKS/COMMENTS	OPTIONAL SPEND EST. (RS)
LICENSE PLATE	6	GOOD	0
HEAD LIGHTS	6	GOOD	0
GRILLE	6	GOOD	0
TURN SIGNAL	6	GOOD	0
PILLAR	6	GOOD	0
FRONT WINDSHIELD	6	GOOD	0
FUEL LID	6	GOOD	0
REAR WINDSHIELD	6	GOOD	0
LUGGAGE COMPARTMENT LIGHT	6	GOOD	0
RH FRONT DOOR	6	MINOR PAINTED	0
BODY RUST	6	GOOD	0
ROOF (REGULAR)	6	GOOD	0
FRONT BUMPER	5	PAINTED AND SCRATCH	3000
FOG LAMPS	3	NOT WORKING	3500
HOOD	3	ACCIDENT AND PAINTED	0
SIDE VIEW MIRRORS	5	PAINTED AND SCRATCH	1000
LH FENDER	5	PAINTED AND MINOR SCRATCH	1000
LH FRONT DOOR	5	PAINTED	0
LH REAR DOOR	5	PAINTED AND SCRATCH	2500
LH RUNNING BOARD	5	PAINTED	0
LH QUARTER PANEL	5	PAINTED	0
REAR BUMPER	5	PAINTED AND SCRATCH	3000
TAIL LIGHT	4	AVERAGE CONDITION	3500
TRUNK LID/TAIL GATE	5	SCRATCH	2500

INSPECTION CHECKPOINTS	SCORE(X/10)	REMARKS/COMMENTS	OPTIONAL SPEND EST. (RS)
RH QUARTER PANEL	5	PAINTED	0
RH RUNNING BOARD	3	PAINTED AND DENT	3000
RH REAR DOOR	5	MINOR PAINTED AND SCRATCH	2500
RH FENDER	5	PAINTED	0
PAINT CONDITION	5	FULL CAR IS PAINTED WITHOUT ROOF	0
