ECO INSPECTION CERTIFICATE

Order ID : 32192

121 Points Vehicle Inspection Certificate

Honda Mobilio S I-Dtec, 2015

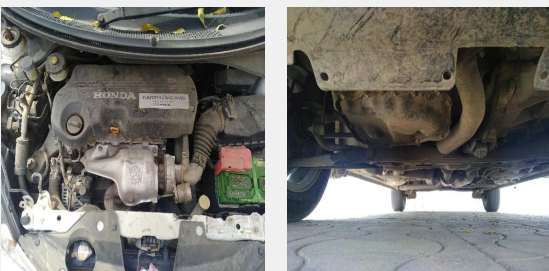
HOOD

| INSPECTION CHECKPOINTS | SCORE(X/10) | REMARKS/COMMENTS | OPTIONAL SPEND EST. (RS) |
|---|---|--|---|
| BATTERY | 7 | COMPANY FITTED WILL NEED TO CHANGE IN 6 MONTHS | 0 |
