# ECO INSPECTION CERTIFICATE

Order ID : 32696

121 Points Vehicle Inspection Certificate

## Maruti Suzuki Baleno ZETA 1.2, 2016

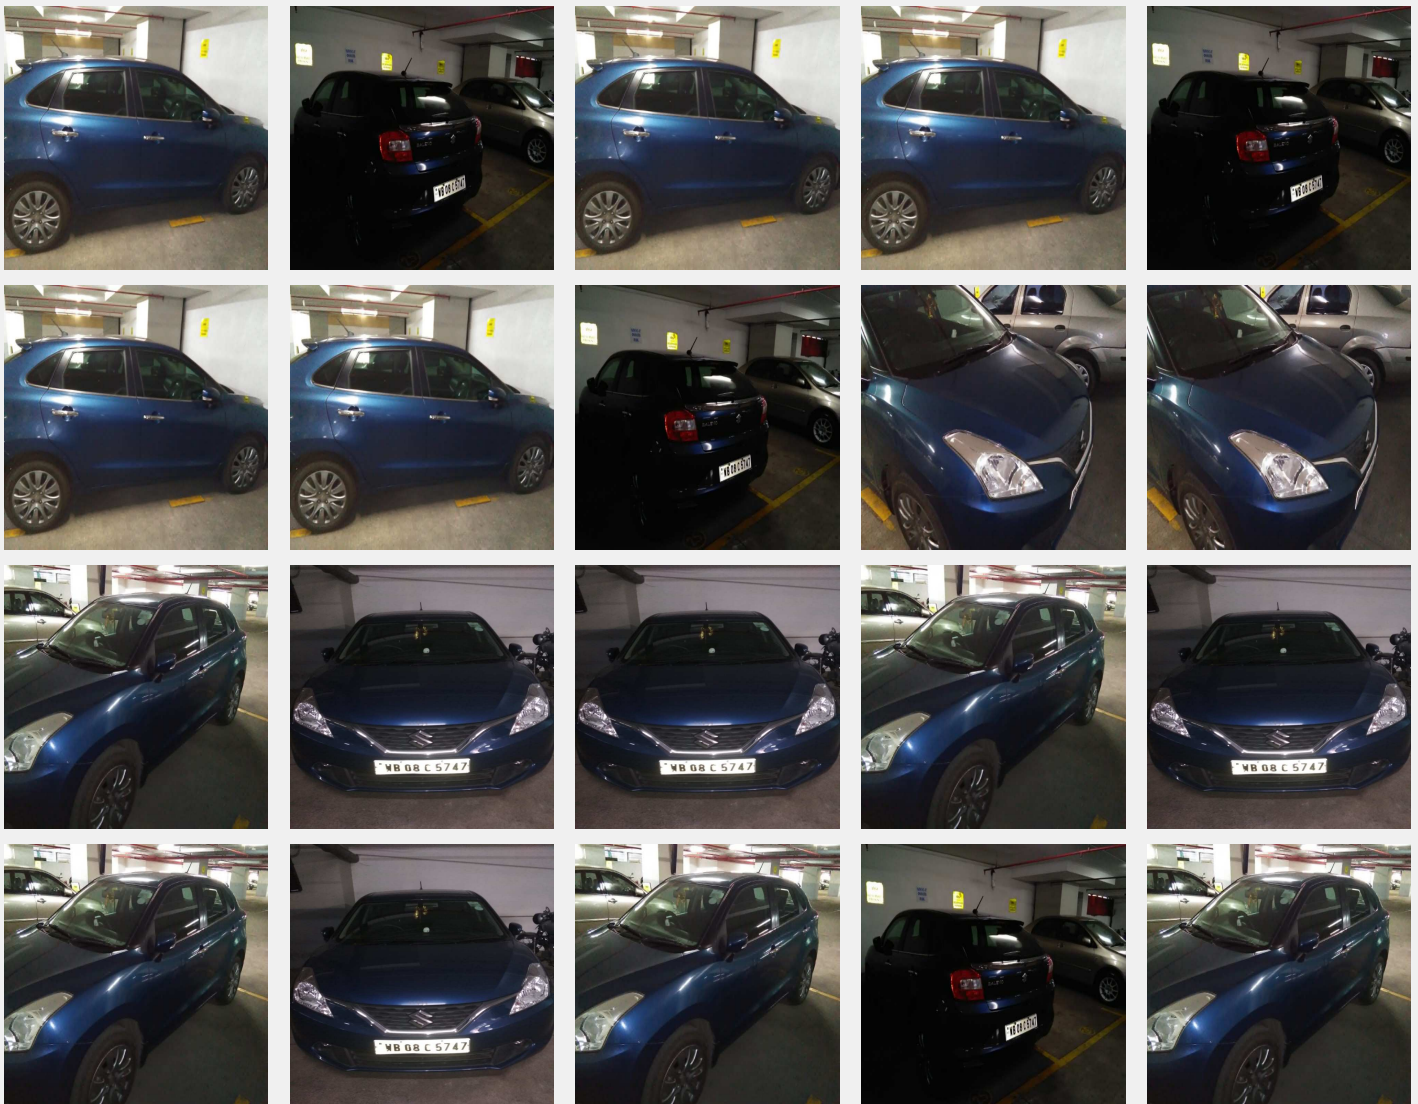
| INSPECTION CHECKPOINTS | SCORE(X/10) | REMARKS/COMMENTS | OPTIONAL SPEND EST. (RS) |
|---|---|---|---|
| LICENSE PLATE | 5 | NEED TO REPLACED | 500 |
