ECO INSPECTION CERTIFICATE

121 Points Vehicle Inspection Certificate

Ford Endeavour TITANIUM 3.2 4X4 AT, 2017

MAKE	FORD	TRANSMISSION TYPE	AUTOMATIC
MODEL	ENDEAVOUR	REGISTRATION NO.	HR26DB5159
YEAR	2017	VIN/CHASIS NUMBER	55300
TRIM	TITANIUM 3.2 4X4 AT	KMS RUN	20478
COLOR	RED	INSURANCE EXPIRY	2018-12-6
BODY TYPE	SUV	LOCATION	DELHI
FUEL TYPE	DIESEL	ENGINE SOUND LINK	LISTEN ENGINE SOUND

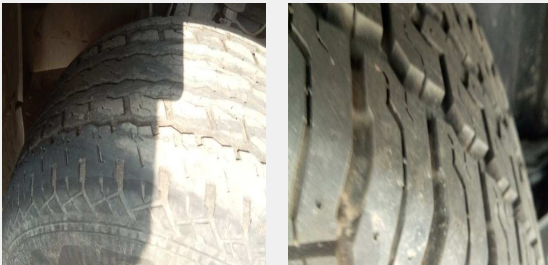
INSPECTION CHECKPOINTS	SCORE(X/10)	REMARKS/COMMENTS	OPTIONAL SPEND EST. (RS)
TYRES	6	FAIR CONDITION	0
SPARE TYRE (YES)	7	GOOD	0
WHEEL ASSEMBLY (STEEL RIM)	7	GOOD	0

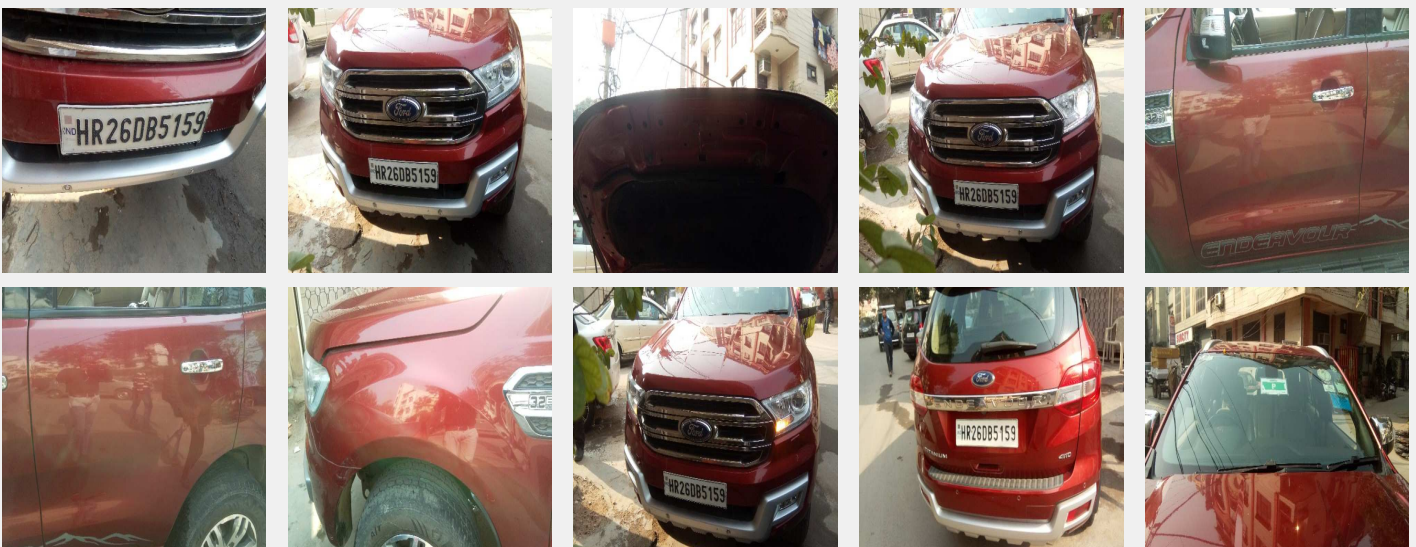
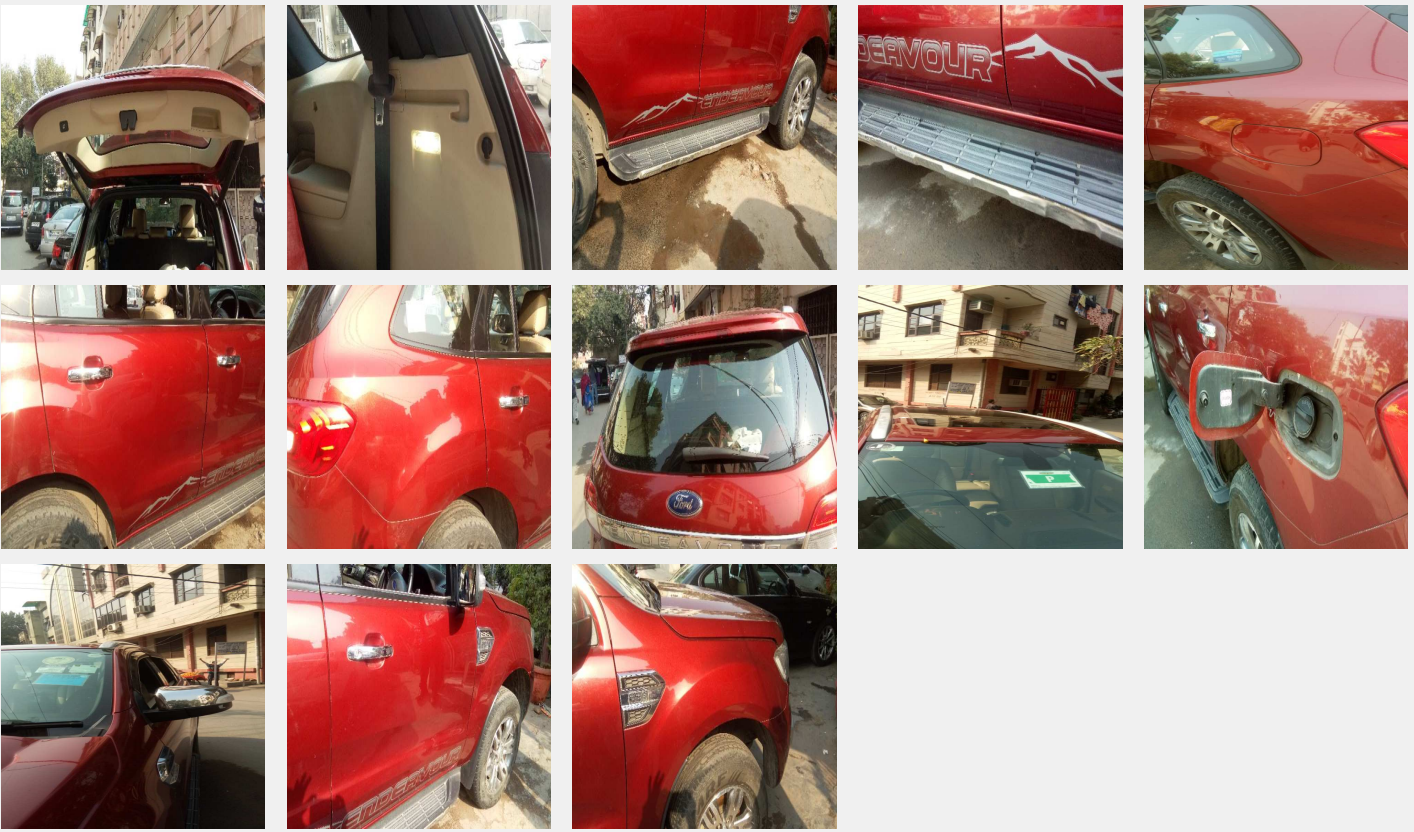
minor scratches in body rear tyre weak overall good condition
