# ECO INSPECTION CERTIFICATE

Order ID : 36619

121 Points Vehicle Inspection Certificate

## Bmw X1 SDRIVE20D, 2012

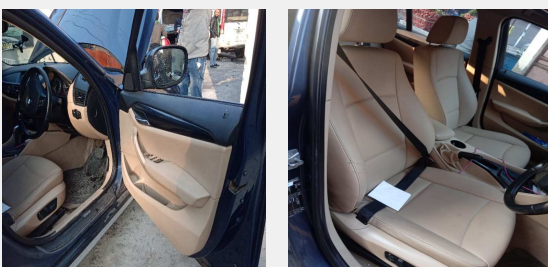
INSPECTION CHECKPOINTS	SCORE(X/10)	REMARKS/COMMENTS	OPTIONAL SPEND EST. (RS)
DOOR PANEL	6	AVERAGE CONDITION	0
DOOR HINGES	7	PROPERLY LUBRICATED	0
CARPET & FLOOR MAT	6	AVERAGE CONDITION	0
SEAT & SEAT BELT	6	RHS SEAT HAVING CRACK MARKS	0
DASHBOARD & INSTRUMENT PANEL	7	WELL MAINTAINED	0
HORN	7	WORKING PROPERLY	0
SPEAKERS & MUSIC SYSTEM	8	WORKING PROPERLY AND SOUND GOOD	0
HANDBRAKE	7	WORKING PROPERLY	0
STEERING-MOUNTED CONTROLS	7	WORKING PROPERLY	0
PEDALS	7	GOOD CONDITION	0
CENTRAL LOCK	8	WORKING PROPERLY	0
A/C VENTS & HEATER	8	WORKING PROPERLY AND COOLING IS GOOD	0
CUP HOLDERS	6	AVERAGE CONDITION	0
NAVIGATION (NO)	10		0
ODOMETER	7	GOOD CONDITION	0
HAZARD LIGHT	7	PROPERLY BLINKING IN CLUSTER	0
POWER WINDOWS (YES)	5	P/W NOISY NEED CLEAN	1500

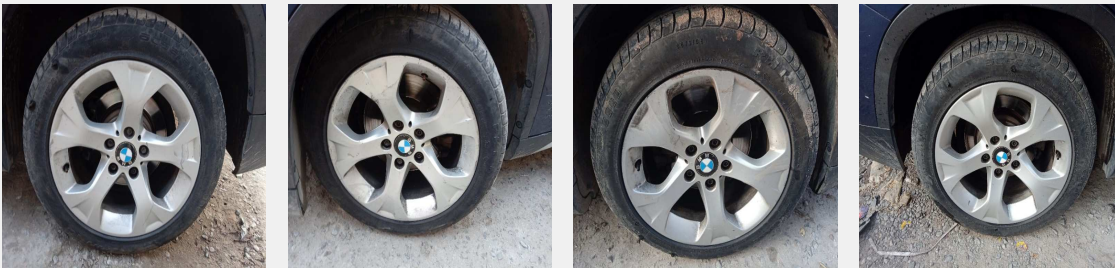
INSPECTION CHECKPOINTS	SCORE(X/10)	REMARKS/COMMENTS	OPTIONAL SPEND EST. (RS)
TYRES	7	GOOD CONDITION	0
SPARE TYRE (NO)	10		0
WHEEL ASSEMBLY (ALLOY RIM)	6	MINOR SCRATCHES	0

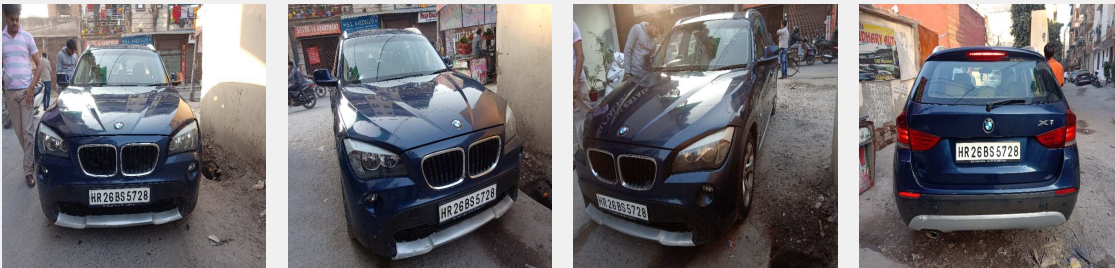
INSPECTION CHECKPOINTS	SCORE(X/10)	REMARKS/COMMENTS	OPTIONAL SPEND EST. (RS)
TAIL LIGHT	4	RHS CRACK NEED REPLACE	20000
RH QUARTER PANEL	4	SCRATCHES AND DENT NEED REPAIR	20000
RH REAR DOOR	4	SCRATCHES AND DENT NEED REPAIR	35000
RH FRONT DOOR	4	SCRATCHES AND DENT NEED REPAIR	30000
PAINT CONDITION	5	SCRATCHES AND DENT NEED REPAIRING AND TOUCHING	50000

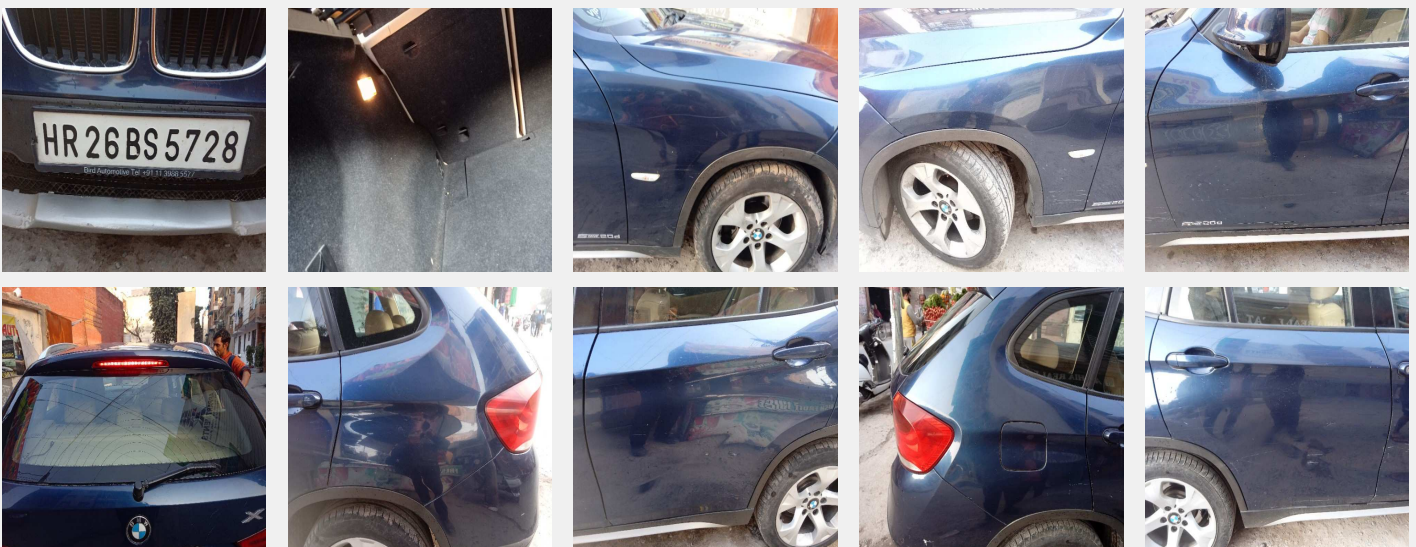
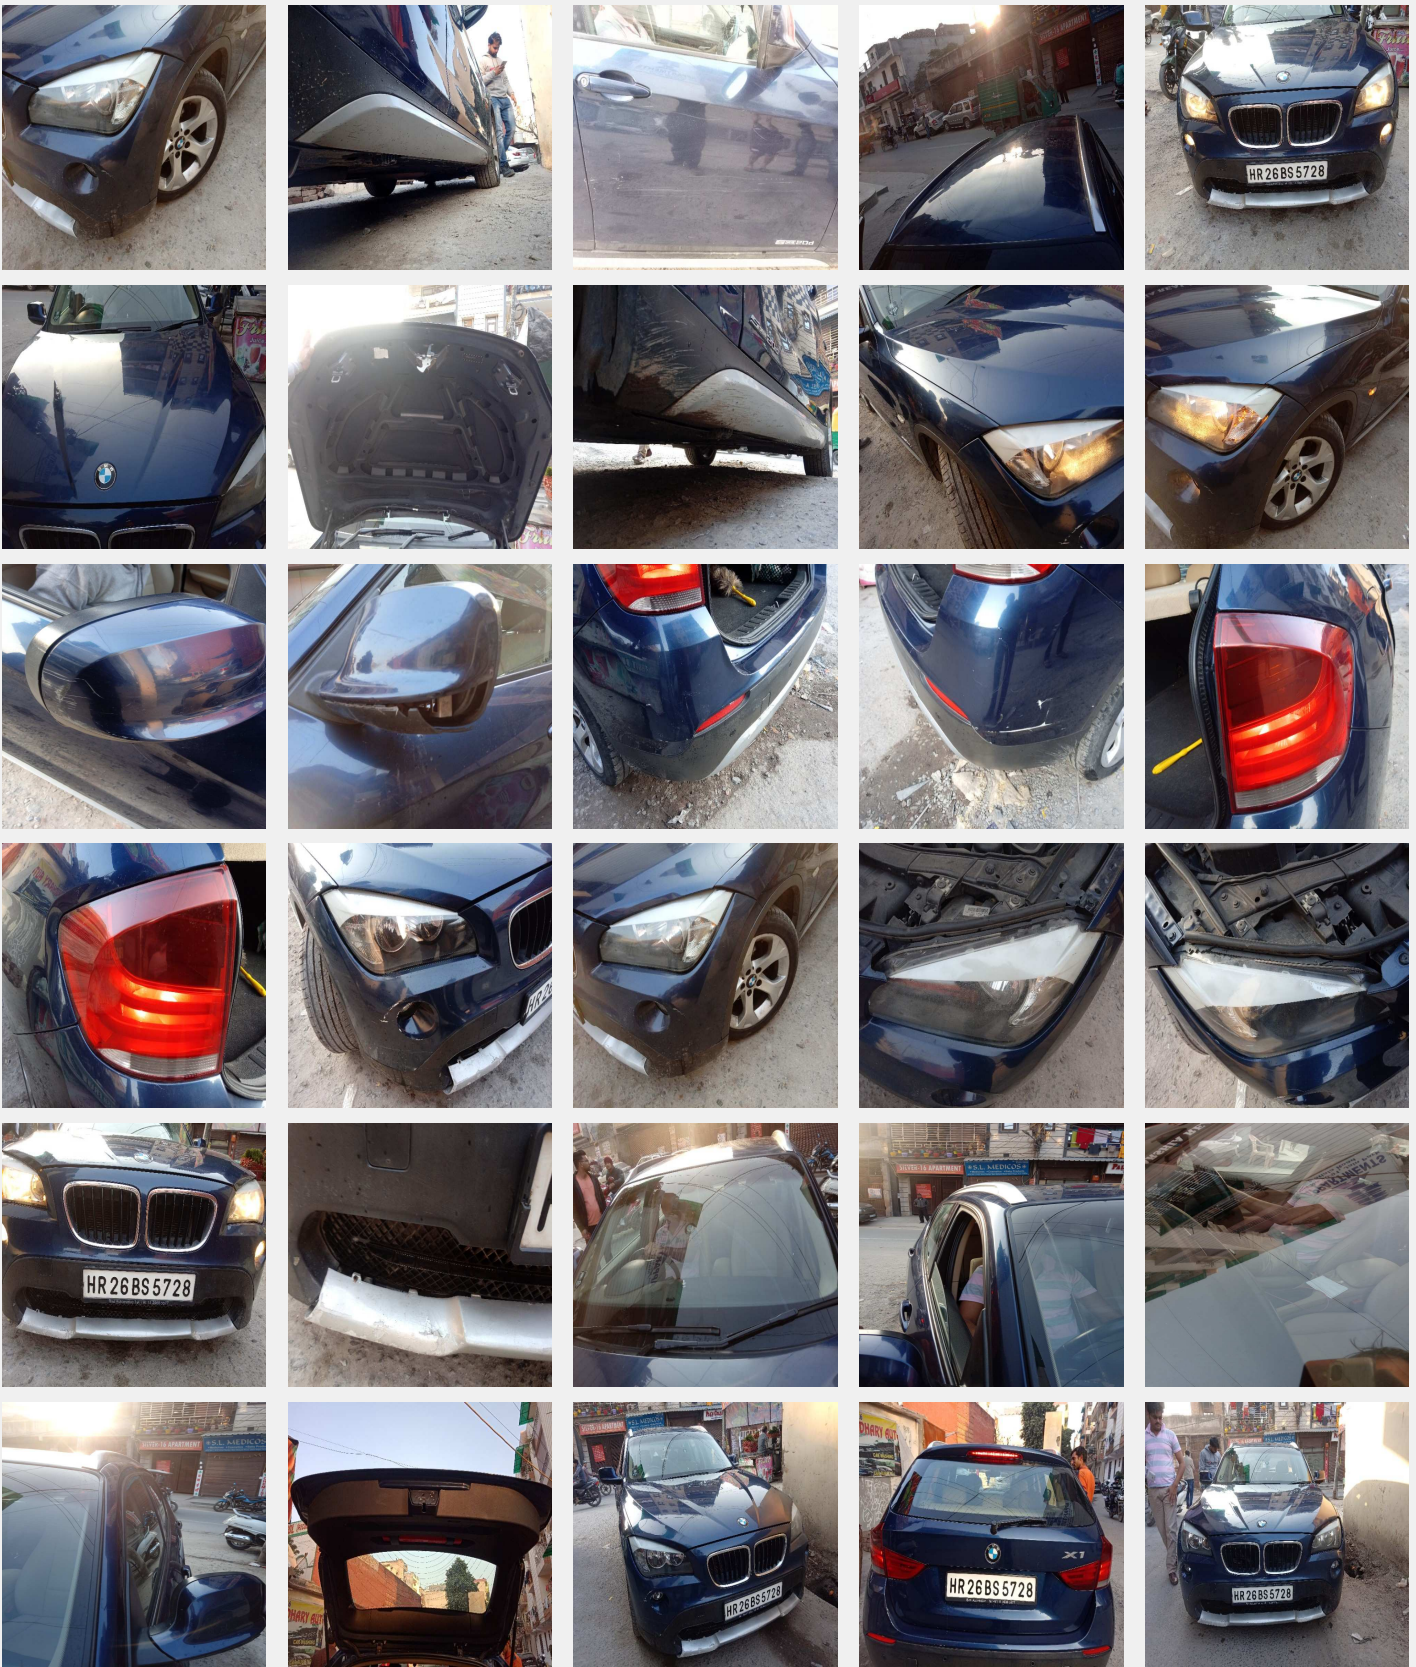
## NEED ATTENTION ⚠️

INSPECTION CHECKPOINTS	SCORE(X/10)	REMARKS/COMMENTS	OPTIONAL SPEND EST. (RS)
LICENSE PLATE	8	GOOD CONDITION	0
TURN SIGNAL	7	WORKING PROPERLY	0
FOG LAMPS	7	WORKING PROPERLY	0
HOOD	6	MINOR SCRATCHES	0
PILLAR	7	GOOD CONDITION	0
FRONT WINDSHIELD	6	STONE SPOT MARK	0
LH REAR DOOR	6	SCRATCHES	0
LH RUNNING BOARD	6	SCRATCHES	0
LH QUARTER PANEL	6	SCRATCHES	0
FUEL LID	7	GOOD CONDITION	0
REAR WINDSHIELD	7	GOOD CONDITION	0
TRUNK LID/TAIL GATE	6	MINOR SCRATCHES	0
LUGGAGE COMPARTMENT LIGHT	7	WORKING PROPERLY	0
RH RUNNING BOARD	6	MINOR SCRATCHES	0
RH FENDER	6	SCRATCHES	0
BODY RUST	7	GOOD CONDITION	0
ROOF (REGULAR)	7	GOOD CONDITION	0
FRONT BUMPER	4	NEED REPAIR	20000
HEAD LIGHTS	3	LHS HEADLIGHT LOCK BROKEN NEED REPLACE HEADLIGHT	30000
GRILLE	4	NEED REPAIR IF POSSIBLE	10000
SIDE VIEW MIRRORS	3	LHS COMPLET NEED REPLACE BROKEN	15000
LH FENDER	4	SCRATCHES AND DENT NEED REPAIR	20000
LH FRONT DOOR	4	SCRATCHES AND DENT NEED	25000

LF FRONT DOOR	4	REPAIR	25000
REAR BUMPER	5	SCRATCHES NEED PAINT	30000

all body having Dent and scratches need repairing
