ECO INSPECTION CERTIFICATE

Order ID : 36786

121 Points Vehicle Inspection Certificate

Fiat Punto EMOTION 1.4, 2009

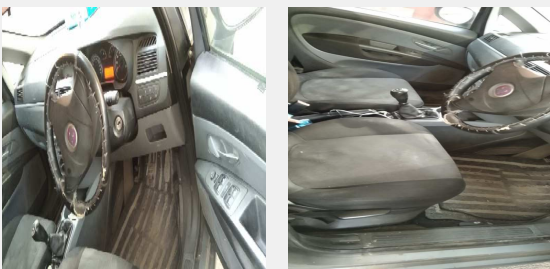
IMAGES

INSPECTION CHECKPOINTS	SCORE(X/10)	REMARKS/COMMENTS	OPTIONAL SPEND EST. (RS)
DOOR PANEL	6	FAIR	0
DOOR HINGES	6	FAIR	0
CARPET & FLOOR MAT	6	FAIR	0
SEAT & SEAT BELT	7	GOOD	0
DASHBOARD & INSTRUMENT PANEL	7	GOOD	0
HORN	7	GOOD	0
SPEAKERS & MUSIC SYSTEM	7	GOOD	0
HANDBRAKE	7	GOOD	0
PEDALS	6	FAIR	0
CENTRAL LOCK	7	GOOD	0
A/C VENTS & HEATER	6	FAIR	0
CUP HOLDERS	6	FAIR	0
NAVIGATION (NO)	10		0
ODOMETER	7	GOOD	0
POWER WINDOWS (YES)	7	GOOD	0
HAZARD LIGHT	6	FAIR	0
STEERING-MOUNTED CONTROLS	0	NA	0

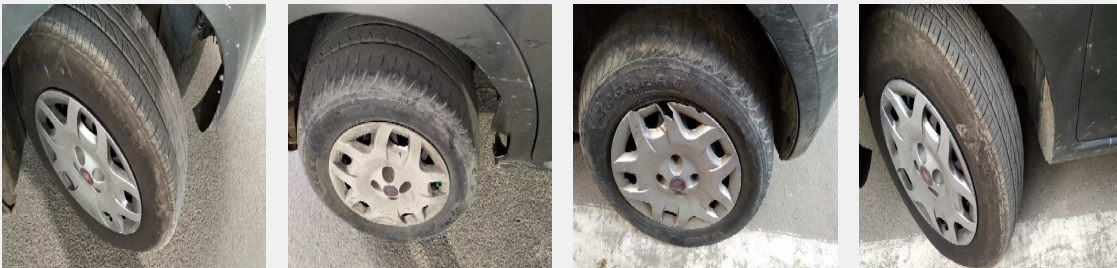
IMAGES

INSPECTION CHECKPOINTS	SCORE(X/10)	REMARKS/COMMENTS	OPTIONAL SPEND EST. (RS)
TYRES	6	FAIR	0
SPARE TYRE (YES)	6	FAIR	0
WHEEL ASSEMBLY (STEEL RIM)	6	FAIR	0

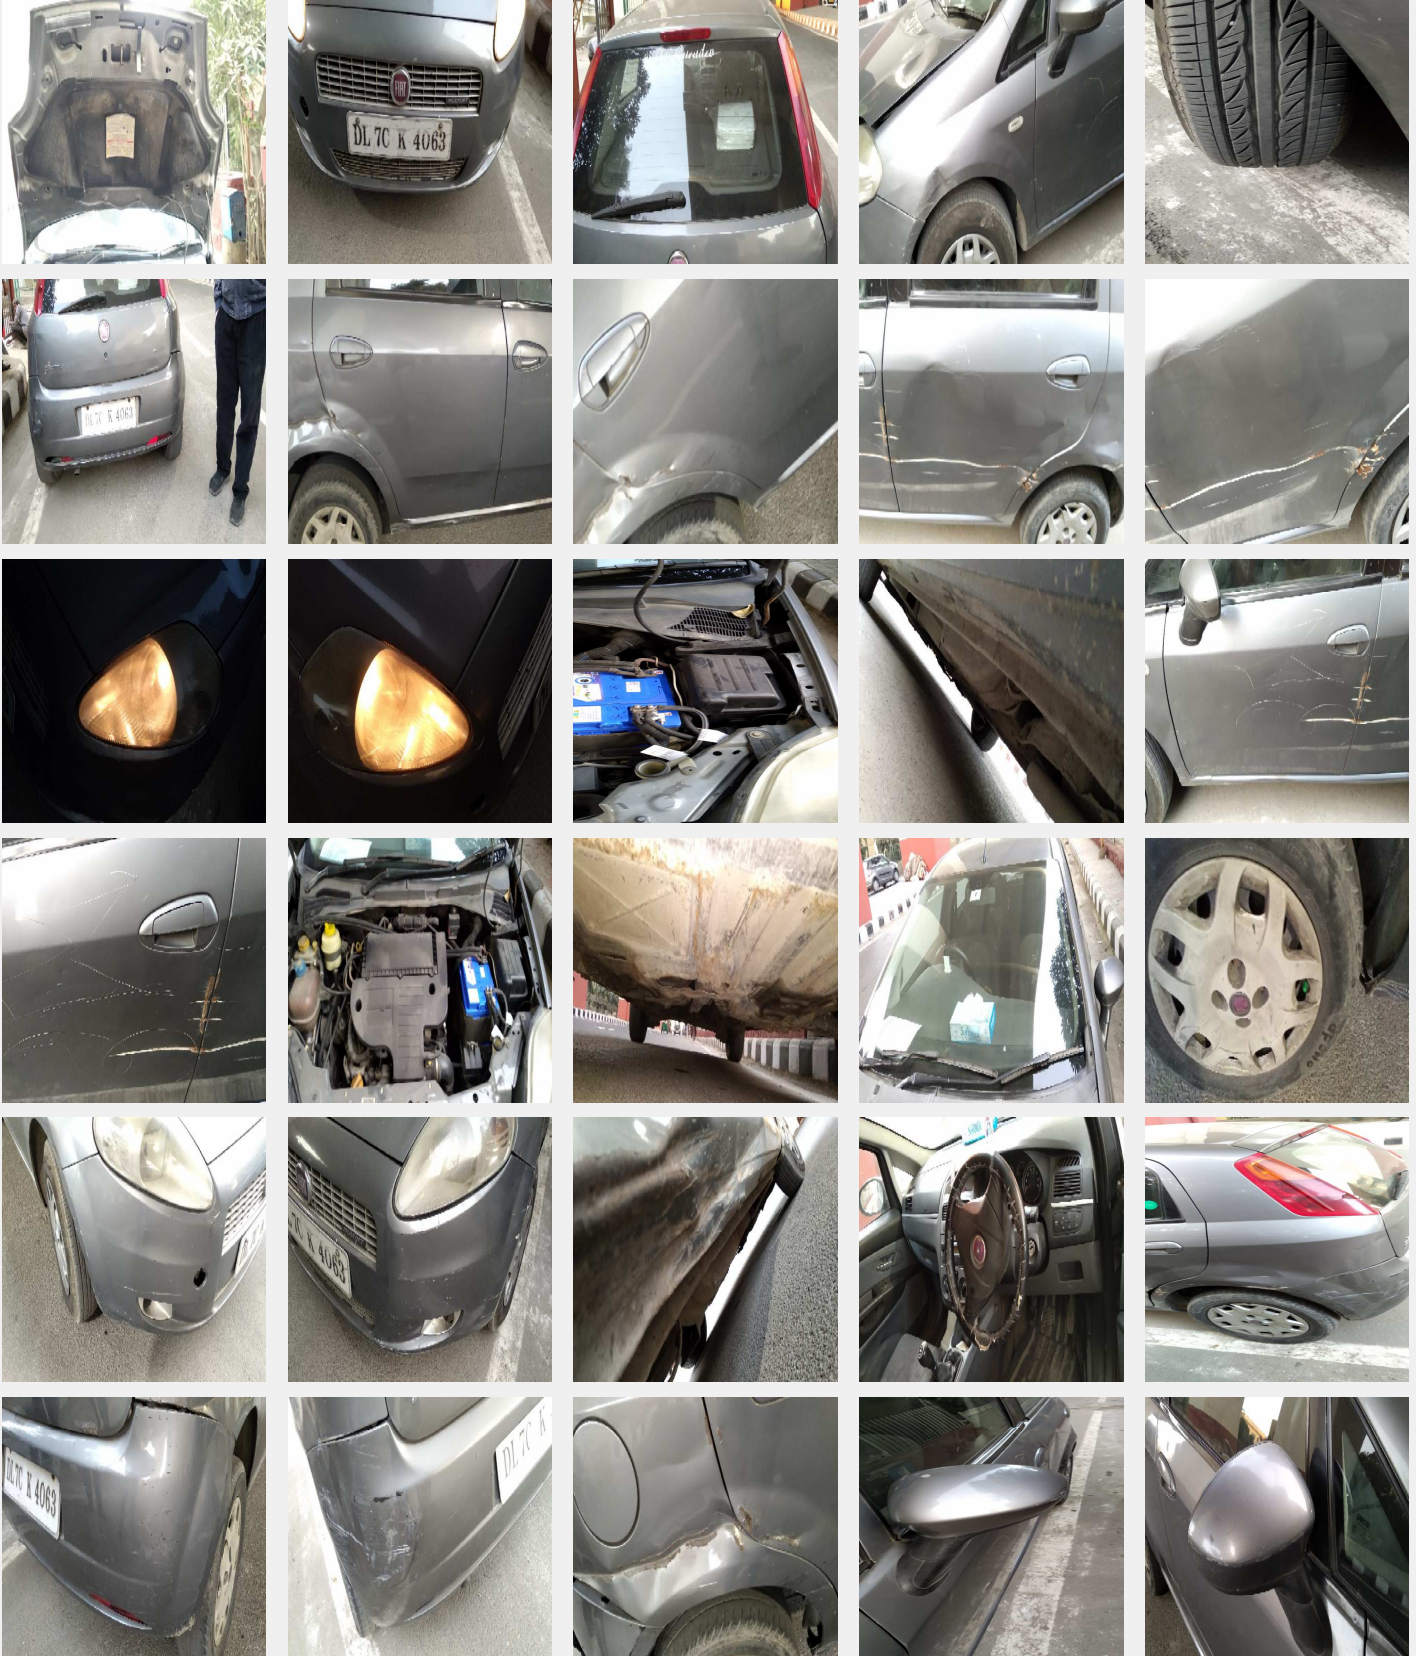
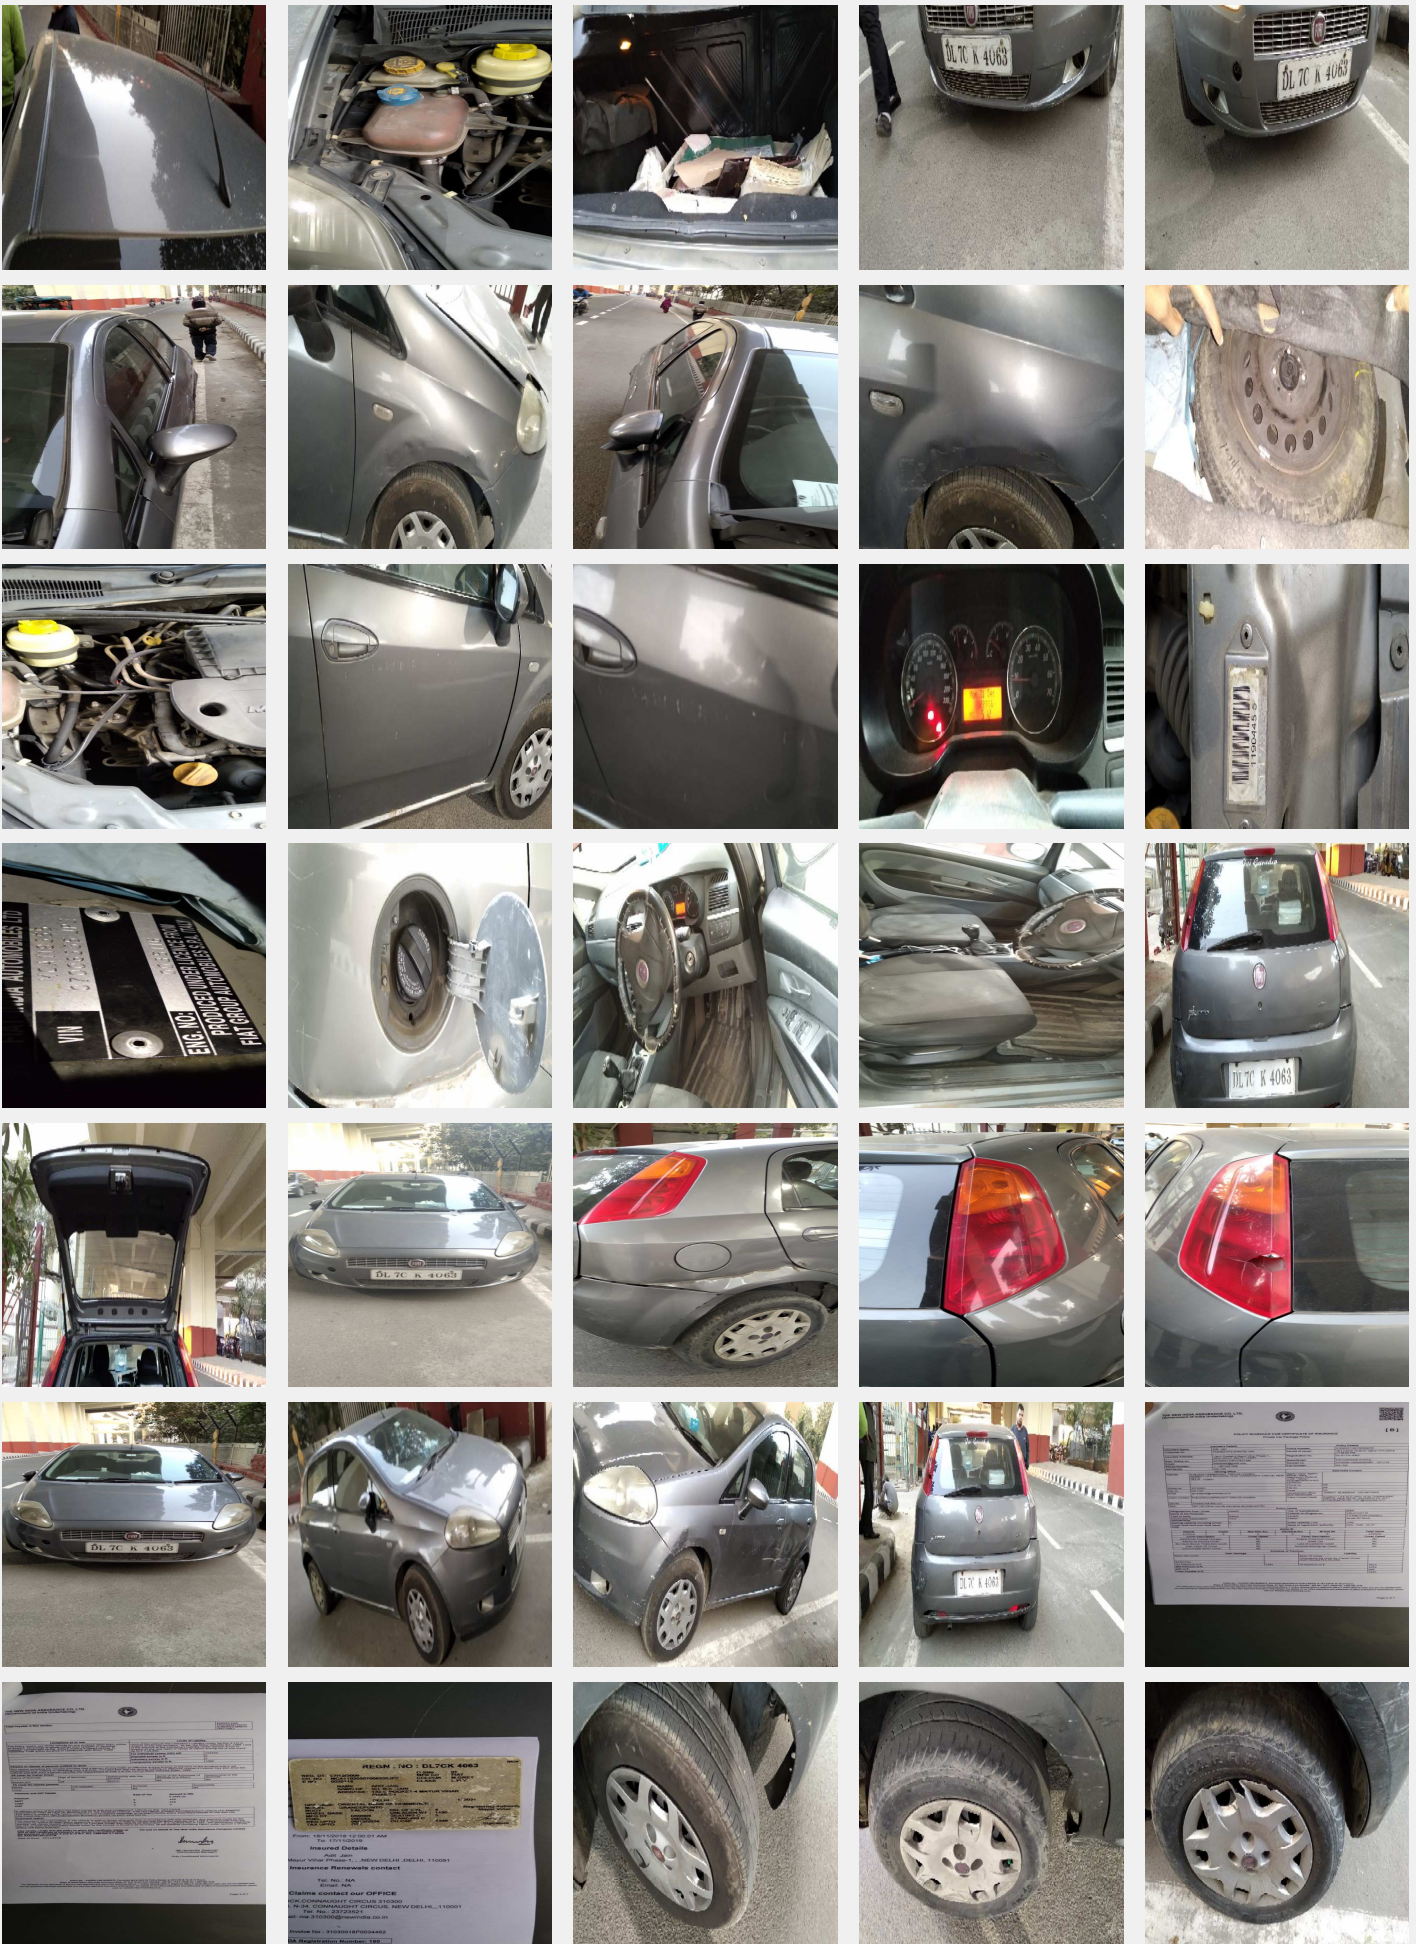
IMAGES

all body dent and scratch rear bumper damage need to change engine starting time noise steering tu
