ECO INSPECTION CERTIFICATE

Order ID : 37528

121 Points Vehicle Inspection Certificate

Hyundai Accent Executive, 2013

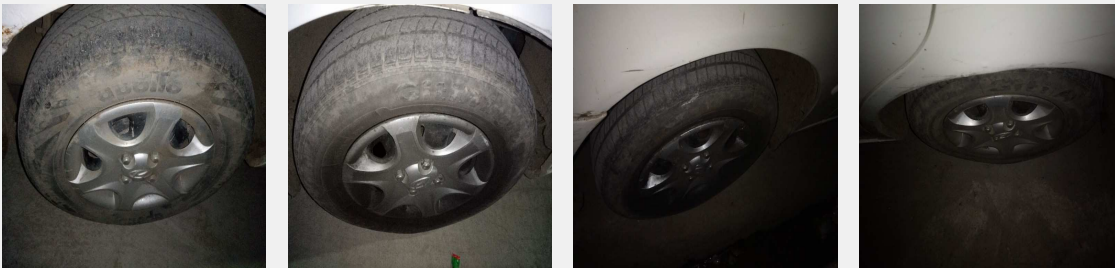
IMAGES

INSPECTION CHECKPOINTS	SCORE(X/10)	REMARKS/COMMENTS	OPTIONAL SPEND EST. (RS)
TYRES	7	GOOD	0
SPARE TYRE (YES)	7	GOOD	0
WHEEL ASSEMBLY (STEEL RIM)	7	GOOD	0

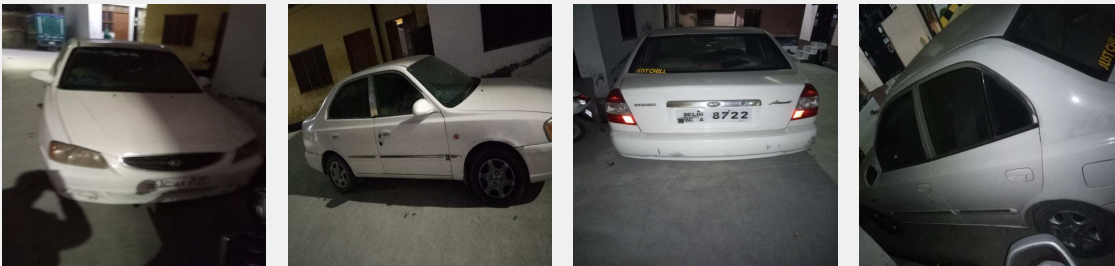
IMAGES

INSPECTION CHECKPOINTS	SCORE(X/10)	REMARKS/COMMENTS	OPTIONAL SPEND EST. (RS)
ROOF (REGULAR)	7	GOOD	0
PAINT CONDITION	7	GOOD	0
FOG LAMPS	0	NA	0
HOOD	4	UPPER SIDE DENT	2500
LH FRONT DOOR	5	MINOR DENT	2000

Dent and minor scratches need to repair Engine head leak need to repair
