ECO INSPECTION CERTIFICATE

Order ID : 37298

121 Points Vehicle Inspection Certificate

Fiat Punto EMOTION 1.3, 2011

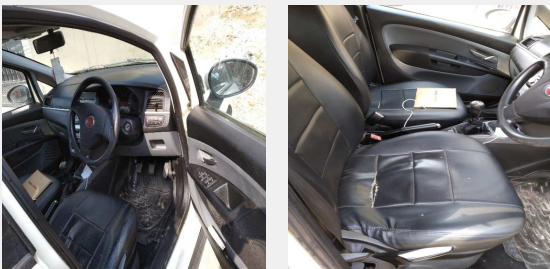
INSPECTION CHECKPOINTS	SCORE(X/10)	REMARKS/COMMENTS	OPTIONAL SPEND EST. (RS)
DOOR PANEL	8	GOOD	0
DOOR HINGES	8	GOOD	0
CARPET & FLOOR MAT	7	GOOD	0
SEAT & SEAT BELT	7	GOOD	0
DASHBOARD & INSTRUMENT PANEL	7	GOOD	0
HORN	7	GOOD	0
SPEAKERS & MUSIC SYSTEM	7	GOOD	0
HANDBRAKE	7	GOOD	0
PEDALS	7	GOOD	0
CENTRAL LOCK	7	GOOD	0
A/C VENTS & HEATER	7	GOOD	0
CUP HOLDERS	7	GOOD	0
NAVIGATION (NO)	10		0
ODOMETER	7	GOOD	0
POWER WINDOWS (YES)	7	GOOD	0
HAZARD LIGHT	7	GOOD	0
STEERING-MOUNTED CONTROLS	0	NA	0

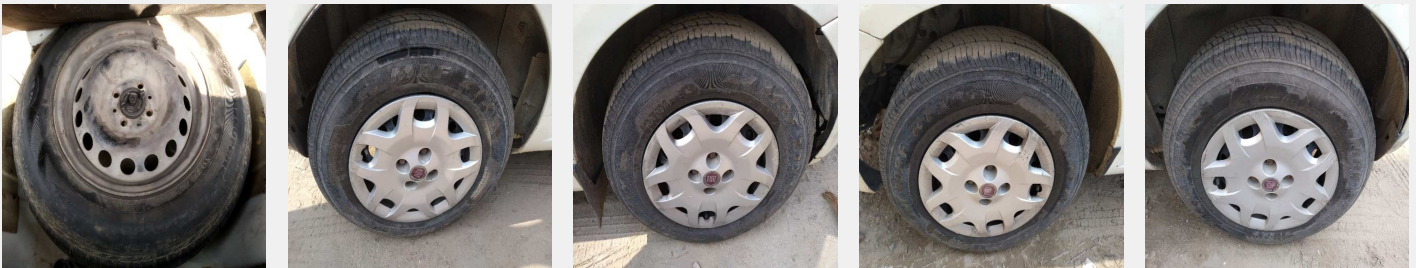
INSPECTION CHECKPOINTS	SCORE(X/10)	REMARKS/COMMENTS	OPTIONAL SPEND EST. (RS)
TYRES	7	GOOD	0
SPARE TYRE (YES)	8	GOOD	0
WHEEL ASSEMBLY (STEEL RIM)	8	GOOD	0

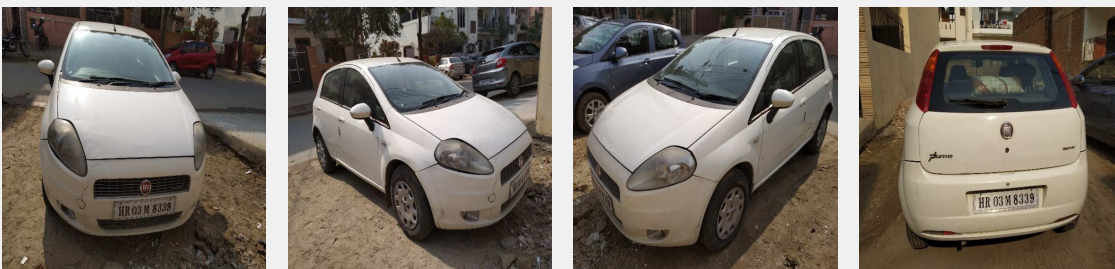
INSPECTION CHECKPOINTS	SCORE(X/10)	REMARKS/COMMENTS	OPTIONAL SPEND EST. (RS)
LH REAR DOOR	3	NEED TO REPAIR	5000
LH QUARTER PANEL	4	NEED TO REPAIR	5000
RH REAR DOOR	4	NEED TO REPAIR	5000
RH FRONT DOOR	4	NEED TO REPAIR	5000
RH FENDER	4	NEED TO REPAIR	4000

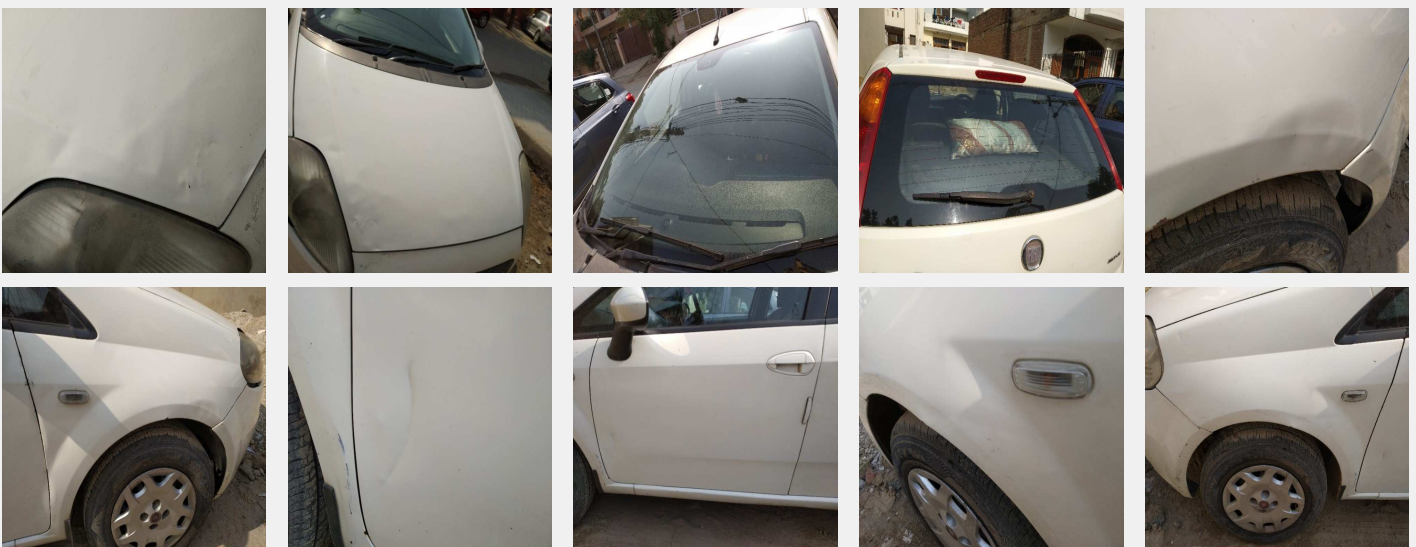
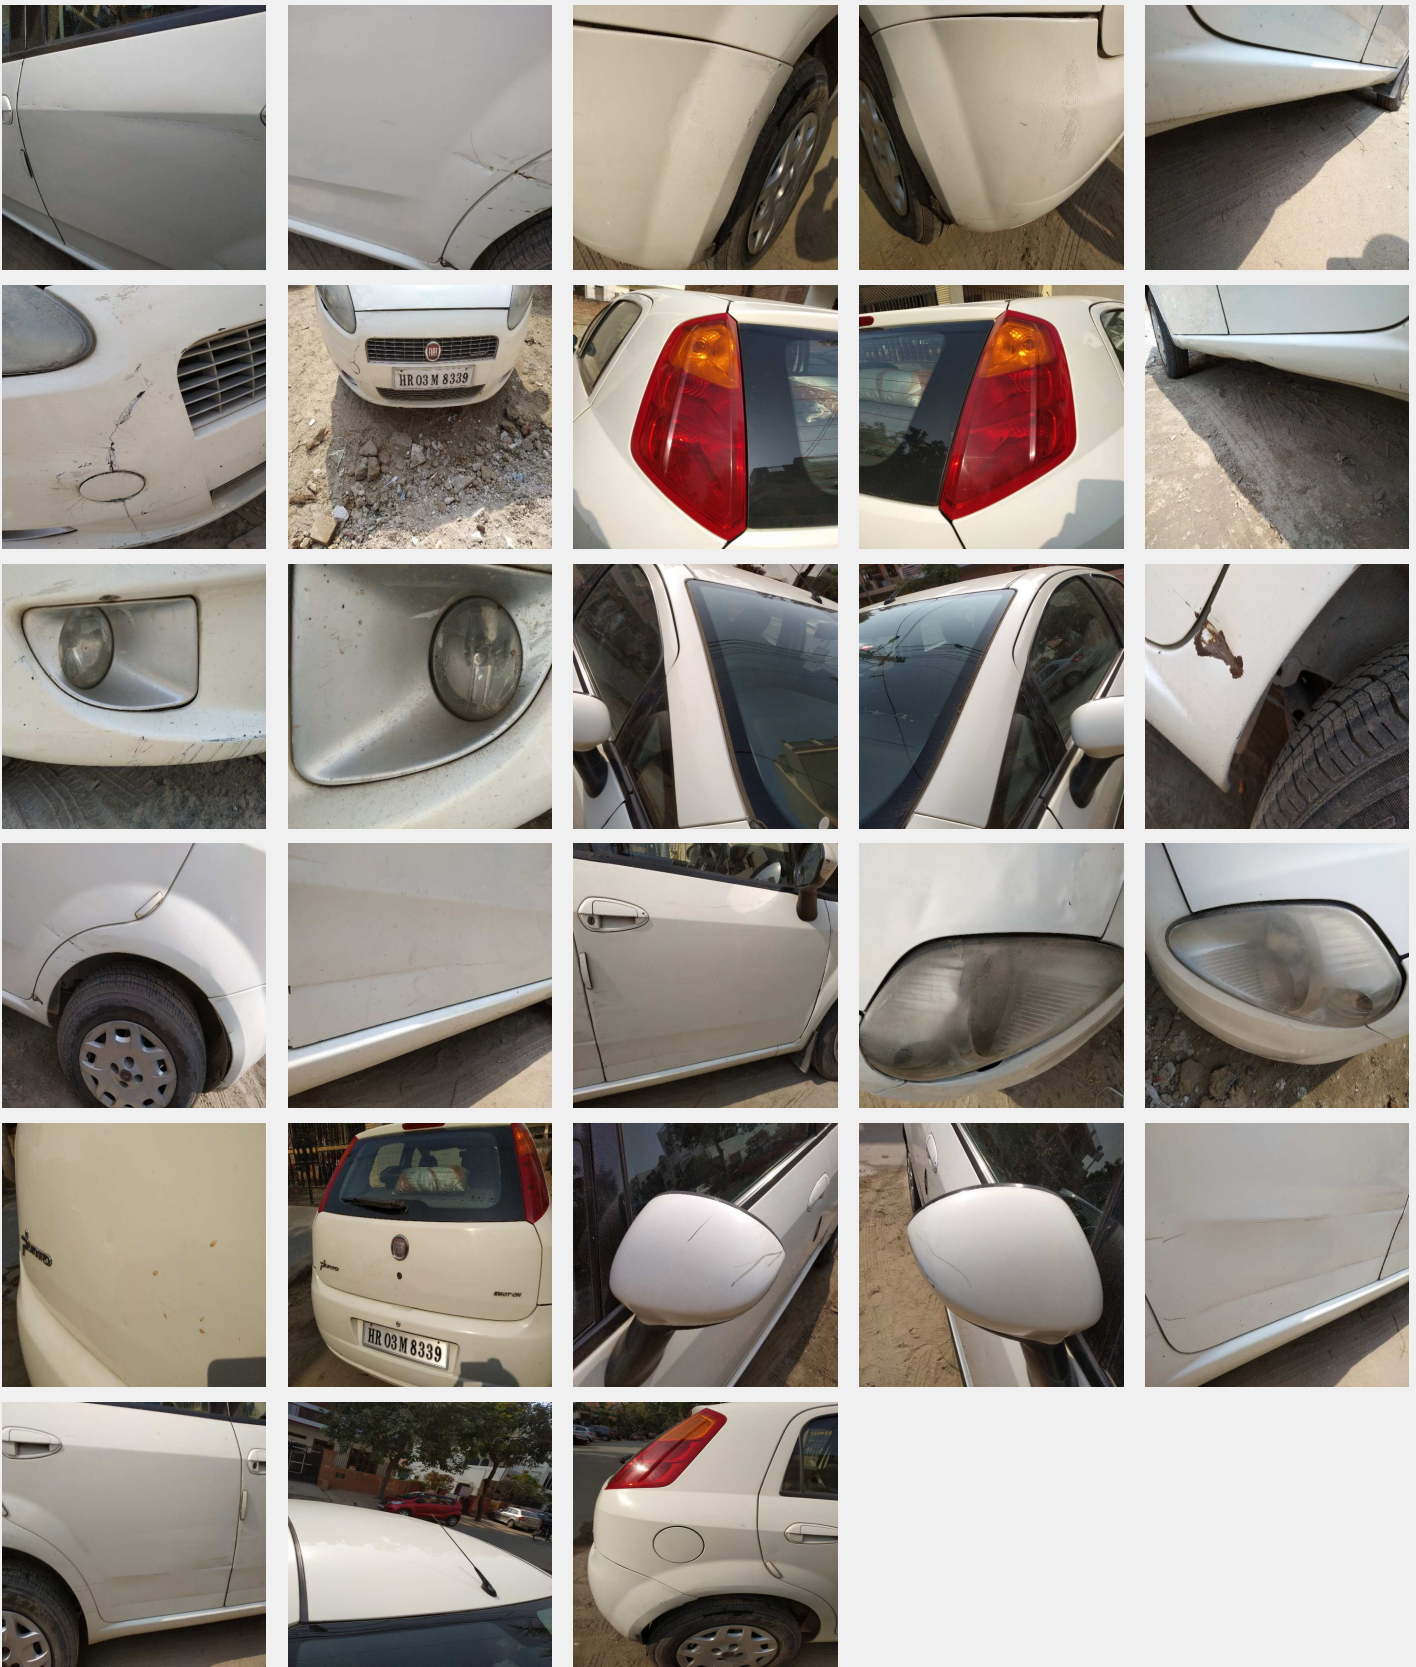
NEED ATTENTION ⚠️

minor scratches and minor dent front bumper and Hood already painted Lh side fender painted rear bum
