# ECO INSPECTION CERTIFICATE

121 Points Vehicle Inspection Certificate

## Honda Aviator 110CC-DRUM ALLOY, 2018

VEHICLE INFORMATION			
MAKE	HONDA	LOCATION	MUMBAI
MODEL	AVIATOR	REGISTRATION NO.	MH03CW7804
YEAR	2018	VIN/CHASIS NUMBER	ME4JF21CKH8013140
TRIM	110CC-DRUM ALLOY	KMS RUN	2675
COLOR	WHITE	INSURANCE EXPIRY	2020-1-19
FUEL TYPE	PETROL	ENGINE SOUND LINK	<a href="#">LISTEN ENGINE SOUND</a>

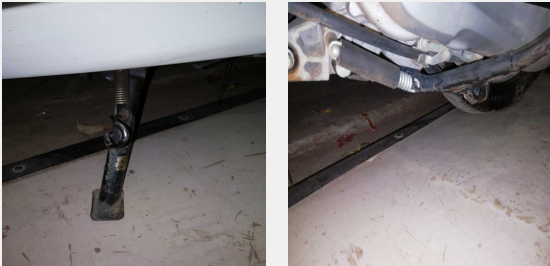
## STAND

INSPECTION CHECKPOINTS	SCORE(X/10)	REMARKS/COMMENTS	OPTIONAL SPEND EST. (RS)
CENTRE STAND CONDITION	8		0
CENTRE STAND RETENTION	8		0
SIDE STAND CONDITION	8		0
SIDE STAND RETENTION	8		0
