ECO INSPECTION CERTIFICATE

Order ID : 40739

121 Points Vehicle Inspection Certificate

Bmw 5 Series 520D, 2008

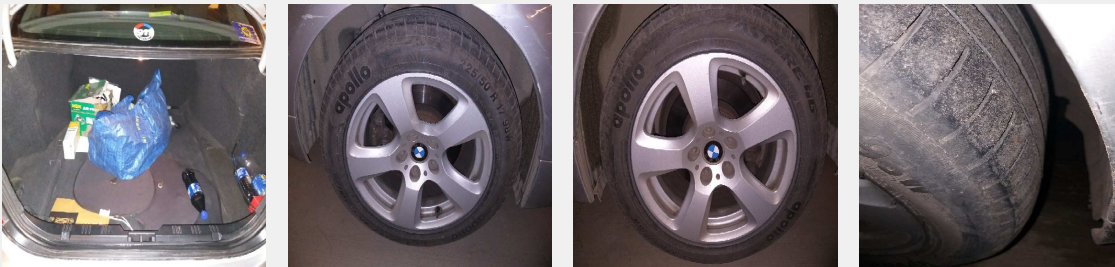
NEED ATTENTION ⚠

INSPECTION CHECKPOINTS	SCORE(X/10)	REMARKS/COMMENTS	OPTIONAL SPEND EST. (RS)
TYRES	7	NORMAL CONDITION	0
SPARE TYRE (NO)	10		0
WHEEL ASSEMBLY (ALLOY RIM)	8	GOODCONDITION AND WORKING PROPERLY	0

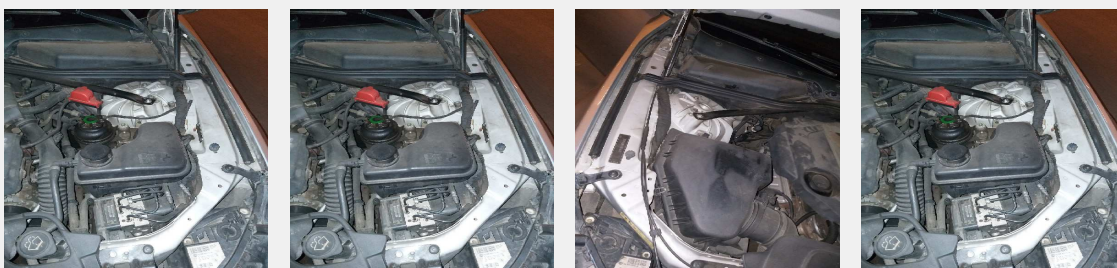
NEED ATTENTION

INSPECTION CHECKPOINTS	SCORE(X/10)	REMARKS/COMMENTS	OPTIONAL SPEND EST. (RS)
LH APRON	8	GOOD	0
RH APRON	8	GOOD	0
RADIATOR	8	GOODCONDITION AND WORKING PROPERLY	0
WIRING	8	GOODCONDITION AND WORKING PROPERLY	0
		GOODCONDITION AND

BATTERY	8	WORKING PROPERLY	0
BRAKE FLUID LEVEL	8	MAXIMUM LAVAL	0
ENGINE OIL	8	MAXIMUM LAVAL	0
COOLANT LEVEL	8	MAXIMUM LAVAL	0
BRAKE & COOLANT HOSE PIPES	8	GOODCONDITION AND WORKING PROPERLY	0
UNDERCARRIAGE	8	GOOD	0
EXHAUST SYSTEM	8	GOOD	0
