ECO INSPECTION CERTIFICATE

Order ID : 37389

121 Points Vehicle Inspection Certificate

Hyundai Accent EXECUTIVE, 2008

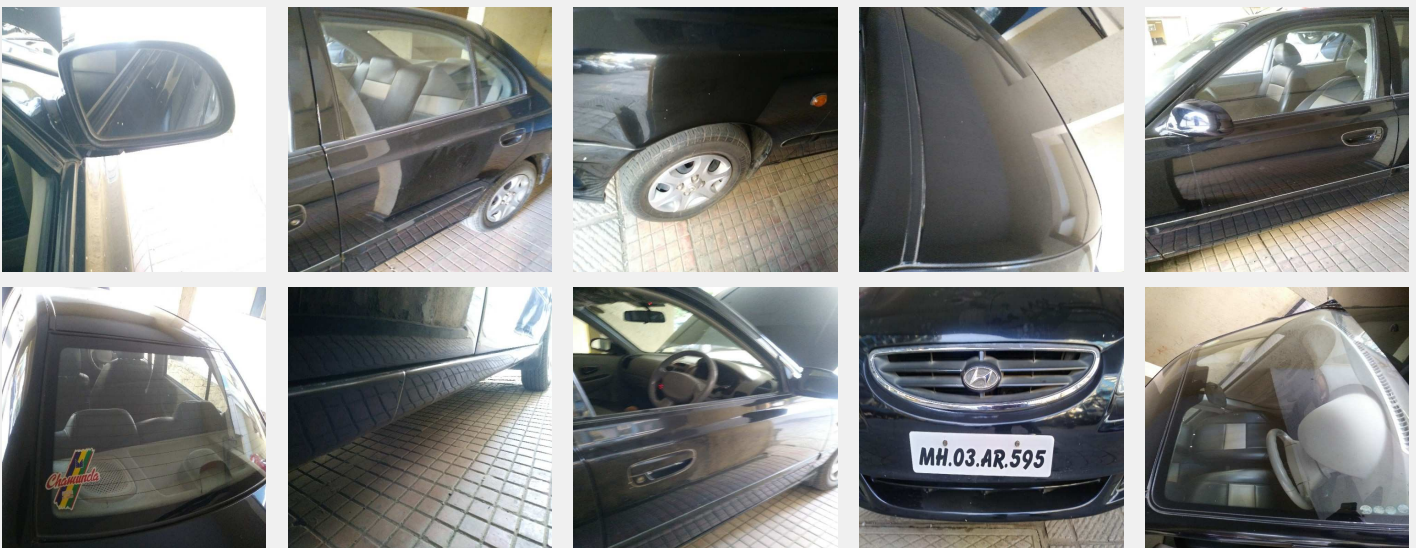
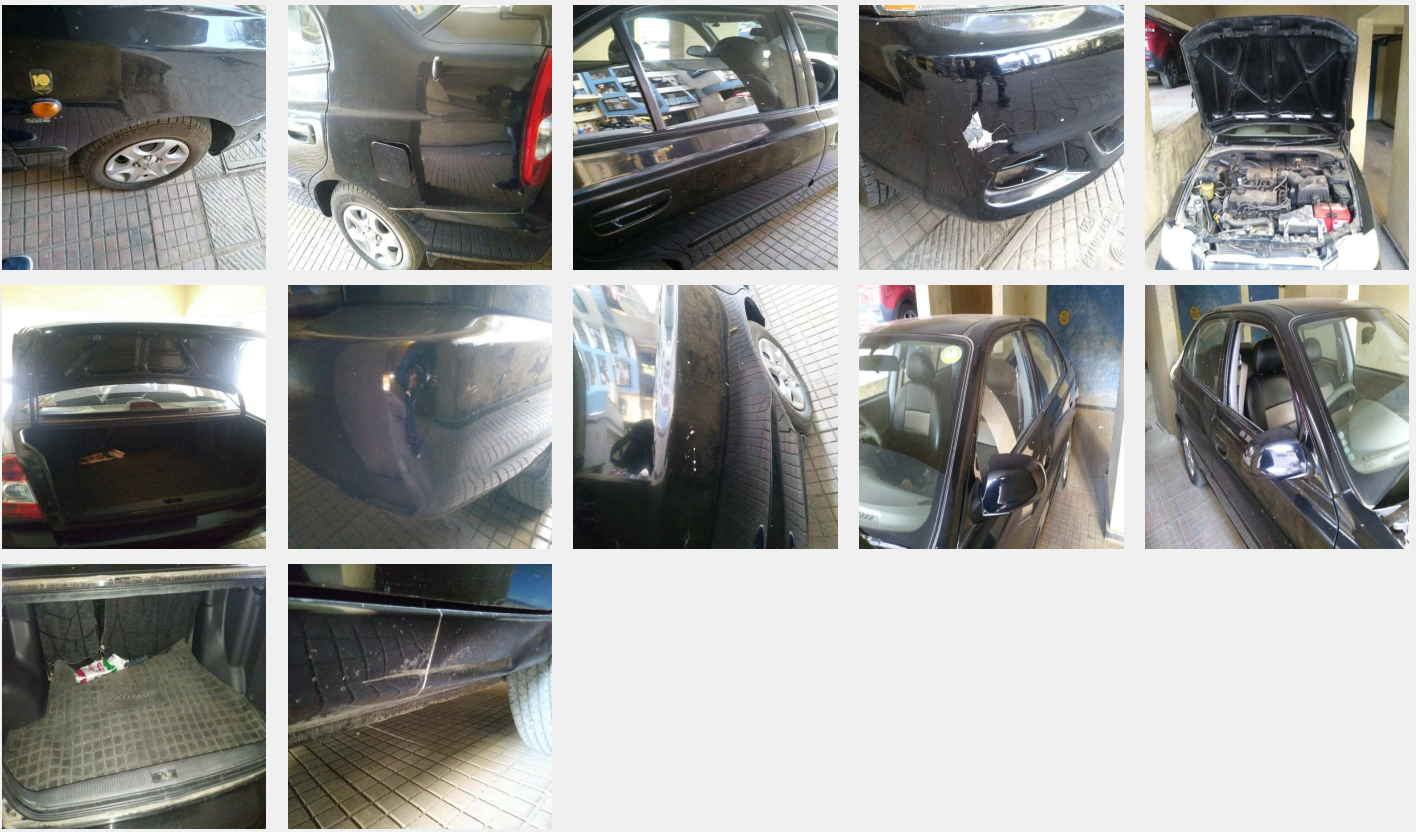
NEED ATTENTION ⚠️

INSPECTION CHECKPOINTS	SCORE(X/10)	REMARKS/COMMENTS	OPTIONAL SPEND EST. (RS)
ROOF (REGULAR)	6	GOOD CONDITION	0
PAINT CONDITION	6	GOOD	0
FRONT BUMPER	4	NEED TO REPAINT REPAIR	2000
LH RUNNING BOARD	5	DENT ON IT	2000
RH QUARTER PANEL	5	NEED TO REPAINT	2000

good car some paint patch is on body which can be remove by polishing good tyre minor dent on it
