ECO INSPECTION CERTIFICATE

Order ID : 41326

121 Points Vehicle Inspection Certificate

Um Renegade Sports S 280CC, 2017

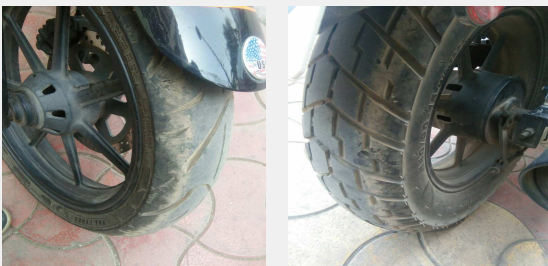
INSPECTION CHECKPOINTS	SCORE(X/10)	REMARKS/COMMENTS	OPTIONAL SPEND EST. (RS)
FRONT TYRE CONDITION & AIR PRESSURE	6	NORML WEAR AND TEAR	0
REAR TYRE CONDITION & AIR PRESSURE	6	NORMAL WEAR AND TEAR	0
WHEEL SPOKES FRONT	6	NO DAMAGE	0
WHEEL SPOKES REAR	6	ACCEPTABLE CONDITION	0
WHEEL RIM FRONT	6	NO CRACKS	0
WHEEL RIM REAR	6	NO DENT AND CRACKS	0
WHEEL BEARINGS FRONT	6	NO DAMAGE	0
WHEEL BEARINGS REAR	6	WORKING CONDITION	0
WHEEL SEALS FRONT	6	NO LEAK FOUND	0
WHEEL SEALS REAR	6	NO LEAK FOUND	0
BRAKE FUNCTION FRONT	6	WORKING CONDITION	0
BRAKE FUNCTION REAR	6	WORKING CONDITION	0
BRAKES CONDITION FRONT	6	ACCEPTABLE CONDITION	0
BRAKES CONDITION REAR	6	WORKING PROPERLY	0

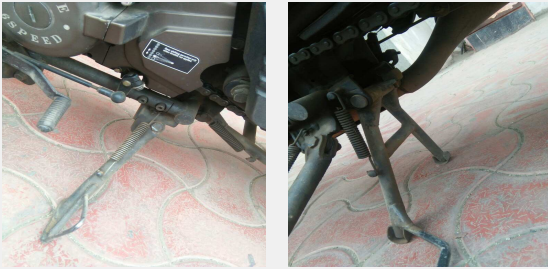
INSPECTION CHECKPOINTS	SCORE(X/10)	REMARKS/COMMENTS	OPTIONAL SPEND EST. (RS)
CENTRE STAND CONDITION	6	ACCEPTABLE CONDITION	0
CENTRE STAND RETENTION	6	WORKING	0
SIDE STAND CONDITION	6	ACCEPTABLE CONDITION	0
SIDE STAND RETENTION	6	WORKING	0

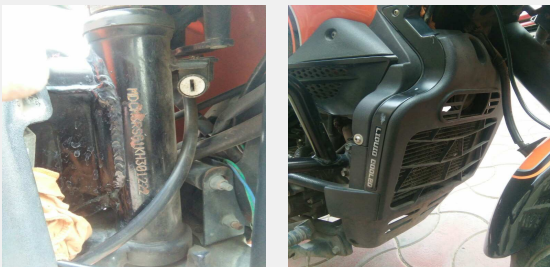
CHASSIS

INSPECTION CHECKPOINTS	SCORE(X/10)	REMARKS/COMMENTS	OPTIONAL SPEND EST. (RS)
FRAME CONDITION	6	NO CRACKS	0
FRAME STEERING-HEAD BEARINGS	6	NO RUSTING	0
FRAME SWINGARM BUSHINGS	6	NO DAMAGE	0
SUSPENSION FRONT FORKS LEFT	6	ACCEPTABLE CONDITION	0
SUSPENSION FRONT FORKS RIGHT	6	ACCEPTABLE CONDITION	0
SUSPENSION REAR SHOCKS LEFT	6	ACCEPTABLE CONDITION	0
SUSPENSION REAR SHOCKS RIGHT	6	ACCEPTABLE CONDITION	0
CHAIN/BELT TENSION	6	WORKING	0
CHAIN/BELT LUBRICATION	6	BETTER LUBRICATED	0
CHAIN/BELT SPROCKETS	6	ACCEPTABLE CONDITION	0
FASTENERS THREADED	6	NO RUST AVAILBLE	0
FASTENERS CLIPS & COTTER PINS	6	NO RUST AVAILABLE	0
ENGINE	6	GOOD PERFORMANCE	0
TRANSMISSION	6	SMOOTH TRANSFER	0
