# ECO INSPECTION CERTIFICATE

Order ID : 41542

121 Points Vehicle Inspection Certificate

## Mahindra Kuv100 K8 6 STR, 2016

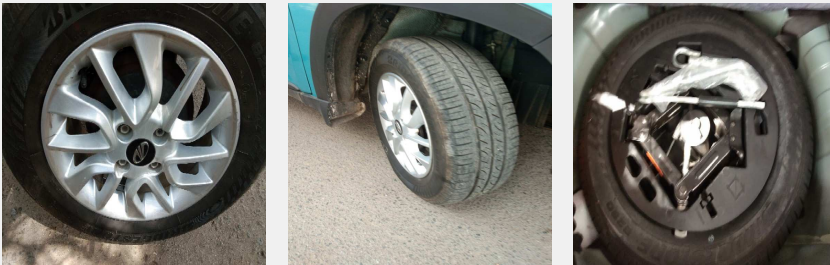
## NEED ATTENTION ⚠

INSPECTION CHECKPOINTS	SCORE(X/10)	REMARKS/COMMENTS	OPTIONAL SPEND EST. (RS)
TYRES	9	OK	0
SPARE TYRE (YES)	10	OK	0
WHEEL ASSEMBLY (ALLOY RIM)	9	OK	0

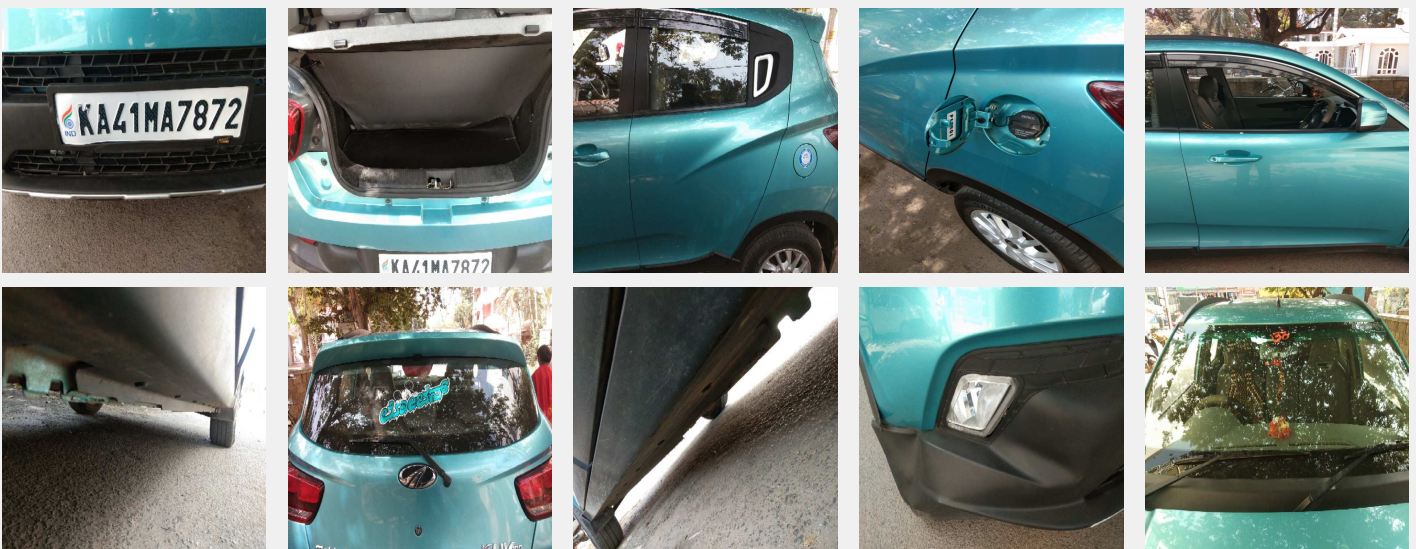
## NEED ATTENTION ⚠️

INSPECTION CHECKPOINTS	SCORE(X/10)	REMARKS/COMMENTS	OPTIONAL SPEND EST. (RS)
LICENSE PLATE	9	OK	0
FRONT BUMPER	8	TINKARINH	4500
HEAD LIGHTS	9	OK	0
GRILLE	9	OK	0
TURN SIGNAL	9	OK	0
FOG LAMPS	9	OK	0
HOOD	9	PAITING	3500
PILLAR	9	OK	0
FRONT WINDSHIELD	9	OK	0
SIDE VIEW MIRRORS	9	OK	0
LH FENDER	9	TINKARING AND PAITING	4500
LH FRONT DOOR	8	PAITING AND TINKARING	5300
LH REAR DOOR	9	OK	0
LH RUNNING BOARD	9	OK	0
LH QUARTER PANEL	9	PAITING	2500
FUEL LID	8	OK	0
REAR WINDSHIELD	9	OK	0
REAR BUMPER	9	PAITING AND TINKARING	5500
TAIL LIGHT	8	OK	0
TRUNK LID/TAIL GATE	8	OK	0
LUGGAGE COMPARTMENT LIGHT	9	OK	0
RH QUARTER PANEL	8	OK	0
RH RUNNING BOARD	9	OK	0
RH REAR DOOR	9	PAINTING	3500

INSPECTION CHECKPOINTS	SCORE(X/10)	REMARKS/COMMENTS	OPTIONAL SPEND EST. (RS)
RH FRONT DOOR	9	OK	0
RH FENDER	8	PAINTING	2500
BODY RUST	9	OK	0
ROOF (REGULAR)	9	OK	0
PAINT CONDITION	9	OK	0
