# ECO INSPECTION CERTIFICATE

121 Points Vehicle Inspection Certificate

Ordered By : Aman	Inspection Date : 2019-02-22	Valid Till : 2019-05-22	  Inspected By

## Maruti Suzuki Dzire LDI, 2013

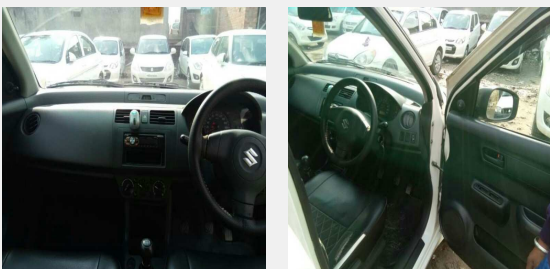
## IMAGES

INSPECTION CHECKPOINTS	SCORE(X/10)	REMARKS/COMMENTS	OPTIONAL SPEND EST. (RS)
DOOR PANEL	7	SAFE	0
DOOR HINGES	6	GOOD	0
CARPET & FLOOR MAT	7	GOOD	0
SEAT & SEAT BELT	7	WELL	0
DASHBOARD & INSTRUMENT PANEL	6	WORKING	0
HORN	6	GOOD	0
SPEAKERS & MUSIC SYSTEM	7	WORKING	0
HANDBRAKE	6	GOOD	0
STEERING-MOUNTED CONTROLS	7	WELL	0
PEDALS	6	SAFE	0
CENTRAL LOCK	7	GOOD	0
A/C VENTS & HEATER	6	WORKING	0
CUP HOLDERS	6	GOOD	0
NAVIGATION (NO)	10		0
ODOMETER	7	GOOD	0
POWER WINDOWS (YES)	7	GOOD	0
HAZARD LIGHT	7	WORKING	0

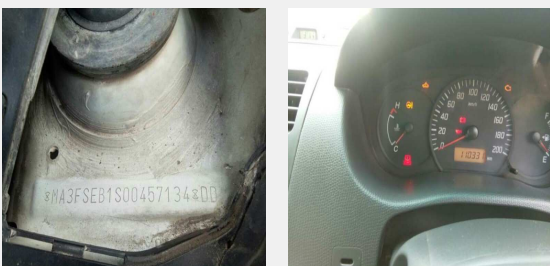
IMAGES

INSPECTION CHECKPOINTS	SCORE(X/10)	REMARKS/COMMENTS	OPTIONAL SPEND EST. (RS)
STEERING PERFORMANCE	6	GOOD	0
BRAKE PERFORMANCE	6	GOOD	0
CLUTCH PERFORMANCE	7	GOOD	0
ENGINE NOISE	6	LESS NOISE	0
IGNITION SYSTEM	6	SMOOTH	0
SUSPENSION PERFORMANCE	6	SAFE	0
SUSPENSION FRONT SHOCKS	7	SAFE	0
SUSPENSION REAR SHOCKS	7	GOOD	0
TRANSMISSION ENGAGE	6	SMOOTH	0
CRUISE CONTROL (NO)	10		0
REAR PARKING SENSORS (NO)	10		0
REAR VIEW CAMERA (NO)	10		0

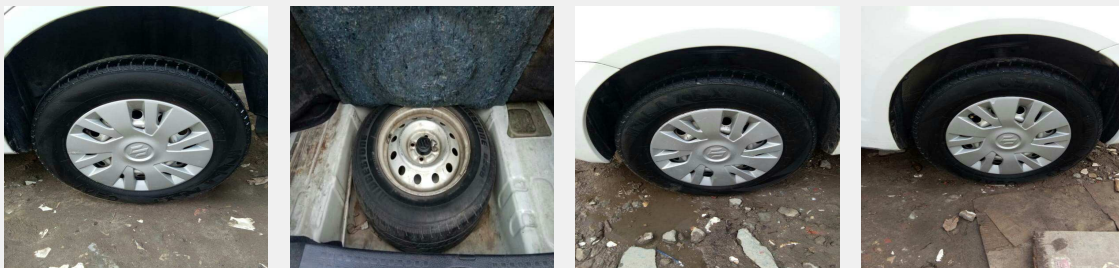
## IMAGES

INSPECTION CHECKPOINTS	SCORE(X/10)	REMARKS/COMMENTS	OPTIONAL SPEND EST. (RS)
TYRES	6	GOOD	0
SPARE TYRE (YES)	6	GOOD	0
WHEEL ASSEMBLY (ALLOY RIM)	6	GOOD	0
