# ECO INSPECTION CERTIFICATE

121 Points Vehicle Inspection Certificate

## Maruti Suzuki Swift VDI ABS, 2010

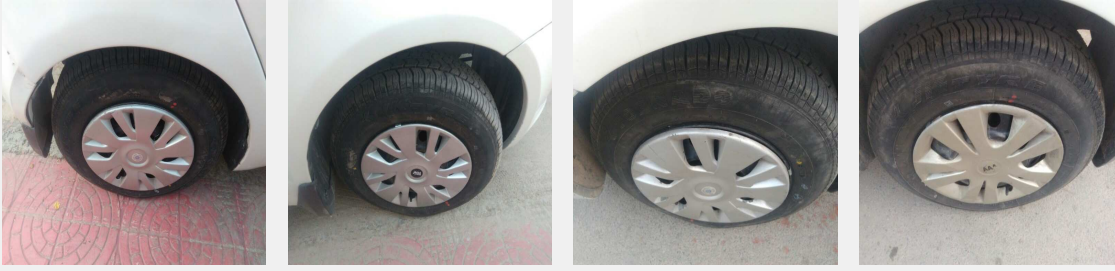
IMAGES

INSPECTION CHECKPOINTS	SCORE(X/10)	REMARKS/COMMENTS	OPTIONAL SPEND EST. (RS)
TYRES	8		0
SPARE TYRE (YES)	7		0
WHEEL ASSEMBLY (STEEL RIM)	6		0

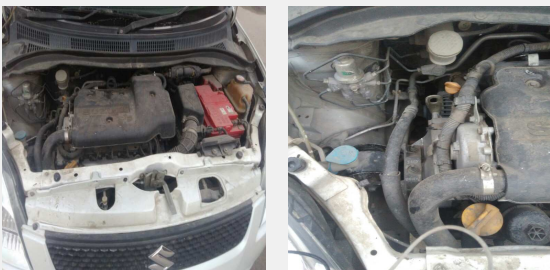
IMAGES

INSPECTION CHECKPOINTS	SCORE(X/10)	REMARKS/COMMENTS	OPTIONAL SPEND EST. (RS)
LH APRON	6		0
RH APRON	6		0
RADIATOR	6		0
WIRING	6		0
BATTERY	6		0
BRAKE FLUID LEVEL	6		0
ENGINE OIL	7		0
COOLANT LEVEL	7		0
BRAKE & COOLANT HOSE PIPES	7		0
UNDERCARRIAGE	6		0
EXHAUST SYSTEM	6		0
