# ECO INSPECTION CERTIFICATE

121 Points Vehicle Inspection Certificate

## Maruti Suzuki Swift LDI, 2007

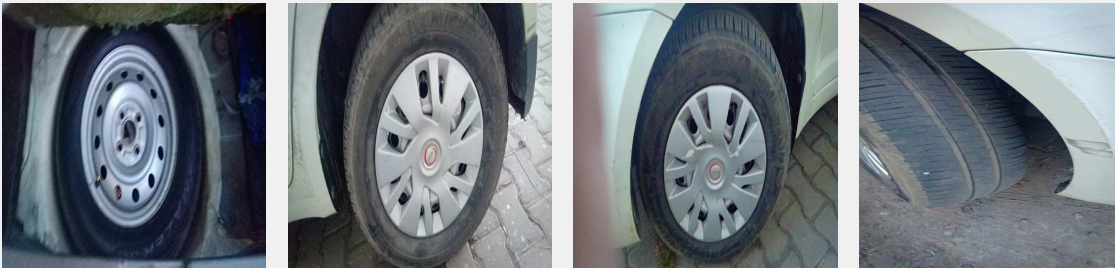
## IMAGES

INSPECTION CHECKPOINTS	SCORE(X/10)	REMARKS/COMMENTS	OPTIONAL SPEND EST. (RS)
WHEEL ASSEMBLY (STEEL RIM)	6	ALL RIMS ARE IN GOOD CONDITION	0
TYRES	4	IN FINE CONDITION	15000
SPARE TYRE (YES)	3	IN FINE CONDITION	1200
