ECO INSPECTION CERTIFICATE

121 Points Vehicle Inspection Certificate

Chevrolet Beat Ls Diesel, 2015

VEHICLE INFORMATION			
MAKE	CHEVROLET	TRANSMISSION TYPE	MANUAL
MODEL	BEAT	REGISTRATION NO.	HR05AP1034
YEAR	2015	VIN/CHASSIS NUMBER	MA6BFBCNFFT007298
TRIM	LS DIESEL	KMS RUN	30743
COLOR	WHITE	INSURANCE EXPIRY	2019-7-16
BODY TYPE	HATCHBACK	LOCATION	CLUB MARKET
FUEL TYPE	DIESEL	ENGINE SOUND LINK	LISTEN ENGINE SOUND

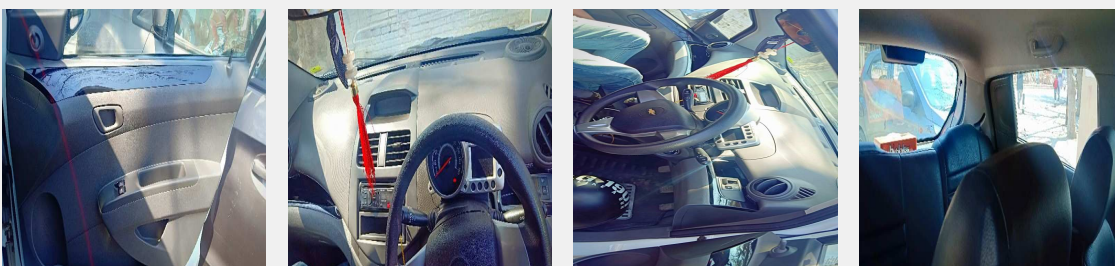
INTERIOR

INSPECTION CHECKPOINTS	SCORE(X/10)	REMARKS/COMMENTS	OPTIONAL SPEND EST. (RS)
DOOR PANEL	6	IN GOOD CONDITION	0
DOOR HINGES	6	IN GOOD CONDITION	0
CARPET & FLOOR MAT	6	NEAT AND CLEAN	0
SEAT & SEAT BELT	6	CLEAN AND GOOD	0
DASHBOARD & INSTRUMENT PANEL	7	ALL GOOD	0
HORN	6	WORK PROPERLY AND GOOD SOUND	0
SPEAKERS & MUSIC SYSTEM	6	SOUND ID GOOD SYSTEM WORK PROPERLY	0
HANDBRAKE	7	WORKING GOOD	0
STEERING-MOUNTED CONTROLS	6	ALL GOOD	0
PEDALS	6	NEAT AND CLEAN	0
CENTRAL LOCK	7	WORK PROPERLY	0
A/C VENTS & HEATER	7	ALL GOOD	0
CUP HOLDERS	6	IN GOOD CONDITION	0
NAVIGATION (NO)	10		0
ODOMETER	7	ALL GOOD	0
POWER WINDOWS (YES - FRONT ONLY)	7	WORKING GOOD	0
HAZARD LIGHT	7	WORK PROPERLY	0

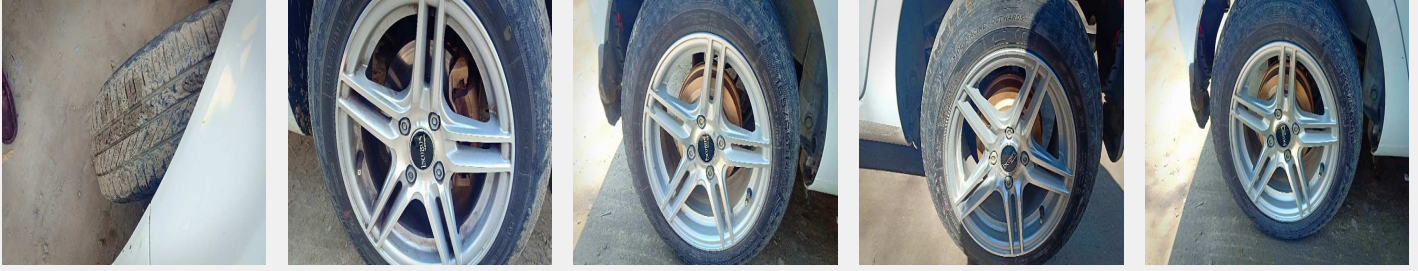
INSPECTION CHECKPOINTS	SCORE(X/10)	REMARKS/COMMENTS	OPTIONAL SPEND EST. (RS)
TYRES	6	IN GOOD CONDITION	0
SPARE TYRE (YES)	7	UNUSED	0
WHEEL ASSEMBLY (ALLOY RIM)	6	ALL LIKE NEW	0

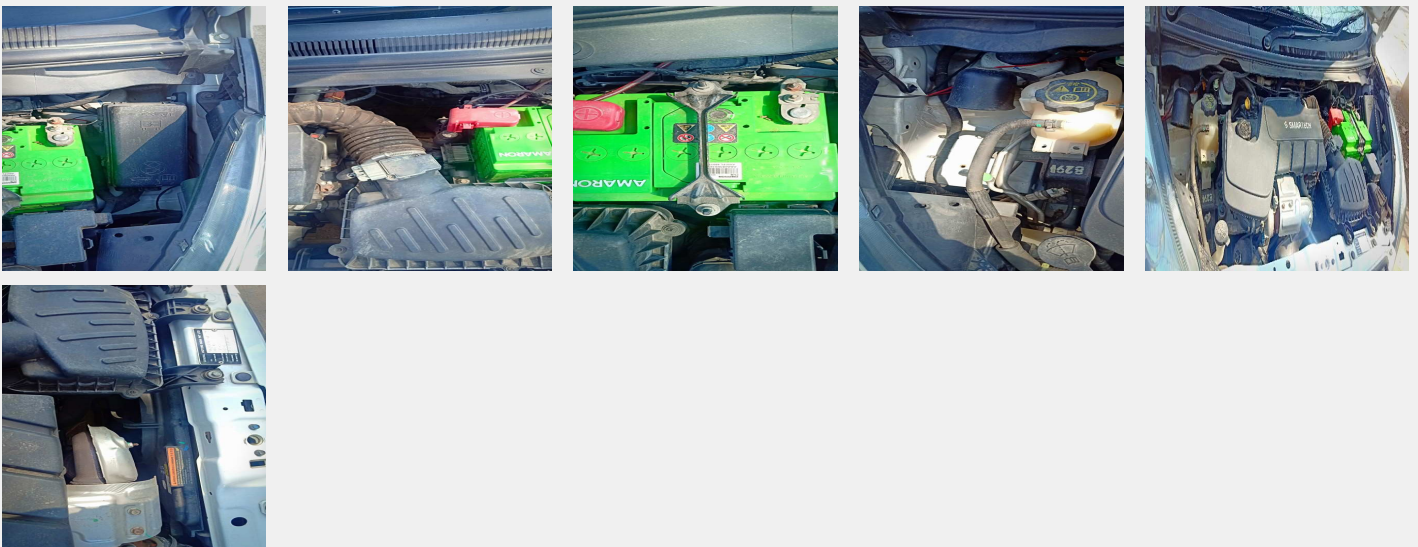
HOOD

INSPECTION CHECKPOINTS	SCORE(X/10)	REMARKS/COMMENTS	OPTIONAL SPEND EST. (RS)
LH APRON	7	ALL CLEAN	0
RH APRON	7	ALL CLEAN	0
RADIATOR	7	IN GOOD CONDITION	0
WIRING	7	ALL GENUINE	0
BATTERY	7	NEW	0
BRAKE FLUID LEVEL	7	TOP OF THE LEVEL	0
ENGINE OIL	6	TOP OF THE LEVEL	0
COOLANT LEVEL	6	TOP OF THE LEVEL	0
BRAKE & COOLANT HOSE PIPES	7	IN GOOD CONDITION	0
UNDERCARRIAGE	7	IN FINE CONDITION	0
EXHAUST SYSTEM	6	NO WHITE AND GREY SMOKE	0

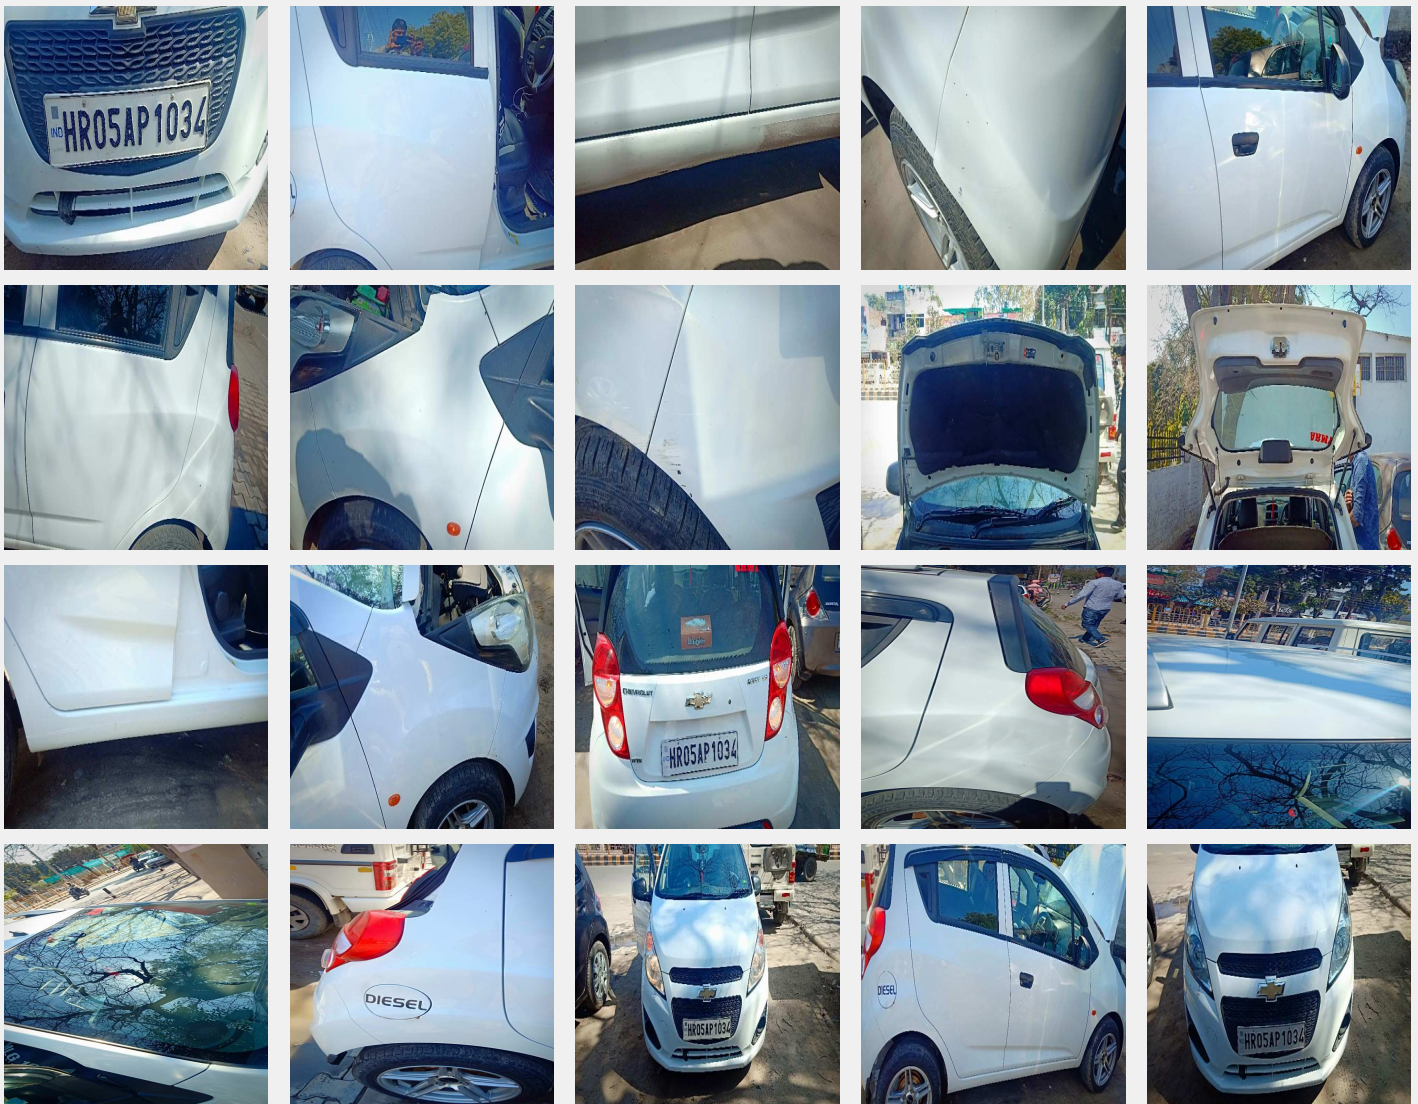
EXTERIOR (CONTINUED)

INSPECTION CHECKPOINTS	SCORE(X/10)	REMARKS/COMMENTS	OPTIONAL SPEND EST. (RS)
LICENSE PLATE	6	IN FINE CONDITION	0
FRONT BUMPER	6	MINOR SCRATCHS ON IT	0
HEAD LIGHTS	7	ALL GOOD WORK PROPERLY	0
GRILLE	6	NEAT AND CLEAN	0
TURN SIGNAL	7	WORK PROPERLY	0
FOG LAMPS	6	IN GOOD CONDITION	0
HOOD	7	IN GOOD CONDITION	0
PILLAR	7	ALL GENUINE	0
FRONT WINDSHIELD	7	NEAT AND CLEAN	0
SIDE VIEW MIRRORS	7	IN GOOD CONDITION	0
LH FENDER	7	NOT EVEN ONE SCRATCH	0
LH FRONT DOOR	7	CLEAN	0
LH REAR DOOR	7	CLEAN	0
LH RUNNING BOARD	7	ALL GENUINE	0
LH QUARTER PANEL	7	ALL GENUINE	0
FUEL LID	7	WORK PROPERLY	0
REAR WINDSHIELD	7	NEAT AND CLEAN	0
REAR BUMPER	6	MINOR SCRATCHS	0
TAIL LIGHT	7	ALL GOOD	0
TRUNK LID/TAIL GATE	7	WORK PROPERLY	0
LUGGAGE COMPARTMENT LIGHT	7	CLEAN	0
RH QUARTER PANEL	7	NOT EVEN ONE SCRATCH	0
RH RUNNING BOARD	7	ALL CLEAN	0
RH REAR DOOR	7	NEAT AND CLEAN	0

INSPECTION CHECKPOINTS	SCORE(X/10)	REMARKS/COMMENTS	OPTIONAL SPEND EST. (RS)
RH FRONT DOOR	6	ALL GENUINE	0
RH FENDER	7	ORIGINAL	0
ROOF (REGULAR)	7	ALL GENUINE	0
PAINT CONDITION	7	GOOD PAINT CONDITION	0
BODY RUST	5	MINOR RUSTING	500
