ECO INSPECTION CERTIFICATE

Order ID : 46566

121 Points Vehicle Inspection Certificate

Maruti Suzuki Swift Vxi, 2014

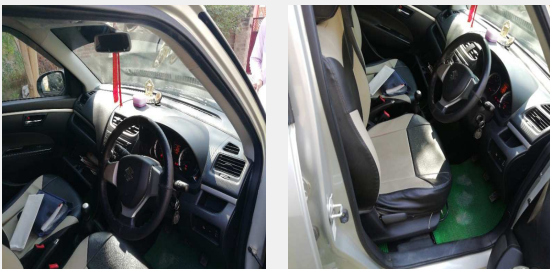
IMAGES

INSPECTION CHECKPOINTS	SCORE(X/10)	REMARKS/COMMENTS	OPTIONAL SPEND EST. (RS)
DOOR PANEL	7		0
DOOR HINGES	7		0
CARPET & FLOOR MAT	7		0
SEAT & SEAT BELT	7		0
DASHBOARD & INSTRUMENT PANEL	7		0
HORN	7		0
SPEAKERS & MUSIC SYSTEM	7		0
HANDBRAKE	8		0
STEERING-MOUNTED CONTROLS	7		0
PEDALS	7		0
CENTRAL LOCK	7		0
A/C VENTS & HEATER	7		0
CUP HOLDERS	7		0
NAVIGATION (YES)	7		0
ODOMETER	8		0
POWER WINDOWS (YES)	7		0
HAZARD LIGHT	7		0

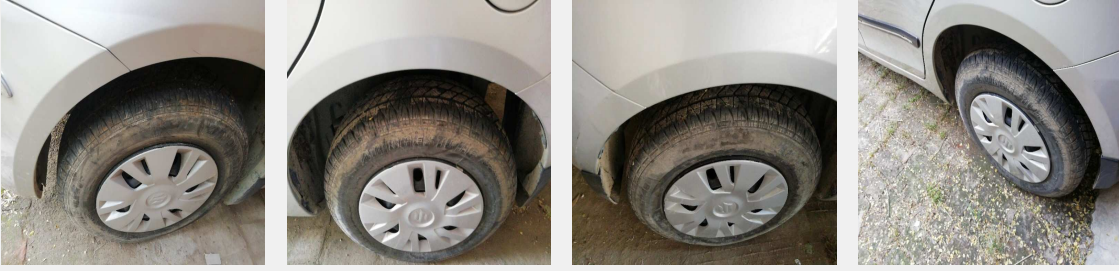
IMAGES

INSPECTION CHECKPOINTS	SCORE(X/10)	REMARKS/COMMENTS	OPTIONAL SPEND EST. (RS)
TYRES	7		0
SPARE TYRE (YES)	8		0
WHEEL ASSEMBLY (STEEL RIM)	7		0

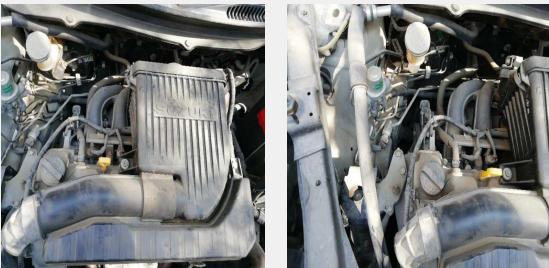
IMAGES

INSPECTION CHECKPOINTS	SCORE(X/10)	REMARKS/COMMENTS	OPTIONAL SPEND EST. (RS)
LH APRON	7		0
RH APRON	7		0
RADIATOR	7		0
WIRING	7		0
BATTERY	7		0
BRAKE FLUID LEVEL	7		0
ENGINE OIL	7		0
COOLANT LEVEL	7		0
BRAKE & COOLANT HOSE PIPES	7		0
UNDERCARRIAGE	7		0
EXHAUST SYSTEM	7		0
