ECO INSPECTION CERTIFICATE

Order ID : 47133

121 Points Vehicle Inspection Certificate

Maruti Suzuki Swift VDI, 2014

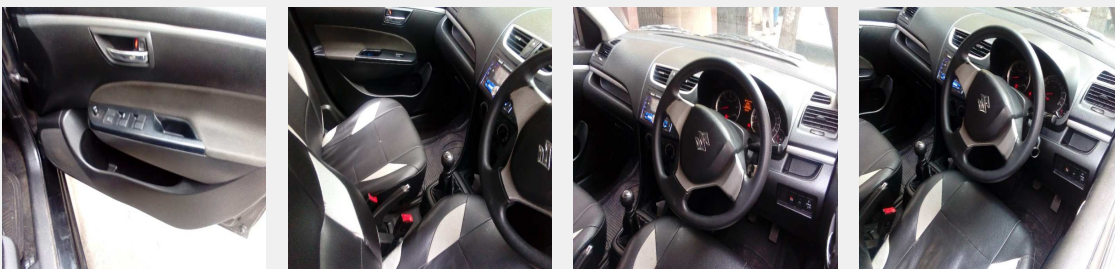
IMAGES

INSPECTION CHECKPOINTS	SCORE(X/10)	REMARKS/COMMENTS	OPTIONAL SPEND EST. (RS)
DOOR PANEL	6	OK	0
DOOR HINGES	6	OK	0
CARPET & FLOOR MAT	6	OK	0
SEAT & SEAT BELT	6	OK	0
DASHBOARD & INSTRUMENT PANEL	6	OK	0
HORN	6	OK	0
SPEAKERS & MUSIC SYSTEM	6	OK	0
HANDBRAKE	6	OK	0
STEERING-MOUNTED CONTROLS	6	OK	0
PEDALS	6	OK	0
CENTRAL LOCK	6	OK	0
A/C VENTS & HEATER	6	OK	0
CUP HOLDERS	6	OK	0
NAVIGATION (YES)	6	OK	0
ODOMETER	6	OK	0
POWER WINDOWS (YES)	6	OK	0
HAZARD LIGHT	6	FLASHING	0

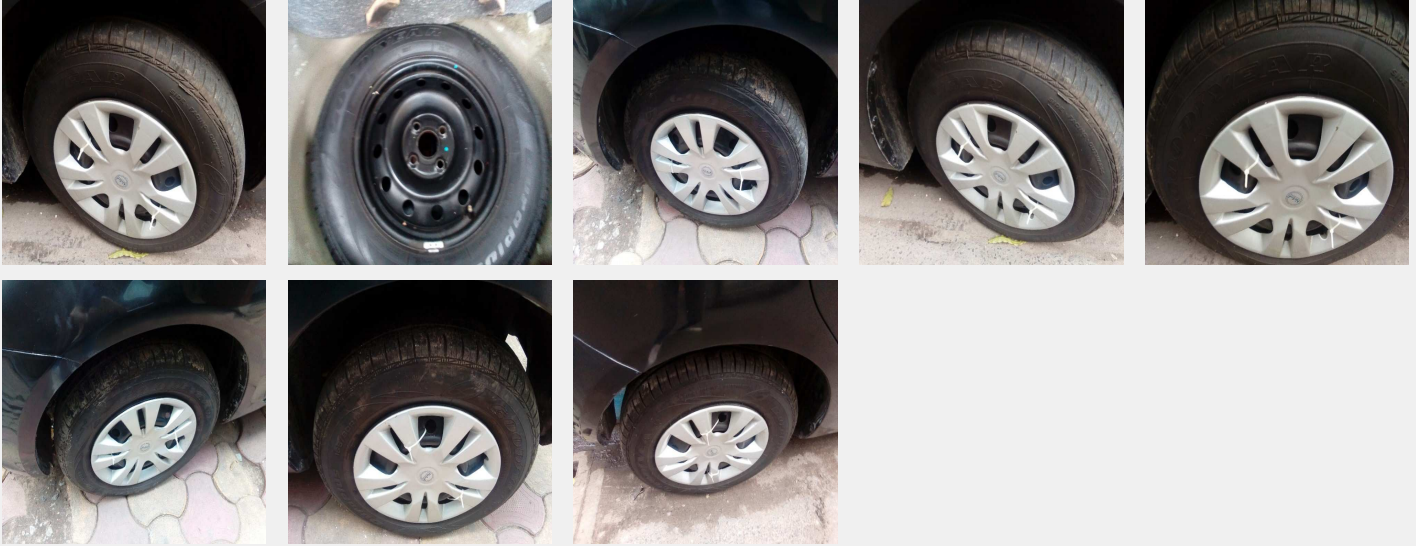
IMAGES

INSPECTION CHECKPOINTS	SCORE(X/10)	REMARKS/COMMENTS	OPTIONAL SPEND EST. (RS)
TYRES	6	GOOD CONDITION	0
SPARE TYRE (YES)	6	GOOD CONDITION	0
WHEEL ASSEMBLY (STEEL RIM)	6	OK	0

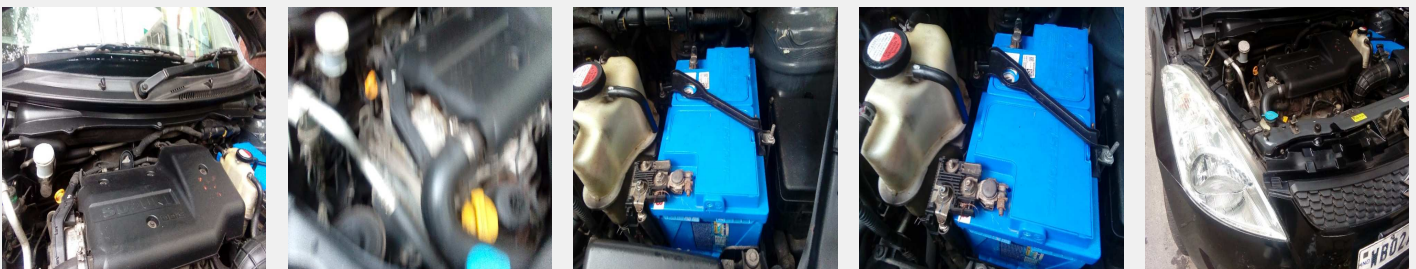
IMAGES

INSPECTION CHECKPOINTS	SCORE(X/10)	REMARKS/COMMENTS	OPTIONAL SPEND EST. (RS)
LH APRON	6	OL	0
RH APRON	6	OK	0
RADIATOR	6	OK	0
WIRING	6	OK	0
BATTERY	6	OK	0
BRAKE FLUID LEVEL	6	FULL	0
ENGINE OIL	6	FULL	0
COOLANT LEVEL	6	NORMAL	0
BRAKE & COOLANT HOSE PIPES	6	OK	0
UNDERCARRIAGE	6	OK	0
EXHAUST SYSTEM	6	OK	0

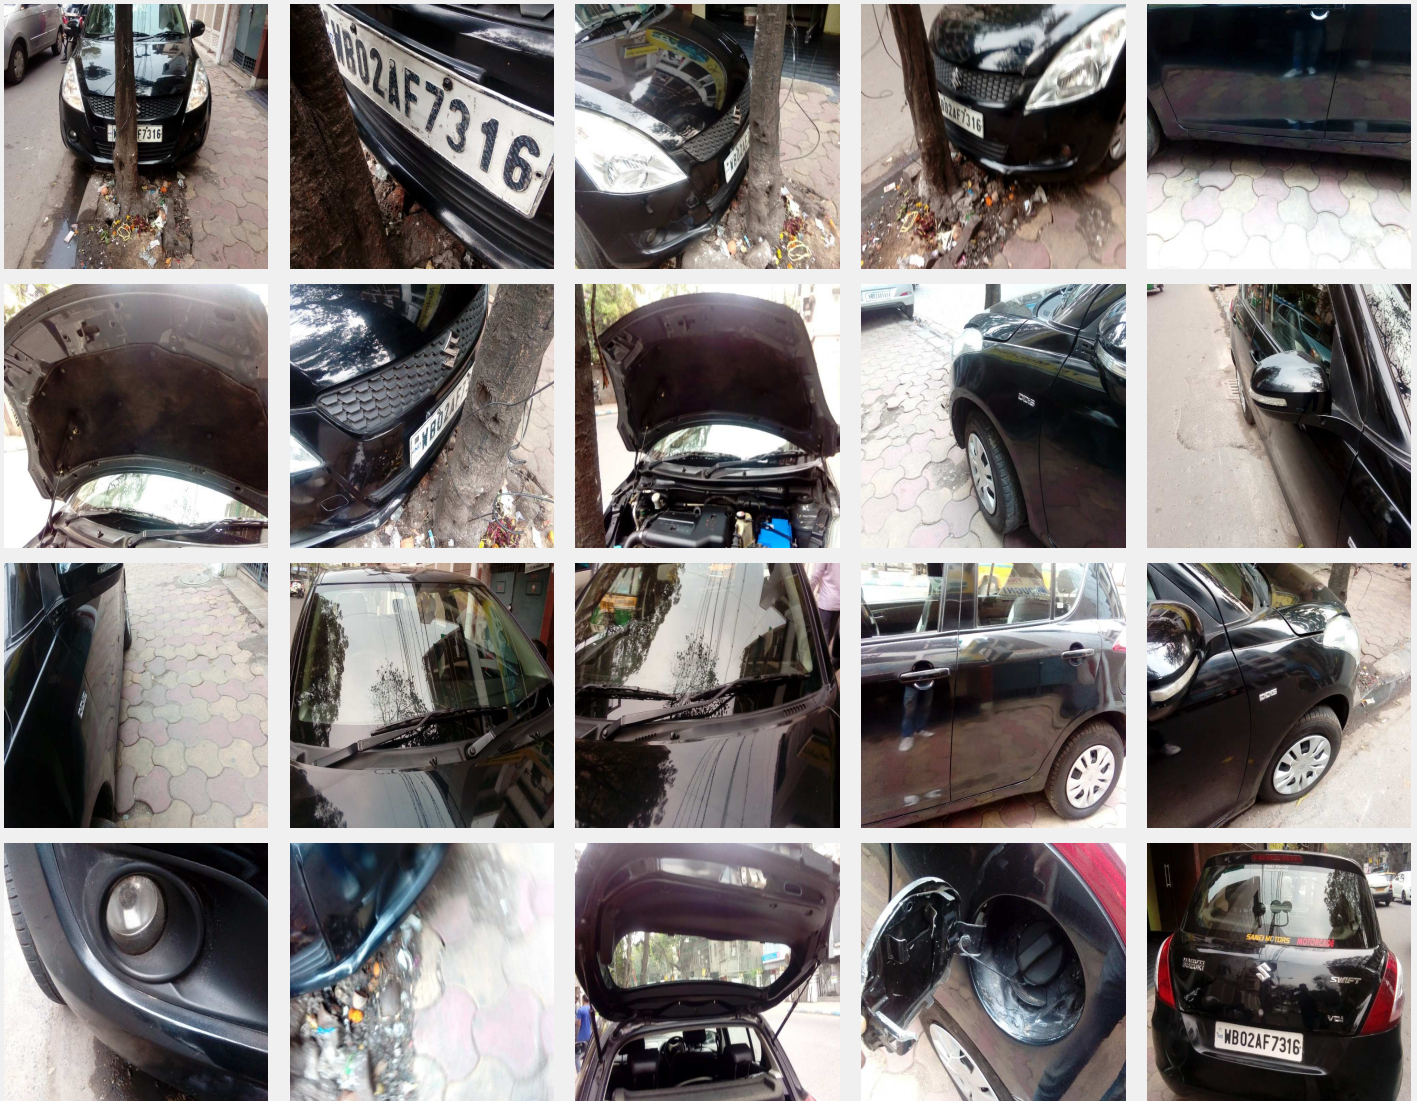
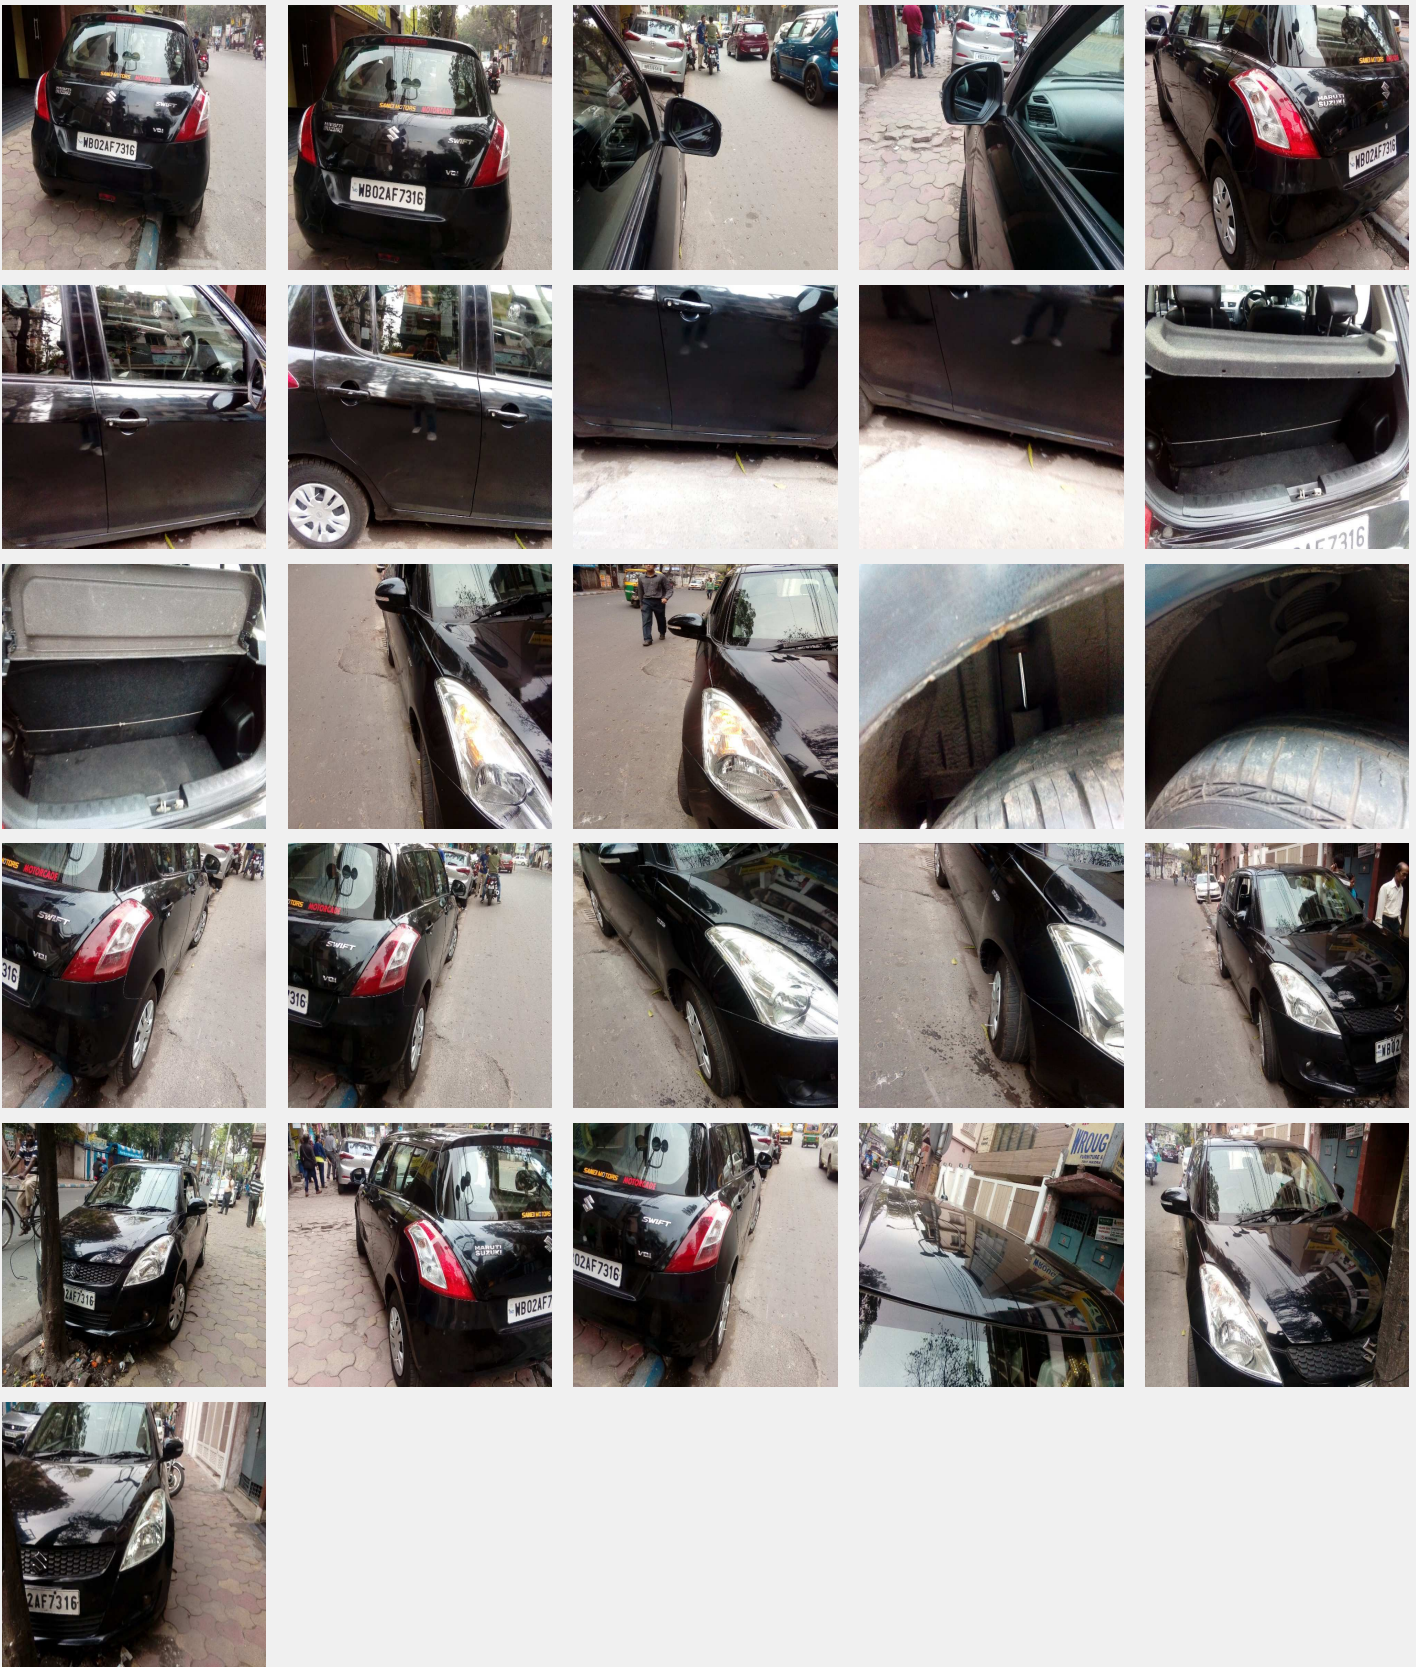
IMAGES

INSPECTION CHECKPOINTS	SCORE(X/10)	REMARKS/COMMENTS	OPTIONAL SPEND EST. (RS)
RH FRONT DOOR	6	OL	0
RH FENDER	6	OK	0
BODY RUST	6	NO BODY RUST	0
ROOF (REGULAR)	6	OK	0
PAINT CONDITION	6	GOOD	0
