# ECO INSPECTION CERTIFICATE

121 Points Vehicle Inspection Certificate

Inspection Date :  
2019-03-04

## Bajaj Discover T 100CC, 2013

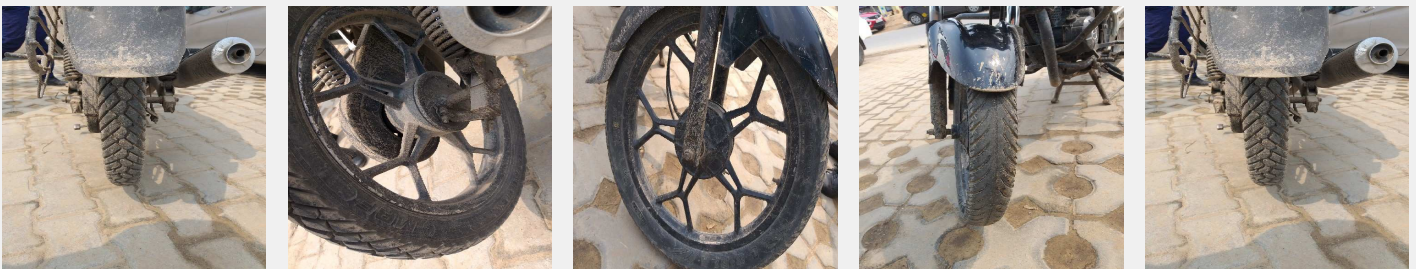
| INSPECTION CHECKPOINTS | SCORE(X/10) | REMARKS/COMMENTS | OPTIONAL SPEND EST. (RS) |
|---|---|---|---|
| FRONT TYRE CONDITION & AIR PRESSURE | 3 | NEED TO BE CHANG | 2500 |
| WHEEL SPOKES FRONT | 3 | NEED TO BE CHANG | 2500 |

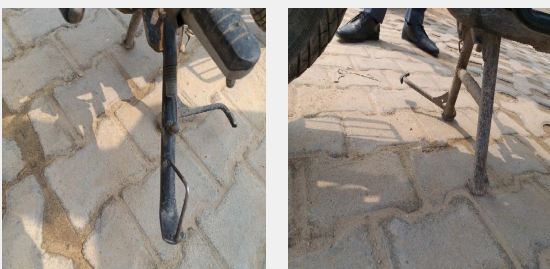
| INSPECTION CHECKPOINTS | SCORE(X/10) | REMARKS/COMMENTS | OPTIONAL SPEND EST. (RS) |
|---|---|---|---|
| CENTRE STAND CONDITION | 7 | GOOD | 0 |
| CENTRE STAND RETENTION | 7 | WORKING PROPERLY | 0 |
| SIDE STAND CONDITION | 7 | GOOD | 0 |
| SIDE STAND RETENTION | 7 | WORKING PROPERLY | 0 |

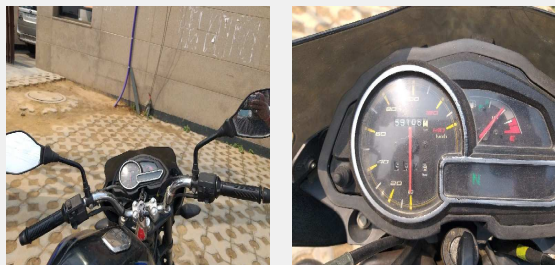
| INSPECTION CHECKPOINTS | SCORE(X/10) | REMARKS/COMMENTS | OPTIONAL SPEND EST. (RS) |
|---|---|---|---|
| HANDLEBARS CONDITION | 7 | GOOD | 0 |
| LEVERS & PEDAL CONDITION | 7 | GOOD | 0 |

| THROTTLE OPERATION | 7 | GOOD CONDITION AND WORKING PROPERLY | 0 |

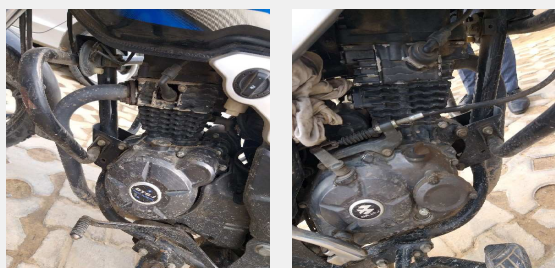
| INSPECTION CHECKPOINTS | SCORE(X/10) | REMARKS/COMMENTS | OPTIONAL SPEND EST. (RS) |
|---|---|---|---|
| LEVELS - ENGINE OIL | 7 | MAXIMUM | 0 |
| LEVELS - FUEL | 6 | MINIMUM | 0 |
| LEAKS - ENGINE OIL | 7 | NO LEAKS | 0 |
| LEAKS - FUEL | 7 | NO LEAKS | 0 |

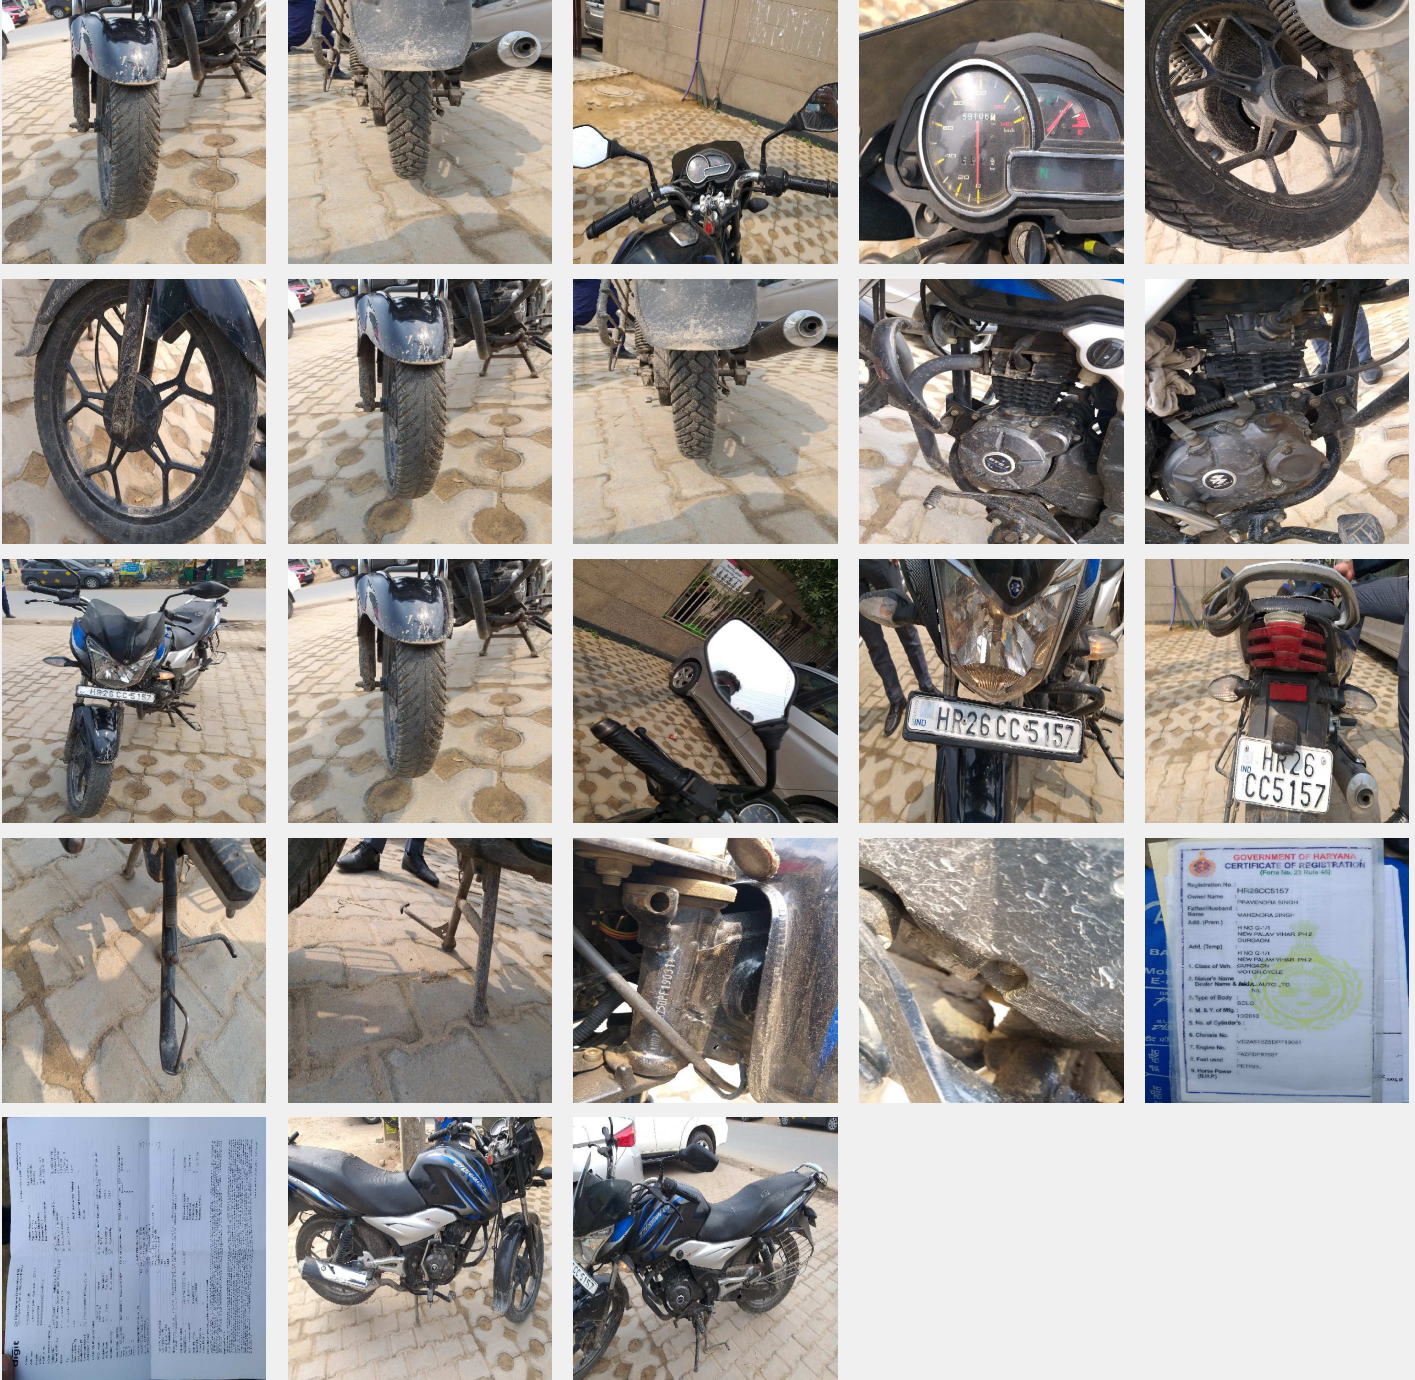
minar scratches seat covers need to be chang minar leak oil front shokkr need to be repair
