ECO INSPECTION CERTIFICATE

Order ID : 47108

121 Points Vehicle Inspection Certificate

Fiat Punto ACTIVE 1.2, 2010

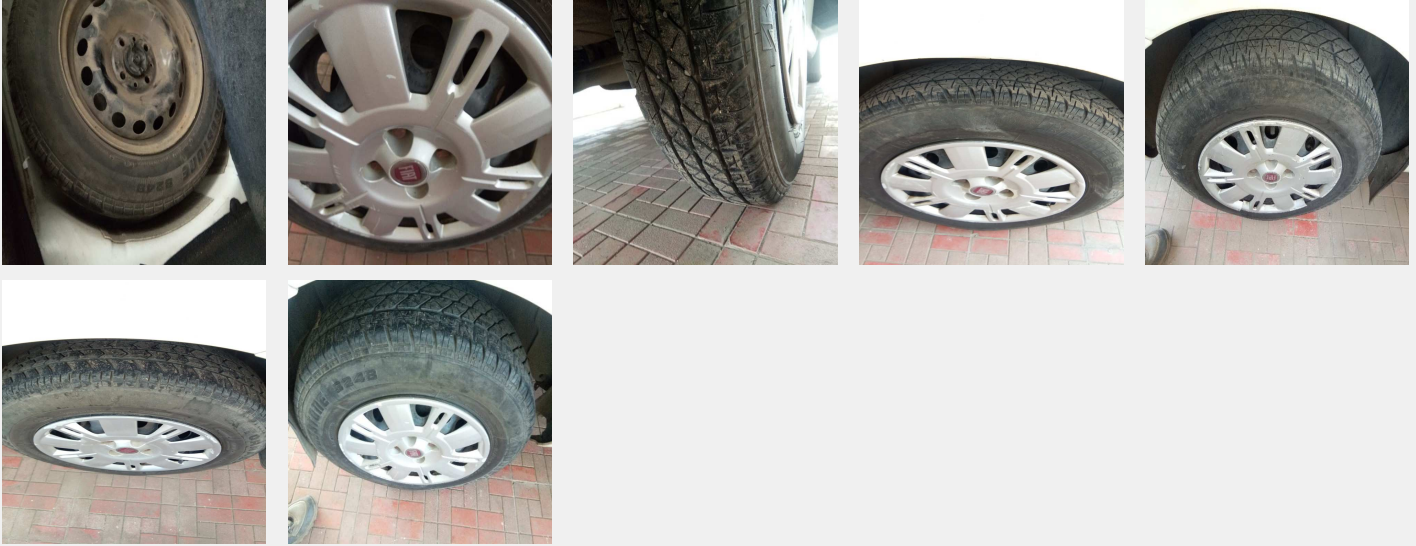
IMAGES

INSPECTION CHECKPOINTS	SCORE(X/10)	REMARKS/COMMENTS	OPTIONAL SPEND EST. (RS)
TYRES	8	GOOD	0
SPARE TYRE (YES)	8	GOOD	0
WHEEL ASSEMBLY (STEEL RIM)	6	GOOD	0

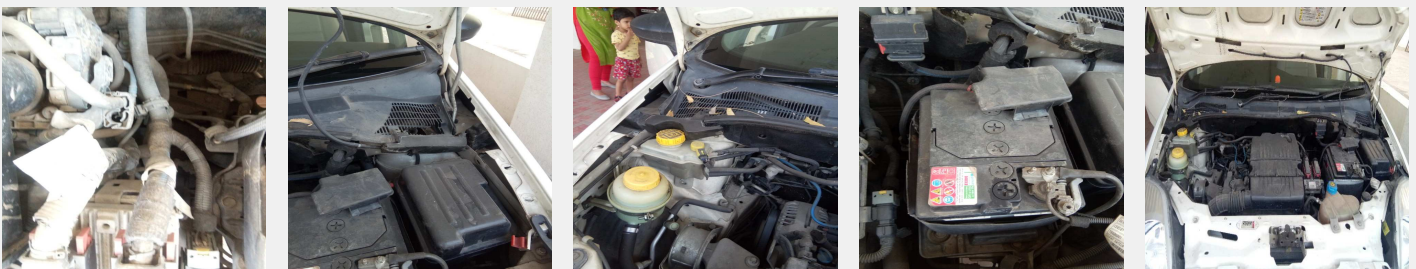
IMAGES

INSPECTION CHECKPOINTS	SCORE(X/10)	REMARKS/COMMENTS	OPTIONAL SPEND EST. (RS)
LH APRON	7	GOOD	0
RH APRON	7	GOOD	0
RADIATOR	7	GOOD	0
WIRING	7	GOOD	0
BATTERY	7	GOOD	0
BRAKE FLUID LEVEL	7	GOOD	0
ENGINE OIL	7	GOOD	0
COOLANT LEVEL	7	GOOD	0
BRAKE & COOLANT HOSE PIPES	7	GOOD	0
UNDERCARRIAGE	7	GOOD	0
EXHAUST SYSTEM	7	GOOD	0

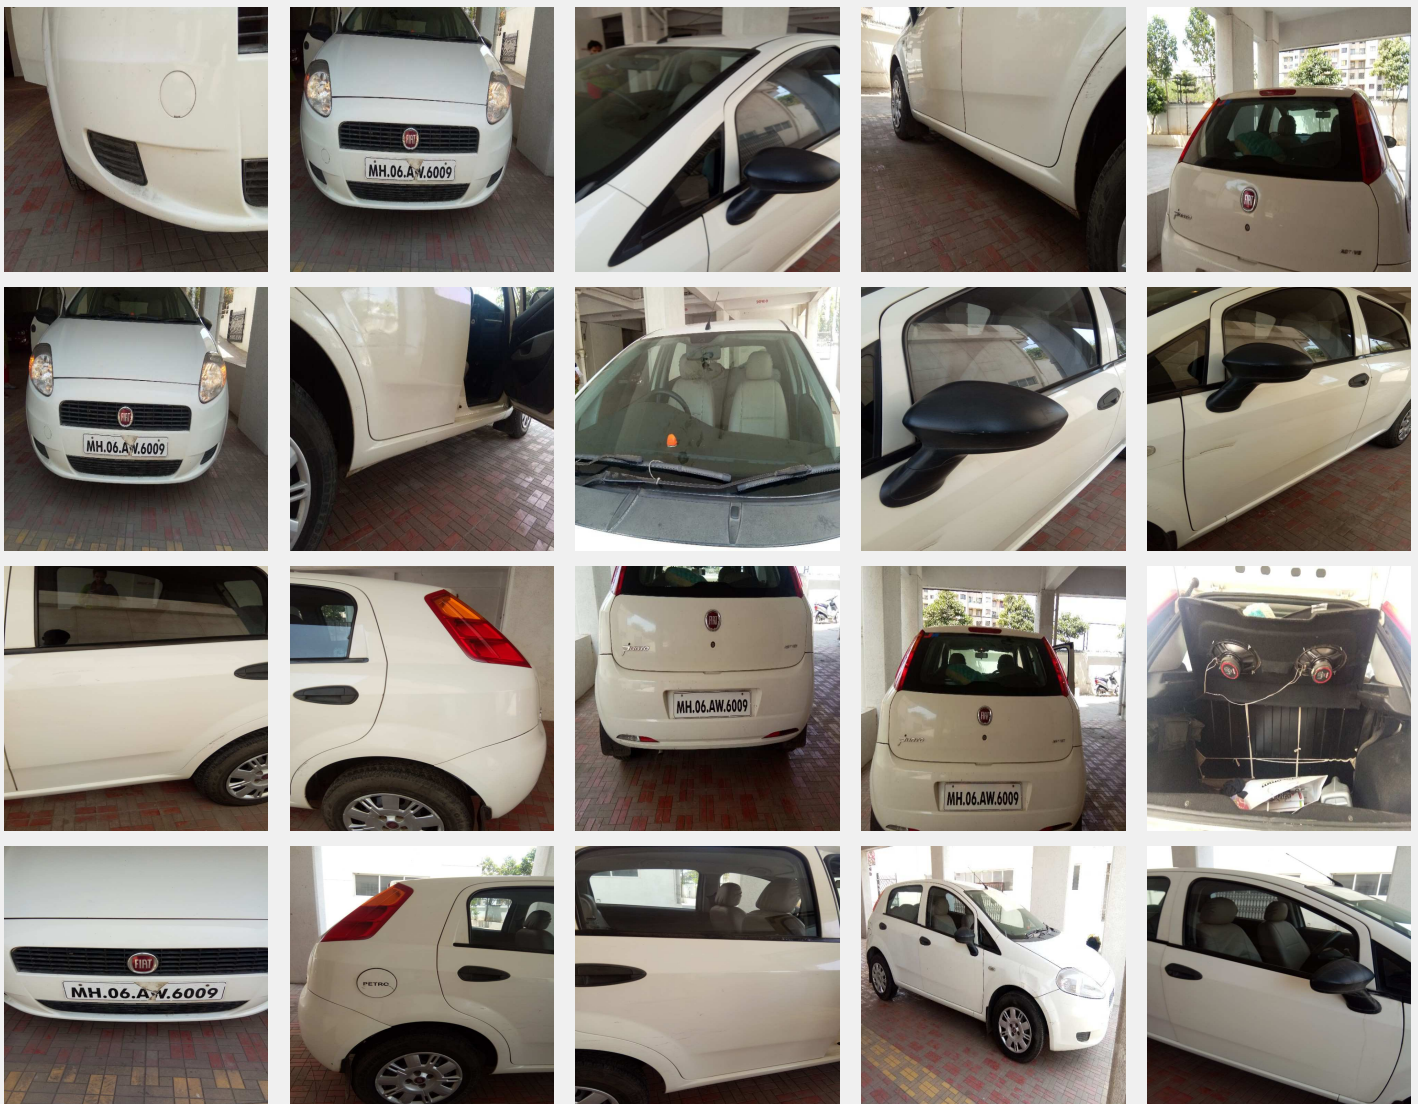
IMAGES

INSPECTION CHECKPOINTS	SCORE(X/10)	REMARKS/COMMENTS	OPTIONAL SPEND EST. (RS)
FRONT BUMPER	4	SMALL SCRATCHES	2000
HOOD	4	SMALL DENT	1000
LH FENDER	4	SMALL SCRATCHES	500
FUEL LID	4	NEED TO REPAIRE	500
RH FENDER	1	BIG DENT	5000
