ECO INSPECTION CERTIFICATE

121 Points Vehicle Inspection Certificate

Toyota Corolla 1.8E, 2004

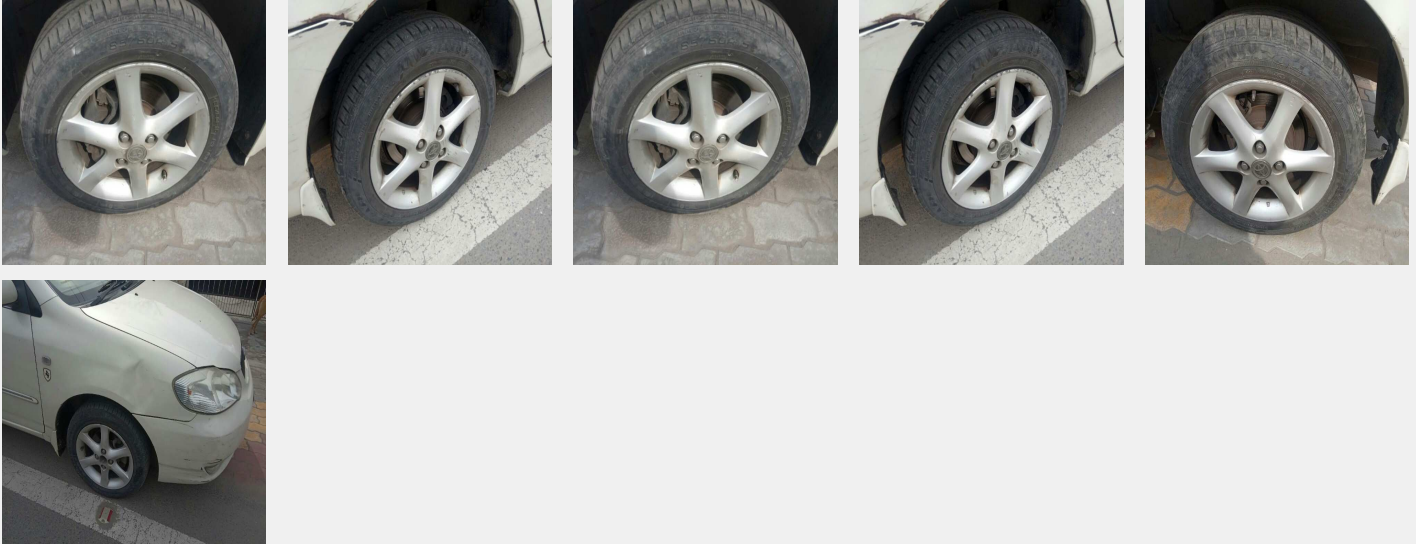
IMAGES

INSPECTION CHECKPOINTS	SCORE(X/10)	REMARKS/COMMENTS	OPTIONAL SPEND EST. (RS)
TYRES	6	GOOD	0
SPARE TYRE (NO)	10		0
WHEEL ASSEMBLY (ALLOY RIM)	7	GOOD	0

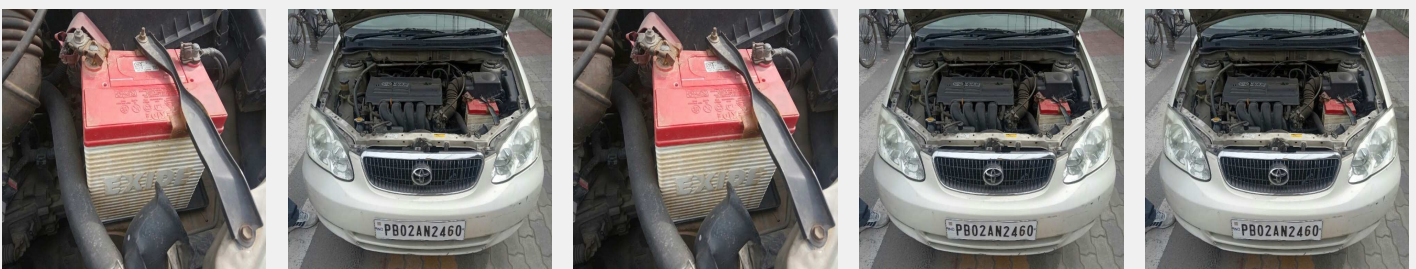
IMAGES

INSPECTION CHECKPOINTS	SCORE(X/10)	REMARKS/COMMENTS	OPTIONAL SPEND EST. (RS)
LH APRON	7	GOOD	0
RH APRON	7	GOOD	0
RADIATOR	7	SAFE	0
WIRING	8	GOOD	0
BATTERY	7	GOOD	0
BRAKE FLUID LEVEL	7	ABOVE AVERAGE	0
ENGINE OIL	7	GOOD	0
COOLANT LEVEL	7	ABOVE AVERAGE	0
BRAKE & COOLANT HOSE PIPES	8	SAFE	0
UNDERCARRIAGE	8	BETTER	0
EXHAUST SYSTEM	7	BETTER	0

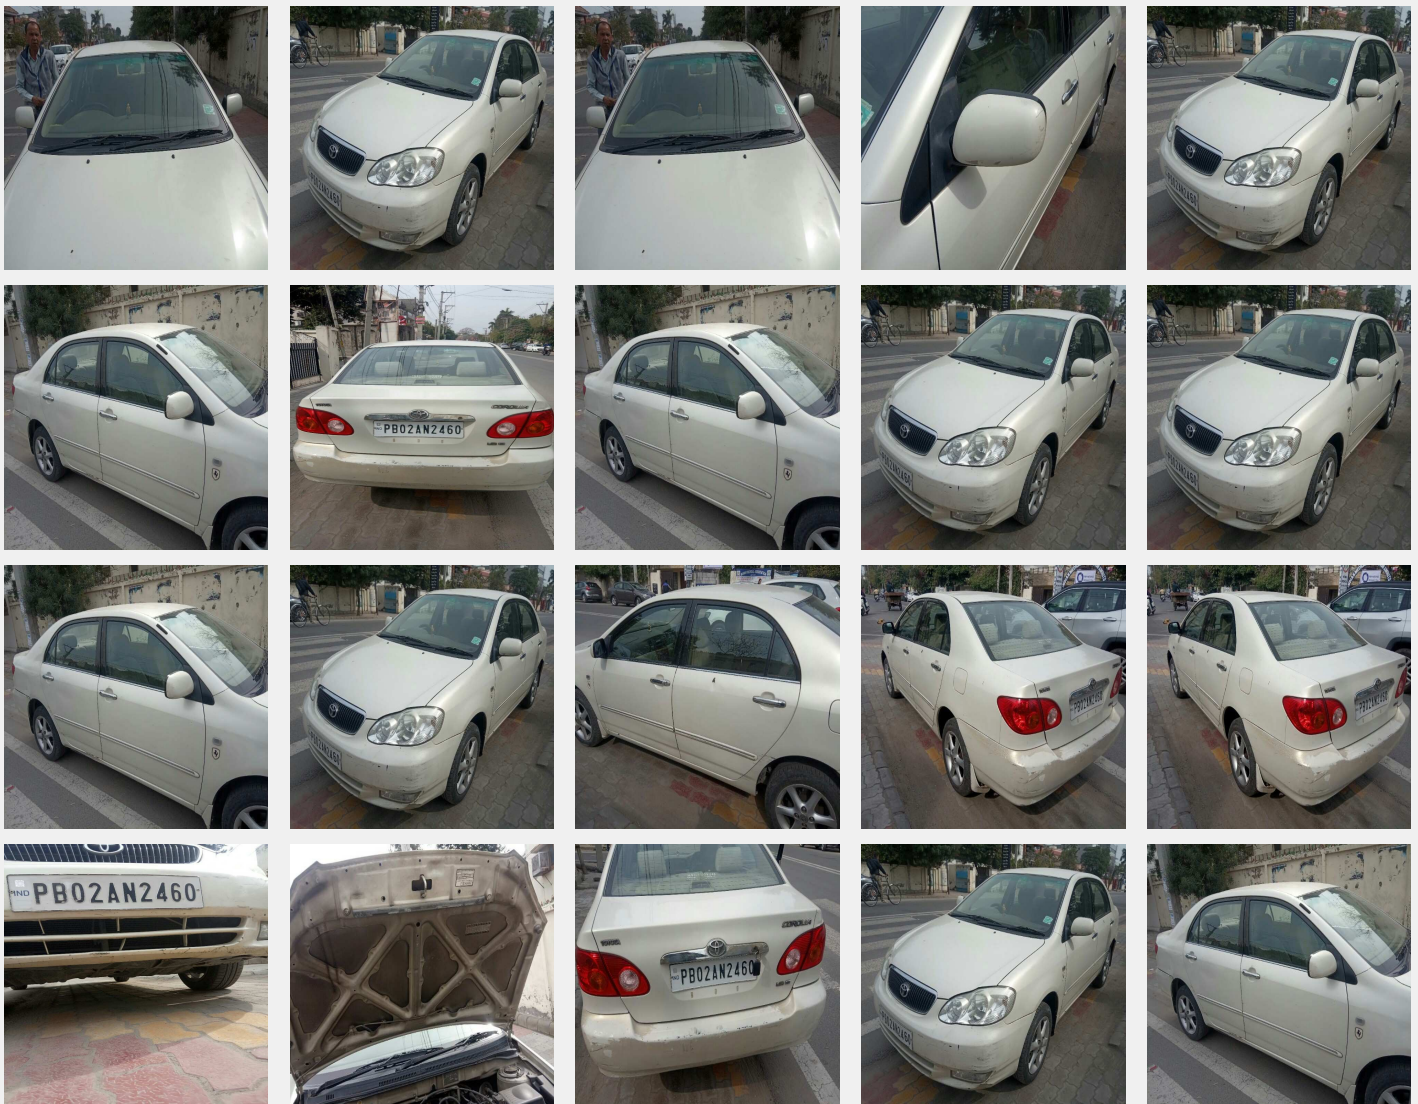
IMAGES

INSPECTION CHECKPOINTS	SCORE(X/10)	REMARKS/COMMENTS	OPTIONAL SPEND EST. (RS)
ROOF (REGULAR)	7	SMOOTH	0
PAINT CONDITION	8	GOOD	0
REAR BUMPER	5	PAINT REMOVED	5000
RH FENDER	4	DAMAGE	6000
BODY RUST	5	RUST ON BUMPER	6000
