ECO INSPECTION CERTIFICATE

Order ID : 42010

121 Points Vehicle Inspection Certificate

Maruti Suzuki 800 AC, 2008

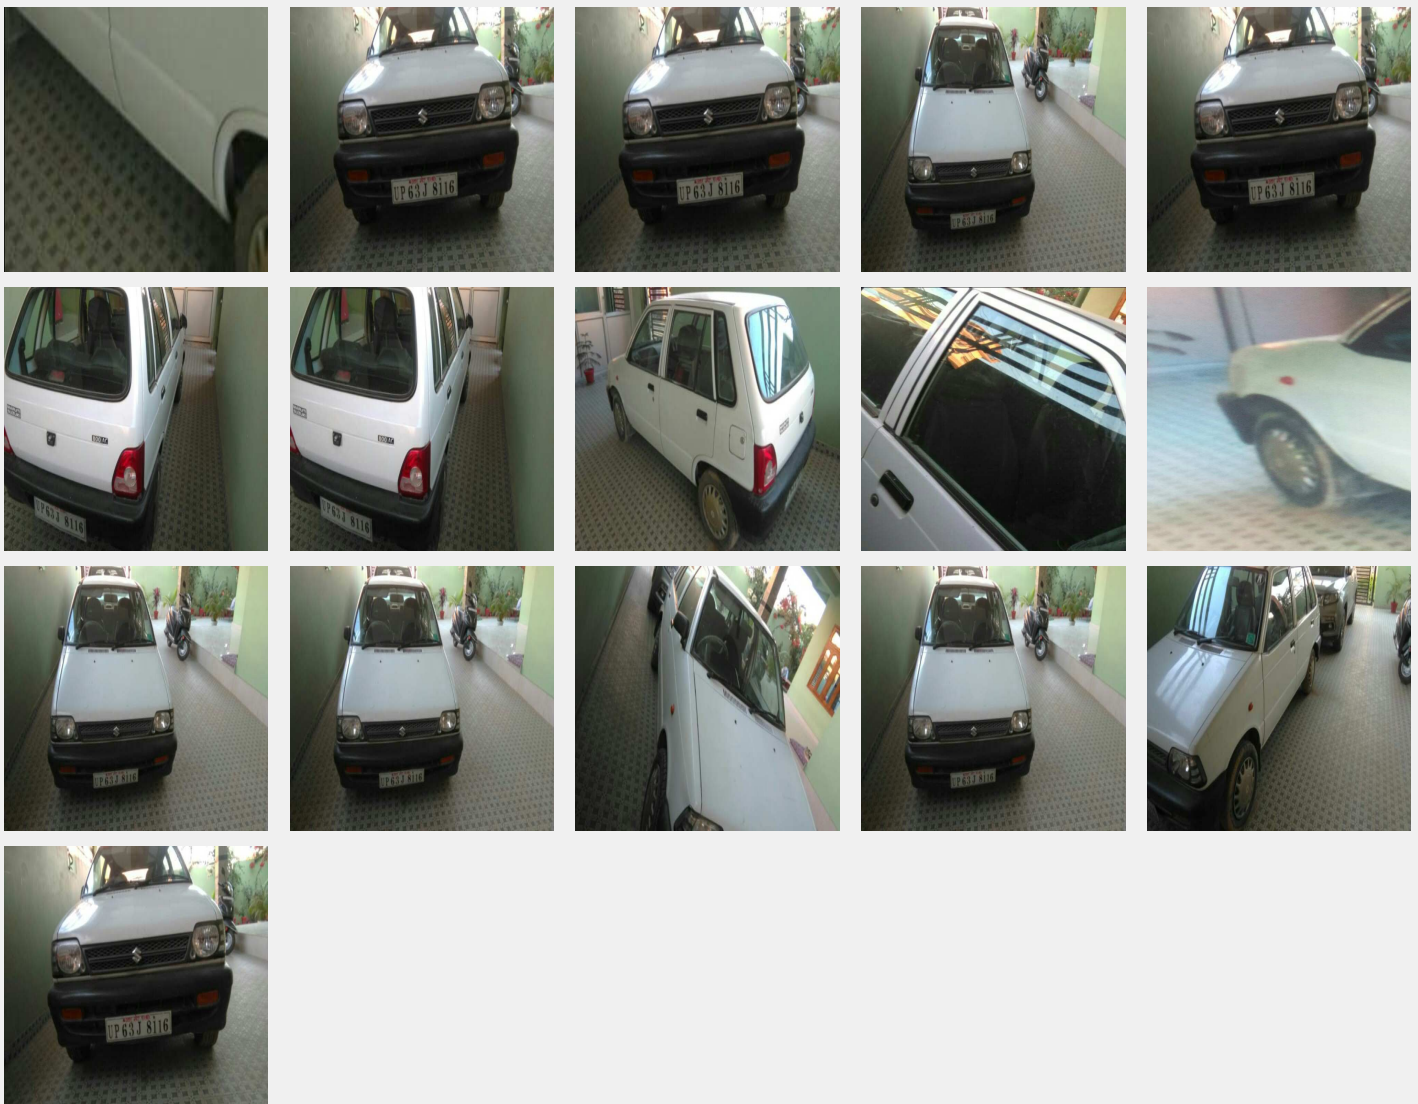
INSPECTION CHECKPOINTS	SCORE(X/10)	REMARKS/COMMENTS	OPTIONAL SPEND EST. (RS)
LICENSE PLATE	6	OK	0
HEAD LIGHTS	6	OK	0
TURN SIGNAL	6	OK	0
HOOD	6	OK	0
FRONT WINDSHIELD	6	OK	0
LH FENDER	6	OK	0
LH REAR DOOR	6	OK	0
LH RUNNING BOARD	6	OK	0
REAR BUMPER	6	OK	0
TRUNK LID/TAIL GATE	6	OK	0
RH REAR DOOR	6	OK	0
ROOF (REGULAR)	6	OK	0
FRONT BUMPER	5	OK	0
GRILLE	5	OK	0
FOG LAMPS	5	OK	0
PILLAR	5	OK	0
SIDE VIEW MIRRORS	5	OK	0
LH FRONT DOOR	5	OK	0
LH QUARTER PANEL	5	OK	0
FUEL LID	5	OK	0
REAR WINDSHIELD	5	OK	0
TAIL LIGHT	3	FAIR	700
LUGGAGE COMPARTMENT LIGHT	5	OK	0
RH QUARTER PANEL	5	OK	0

NEED ATTENTION
