ECO INSPECTION CERTIFICATE

Order ID : 49004

121 Points Vehicle Inspection Certificate

Honda Wr-V VX PETROL, 2017

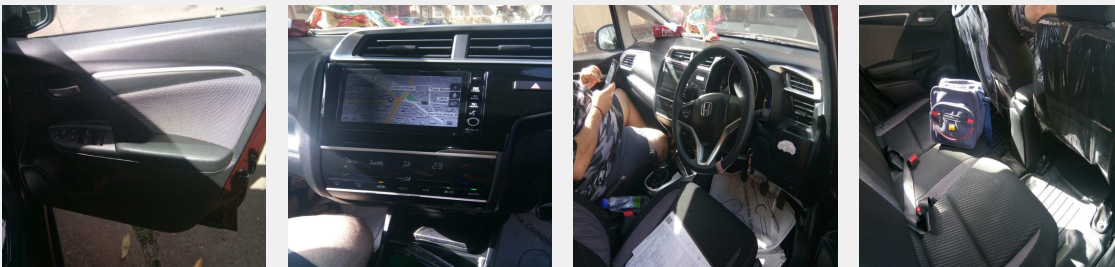
INSPECTION CHECKPOINTS	SCORE(X/10)	REMARKS/COMMENTS	OPTIONAL SPEND EST. (RS)
DOOR PANEL	7	GOOD	0
DOOR HINGES	7	GOOD	0
CARPET & FLOOR MAT	7	GOOD	0
SEAT & SEAT BELT	7	GOOD	0
DASHBOARD & INSTRUMENT PANEL	7	GOOD	0
HORN	7	GOOD	0
SPEAKERS & MUSIC SYSTEM	7	GOOD	0
HANDBRAKE	7	GOOD	0
STEERING-MOUNTED CONTROLS	7	GOOD	0
PEDALS	6	GOOD	0
CENTRAL LOCK	7	GOOD	0
A/C VENTS & HEATER	7	GOOD	0
CUP HOLDERS	7	GOOD	0
NAVIGATION (YES)	7	GOOD	0
ODOMETER	7	GOOD	0
POWER WINDOWS (YES)	7	GOOD	0
HAZARD LIGHT	7	GOOD	0

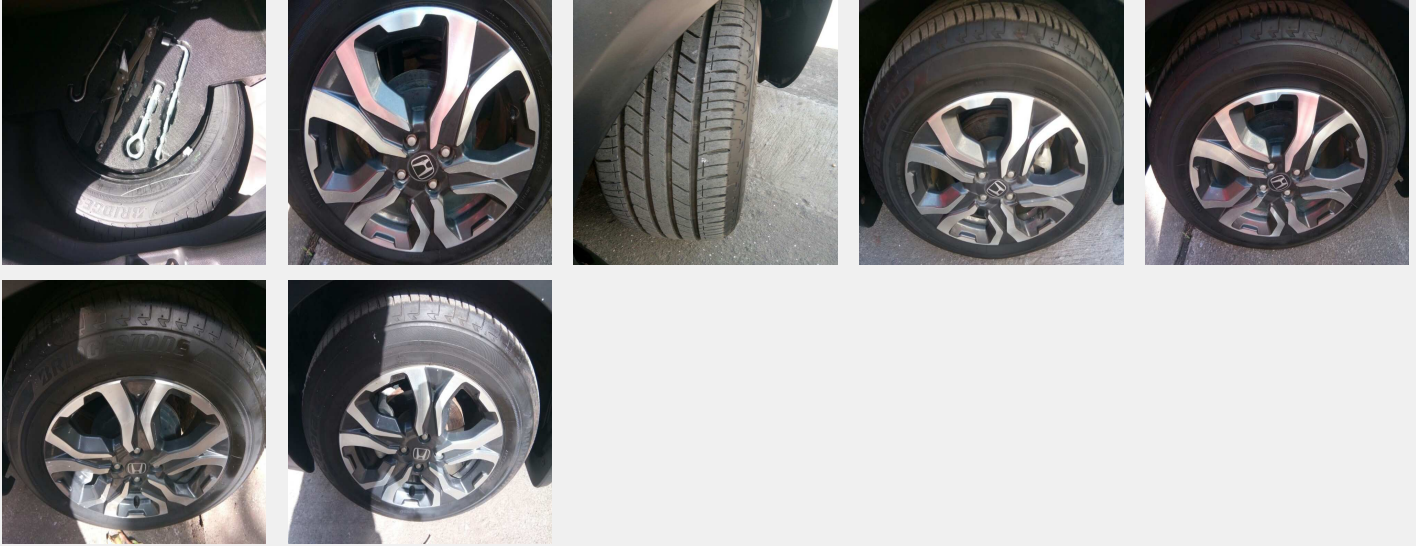
INSPECTION CHECKPOINTS	SCORE(X/10)	REMARKS/COMMENTS	OPTIONAL SPEND EST. (RS)
TYRES	7	GOOD	0
SPARE TYRE (YES)	7	GOOD	0
WHEEL ASSEMBLY (ALLOY RIM)	7	GOOD	0

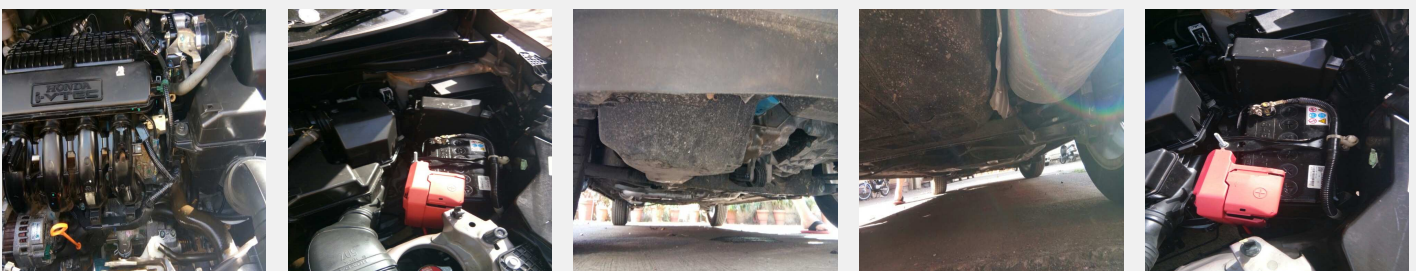
INSPECTION CHECKPOINTS	SCORE(X/10)	REMARKS/COMMENTS	OPTIONAL SPEND EST. (RS)
LH APRON	7	GOOD	0
RH APRON	7	GOOD	0
RADIATOR	7	GOOD	0
WIRING	7	GOOD	0
BATTERY	7	GOOD	0
BRAKE FLUID LEVEL	7	GOOD	0
ENGINE OIL	7	GOOD	0
COOLANT LEVEL	7	GOOD	0
BRAKE & COOLANT HOSE PIPES	7	GOOD	0
UNDERCARRIAGE	7	GOOD	0
EXHAUST SYSTEM	7	GOOD	0

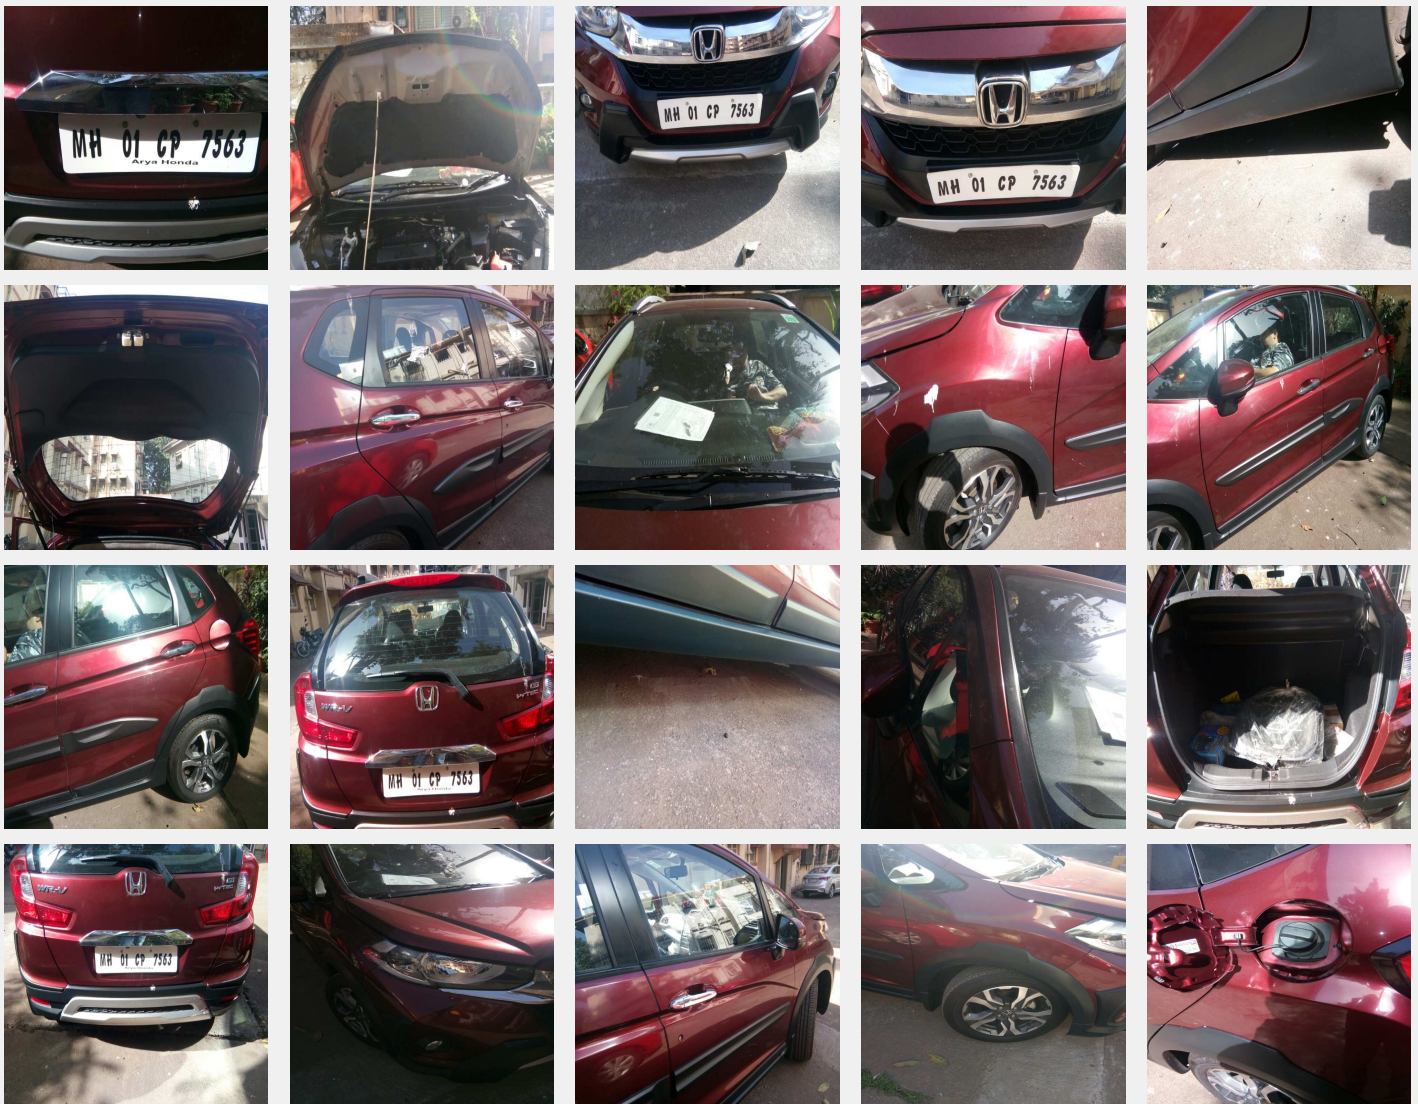
INSPECTION CHECKPOINTS	SCORE(X/10)	REMARKS/COMMENTS	OPTIONAL SPEND EST. (RS)
RH FENDER	7	GOOD	0
BODY RUST	8	GOOD	0
ROOF (REGULAR)	7	GOOD	0
PAINT CONDITION	8	GOOD	0
REAR BUMPER	3	NOT OK	1500

car need washing. rear bumper not ok. overall car ok.
