# ECO INSPECTION CERTIFICATE

Order ID : 47250

121 Points Vehicle Inspection Certificate

## Hyundai Santro Xing Xs, 2005

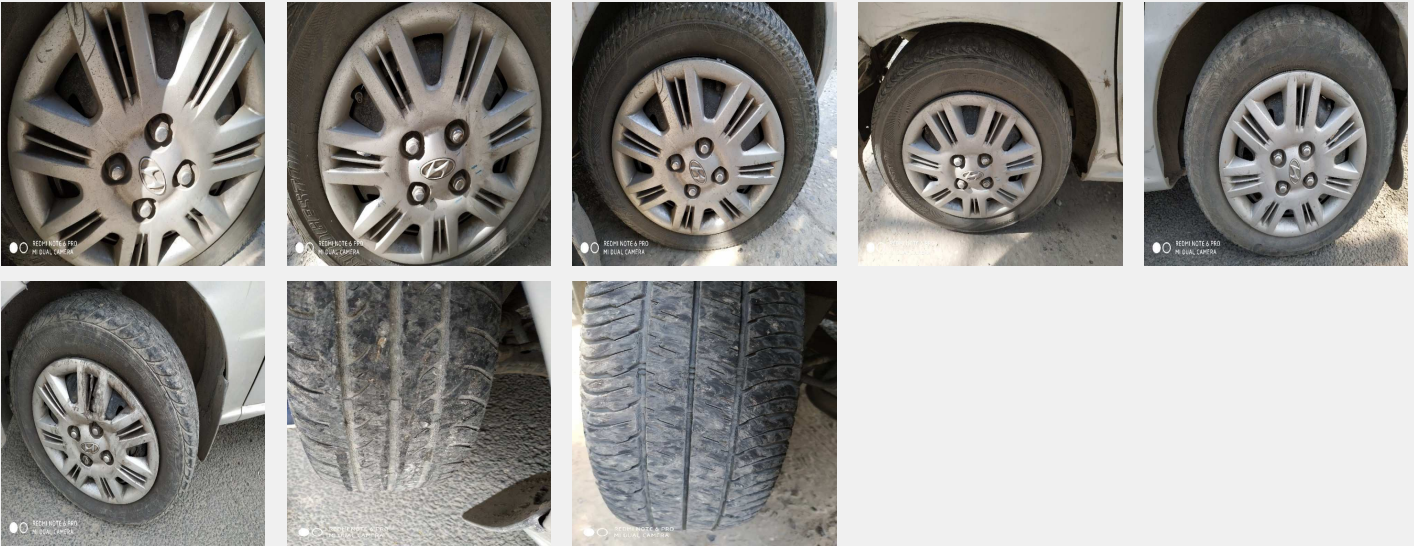
INSPECTION CHECKPOINTS	SCORE(X/10)	REMARKS/COMMENTS	OPTIONAL SPEND EST. (RS)
TYRES	7		0
WHEEL ASSEMBLY (STEEL RIM)	7		0

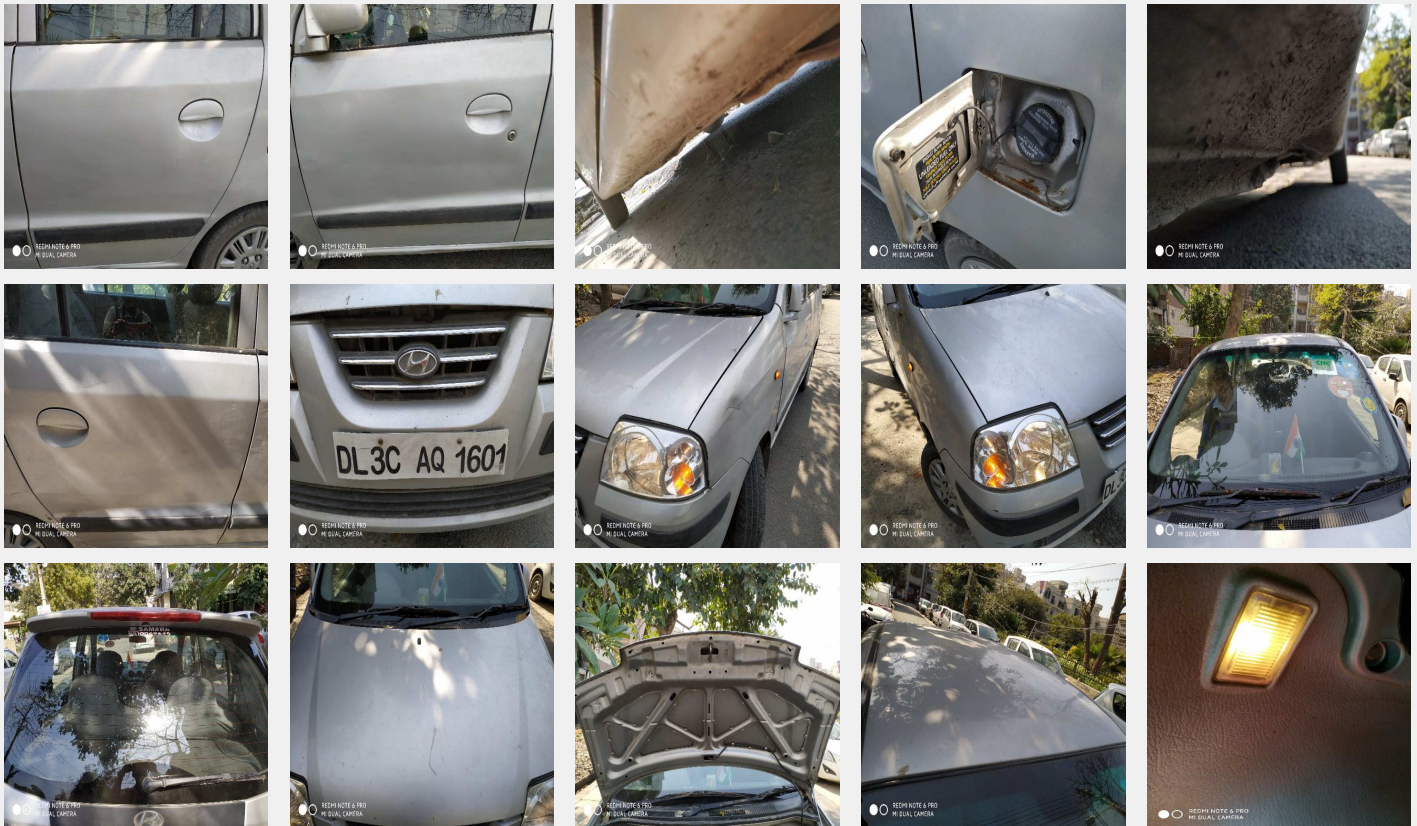
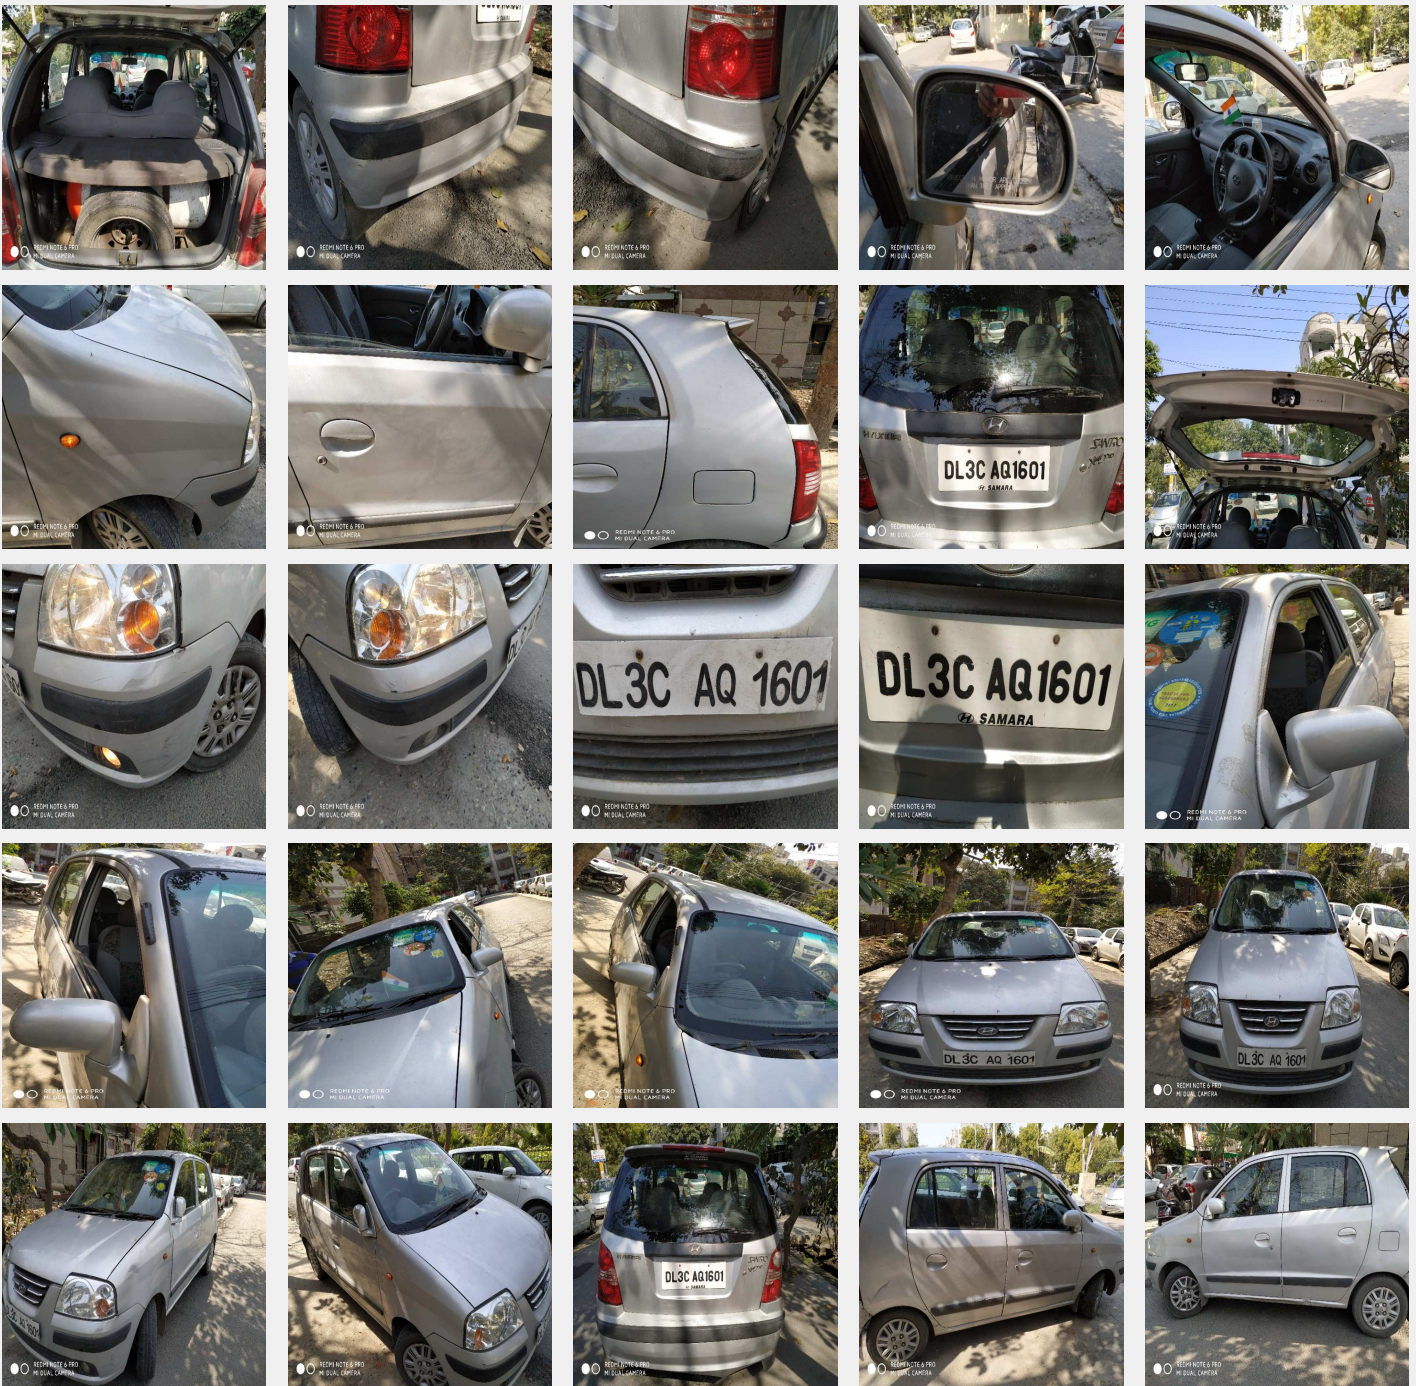
INSPECTION CHECKPOINTS	SCORE(X/10)	REMARKS/COMMENTS	OPTIONAL SPEND EST. (RS)
LICENSE PLATE	7		0
HEAD LIGHTS	7		0
GRILLE	7		0
TURN SIGNAL	7		0
HOOD	6	SOME SCRATCHES	500
PILLAR	6	MINOR SCRATCHES	500
FRONT WINDSHIELD	7		0
SIDE VIEW MIRRORS	7		0
LH FRONT DOOR	6	MINOR SCRATCHES	500
LH REAR DOOR	6	MINOR SCRATCHES	500
LH RUNNING BOARD	6	SOME SCRATCHES	1000
LH QUARTER PANEL	6	MINOR SCRATCHES	500
FUEL LID	7		0
REAR WINDSHIELD	7		0
REAR BUMPER	6	SOME SCRATCHES	1000
TRUNK LID/TAIL GATE	6	SOME SCRATCHES	500
LUGGAGE COMPARTMENT LIGHT	7		0
RH RUNNING BOARD	6	SOME SCRATCHES	0
RH REAR DOOR	6	MINOR SCRATCHES	500
RH FRONT DOOR	6	MINOR SCRATCHES	500
RH FENDER	6	MINOR SCRATCHES	500
ROOF (REGULAR)	7		0
PAINT CONDITION	7		0
FRONT BUMPER	5	MANY SCRATCHES NEED TO BE PAINT	1500

INSPECTION CHECKPOINTS	SCORE(X/10)	REMARKS/COMMENTS	OPTIONAL SPEND EST. (RS)
FOG LAMPS	5	RIGHT HAND SIDE NOT WORKING NEED CHANGE BULB	150
LH FENDER	5	DENT AND SOME SCRATCHES NEED REPAIR	1500
TAIL LIGHT	5	RIGHT HAND SIDE DAMAGE	1500
RH QUARTER PANEL	5	SOME SCRATCHES NEED REPAIR	1000
BODY RUST	0	NA	0

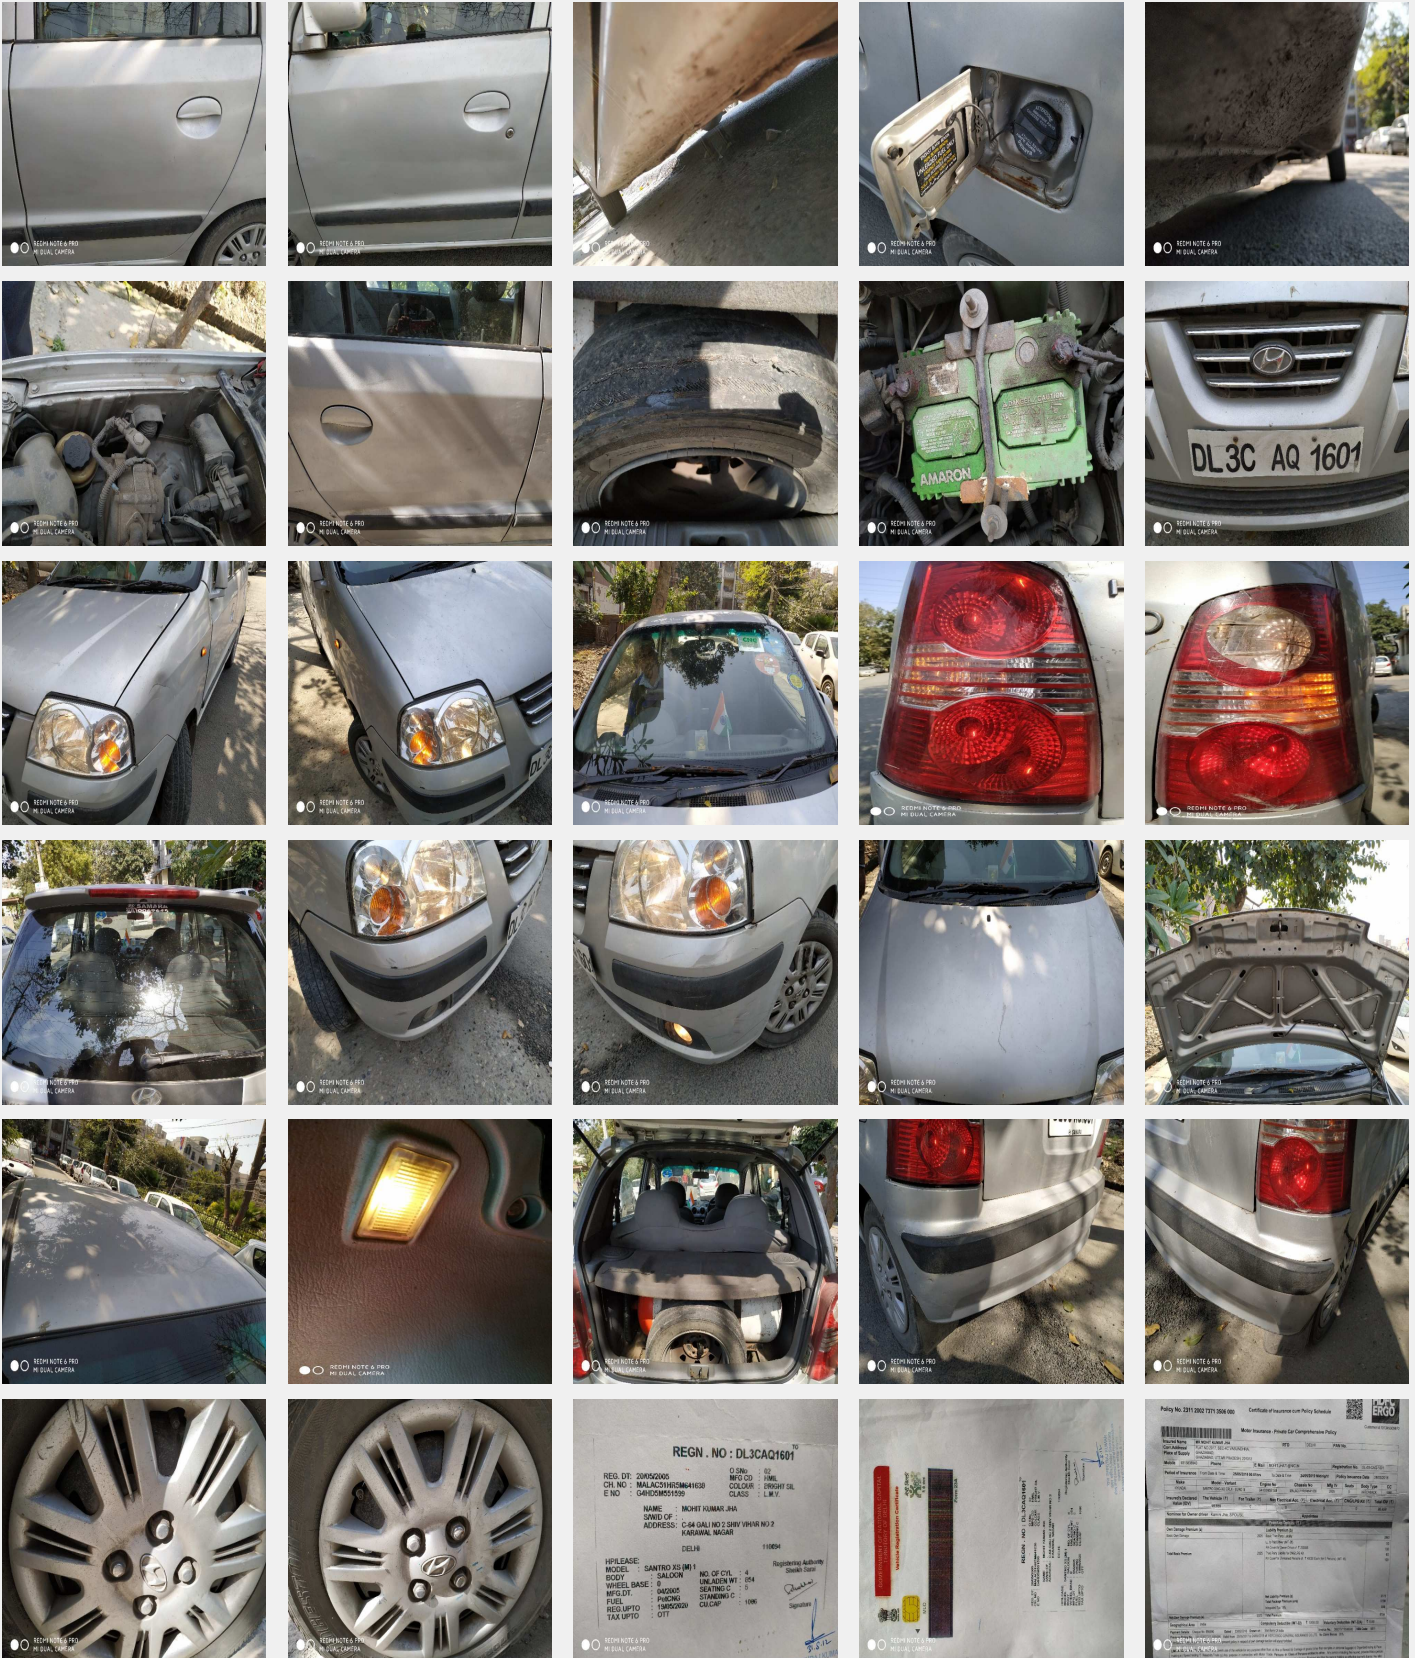
some scratches on all body frame and dent tyre change after the 15000km
