# ECO INSPECTION CERTIFICATE

Order ID : 49351

121 Points Vehicle Inspection Certificate

## Skoda Rapid 1.5 TDI CR ELEGANCE, 2012

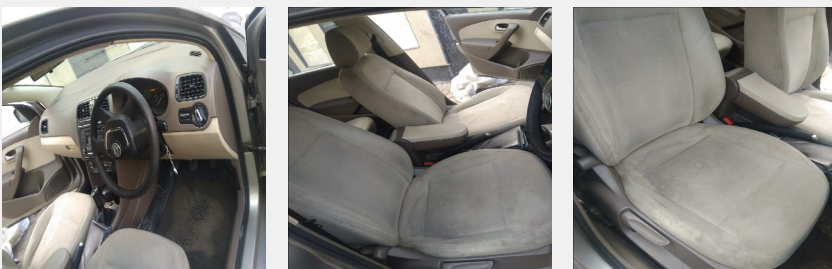
INSPECTION CHECKPOINTS	SCORE(X/10)	REMARKS/COMMENTS	OPTIONAL SPEND EST. (RS)
DOOR PANEL	7	DRYCLEAN REQUIRED	5000
DOOR HINGES	7		0
SEAT & SEAT BELT	7		0
DASHBOARD & INSTRUMENT PANEL	7		0
HORN	7		0
SPEAKERS & MUSIC SYSTEM	7		0
HANDBRAKE	7		0
STEERING-MOUNTED CONTROLS	7		0
PEDALS	7		0
CENTRAL LOCK	7		0
A/C VENTS & HEATER	7		0
CUP HOLDERS	7		0
NAVIGATION (NO)	10		0
ODOMETER	7		0
POWER WINDOWS (YES)	8		0
HAZARD LIGHT	7		0
CARPET & FLOOR MAT	5	NEW MATS REQUIRED	1000

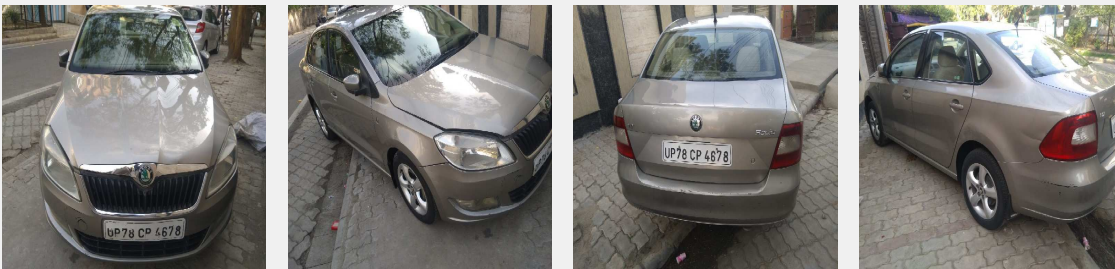
INSPECTION CHECKPOINTS	SCORE(X/10)	REMARKS/COMMENTS	OPTIONAL SPEND EST. (RS)
LICENSE PLATE	7		0
HEAD LIGHTS	7		0
GRILLE	7		0
TURN SIGNAL	7		0
FOG LAMPS	7		0
HOOD	7		0
PILLAR	7		0
FRONT WINDSHIELD	7		0
SIDE VIEW MIRRORS	7		0
LH FENDER	7		0
LH FRONT DOOR	7	DENT PAINT	2000
LH REAR DOOR	7		0
LH RUNNING BOARD	7		1500
LH QUARTER PANEL	7		0
FUEL LID	7		0
REAR WINDSHIELD	7		0
TAIL LIGHT	7		0
TRUNK LID/TAIL GATE	7		0
LUGGAGE COMPARTMENT LIGHT	7		0
RH QUARTER PANEL	7		0
RH RUNNING BOARD	7		0
RH REAR DOOR	7		1500
RH FRONT DOOR	7		0
RH FENDER	7		0

INSPECTION CHECKPOINTS	SCORE(X/10)	REMARKS/COMMENTS	OPTIONAL SPEND EST. (RS)
BODY RUST	7		0
ROOF (REGULAR)	7		0
PAINT CONDITION	7		0
FRONT BUMPER	5	BUMPER CRACKED NEED TO CHANGE	6000
REAR BUMPER	5	PAINTING NEED	2000
