ECO INSPECTION CERTIFICATE

Order ID : 47170

121 Points Vehicle Inspection Certificate

Volkswagen Vento TRENDLINE DIESEL, 2013

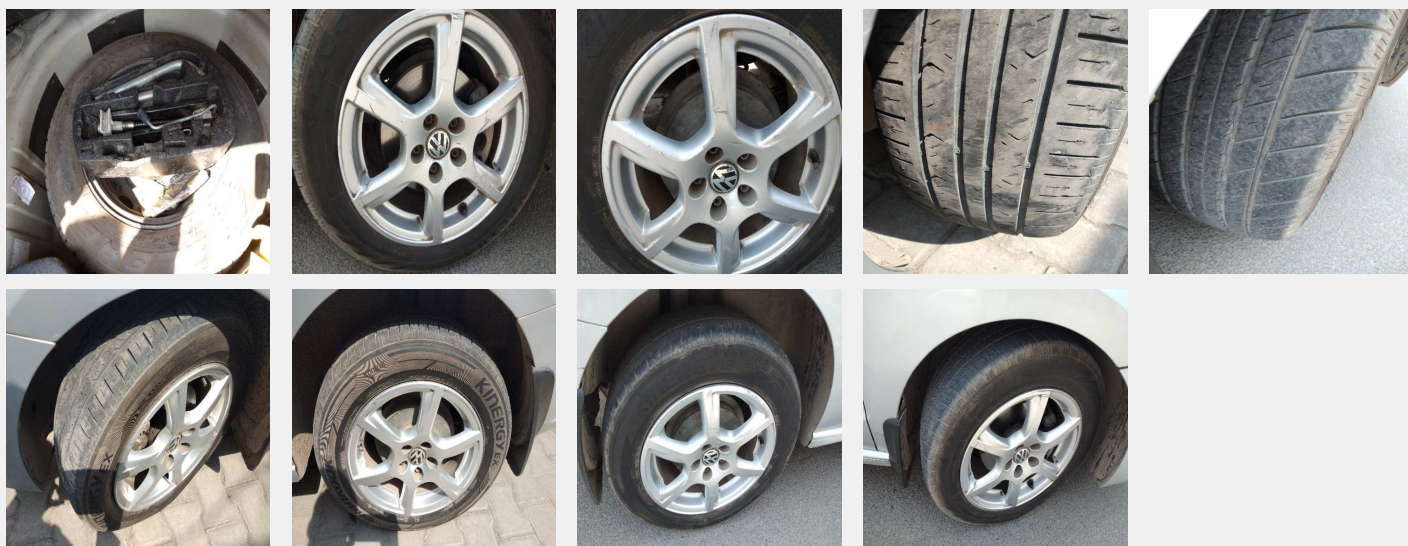
INSPECTION CHECKPOINTS	SCORE(X/10)	REMARKS/COMMENTS	OPTIONAL SPEND EST. (RS)
TYRES	7		0
SPARE TYRE (YES)	7		0

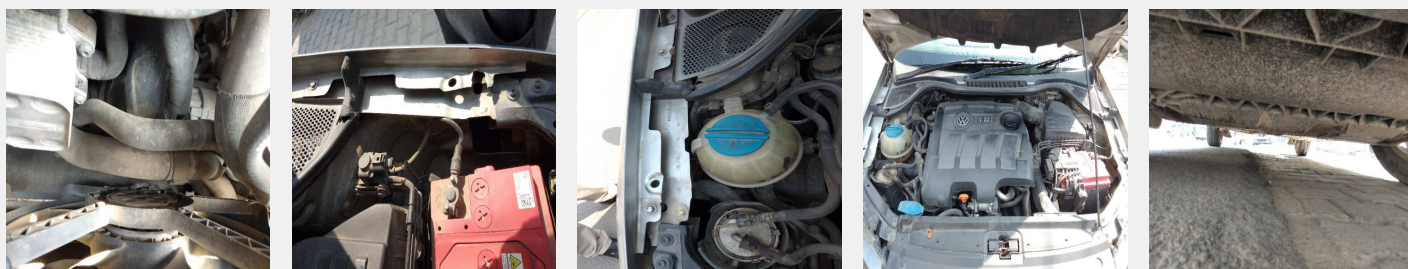
INSPECTION CHECKPOINTS	SCORE(X/10)	REMARKS/COMMENTS	OPTIONAL SPEND EST. (RS)
LH APRON	7		0
RH APRON	7		0
RADIATOR	7		0
WIRING	7		0
BATTERY	7		0
BRAKE FLUID LEVEL	7		0
ENGINE OIL	7		0
COOLANT LEVEL	7		0
BRAKE & COOLANT HOSE PIPES	7		0
UNDERCARRIAGE	7		0
EXHAUST SYSTEM	7		0

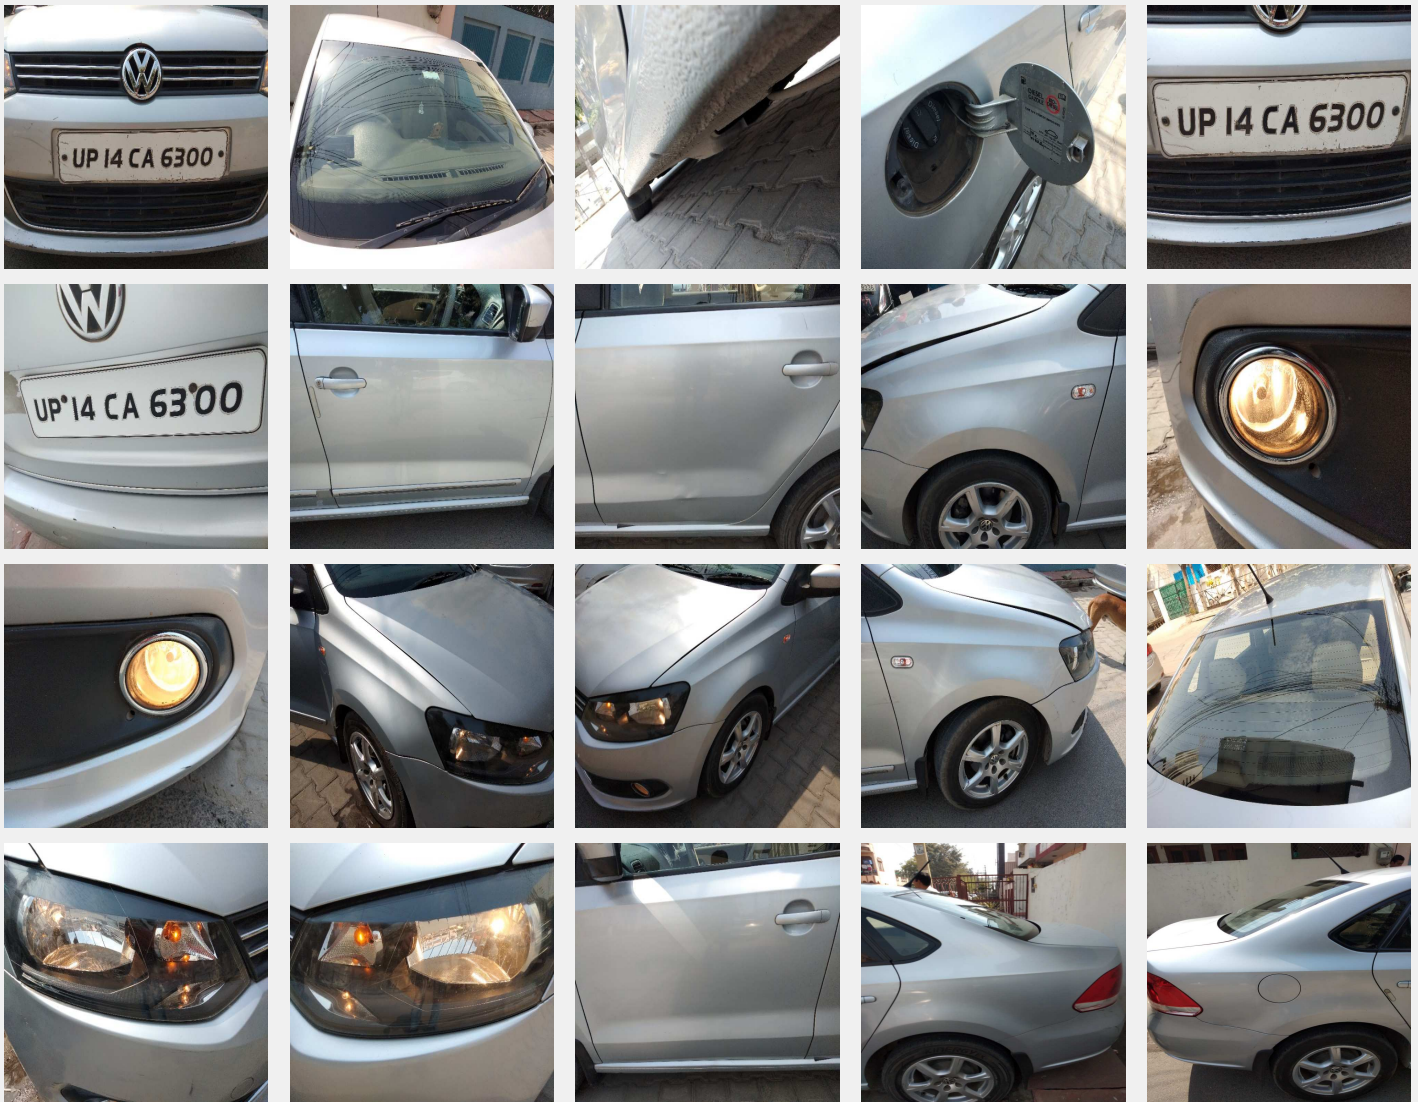
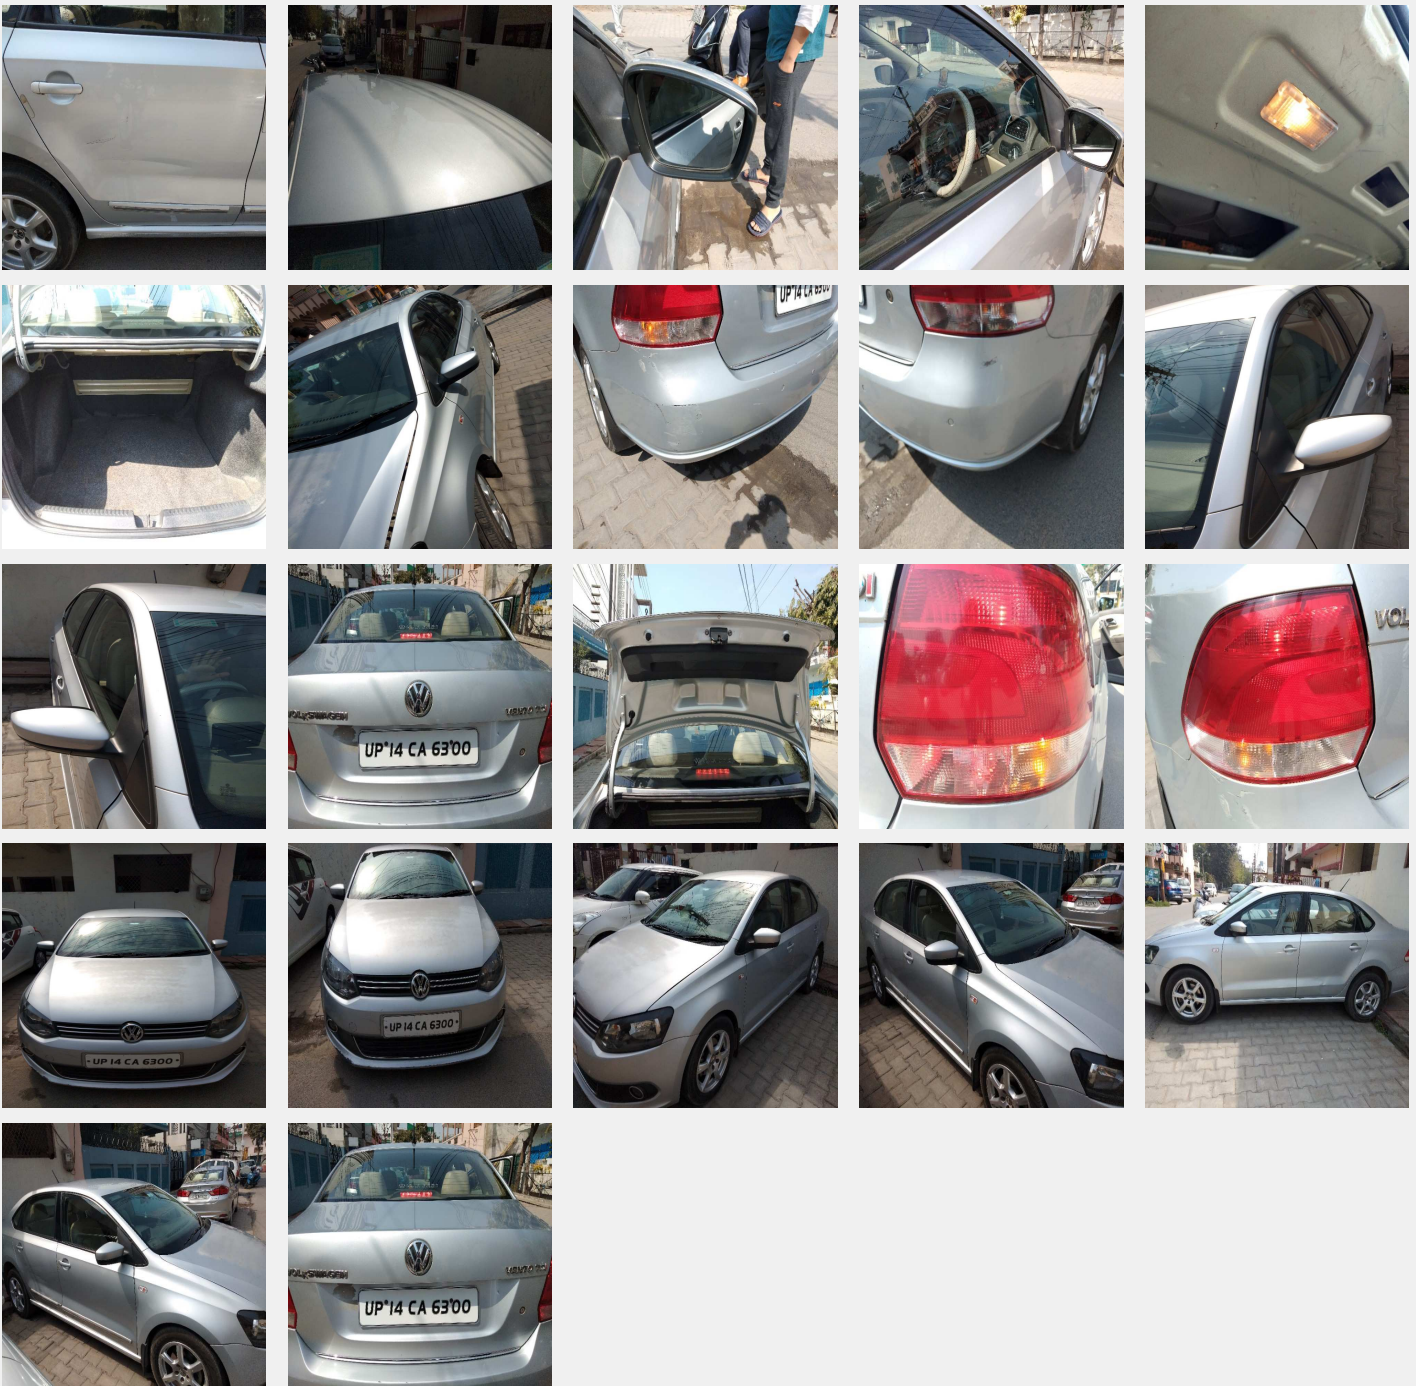
INSPECTION CHECKPOINTS	SCORE(X/10)	REMARKS/COMMENTS	OPTIONAL SPEND EST. (RS)
LICENSE PLATE	7		0
HEAD LIGHTS	7		0
GRILLE	6	MINOR SCRATCHES	500
TURN SIGNAL	7		0
FOG LAMPS	7		0
PILLAR	6	MINOR SCRATCHES	500
FRONT WINDSHIELD	7		0
SIDE VIEW MIRRORS	7		0
LH FENDER	7		0
LH FRONT DOOR	6	MINOR SCRATCHES	500
LH REAR DOOR	6	MINOR DENT AND SCRATCHES	1000
LH RUNNING BOARD	6	MINOR DENT	500
LH QUARTER PANEL	7		0
FUEL LID	7		0
REAR WINDSHIELD	7		0
REAR BUMPER	6	SOME SCRATCHES	1000
TAIL LIGHT	7		0
TRUNK LID/TAIL GATE	7		0
LUGGAGE COMPARTMENT LIGHT	7		0
RH QUARTER PANEL	6	MINOR SCRATCHES	500
RH RUNNING BOARD	7		0
RH REAR DOOR	6	SOME SCRATCHES	500
RH FRONT DOOR	6	MINOR SCRATCHES	500
RH FENDER	7		0

INSPECTION CHECKPOINTS	SCORE(X/10)	REMARKS/COMMENTS	OPTIONAL SPEND EST. (RS)
ROOF (REGULAR)	7		0
PAINT CONDITION	7		0
FRONT BUMPER	5	NEED TO BE PAINT	1500
HOOD	4	PAINT FADE NEED TO BE PAINT	1500
BODY RUST	0	NA	0

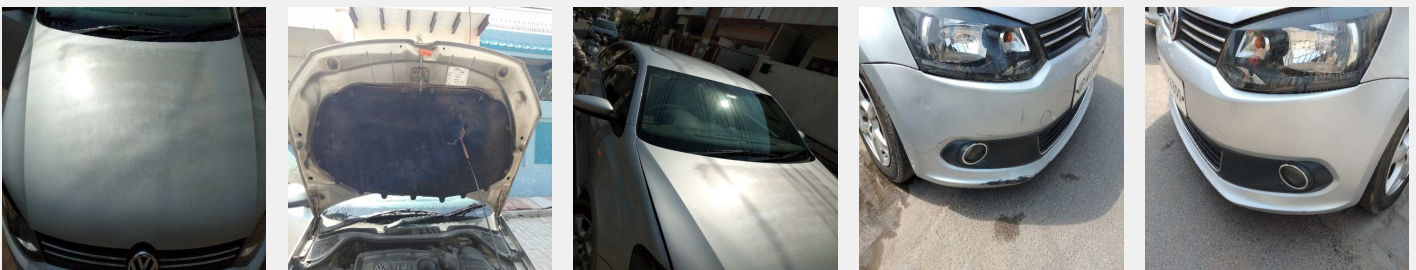
**NEED ATTENTION**

minor scratches and dent on all body dream, tyre change after the 15000km
