ECO INSPECTION CERTIFICATE

Order ID : 49265

121 Points Vehicle Inspection Certificate

Maruti Suzuki Ritz LDI, 2011

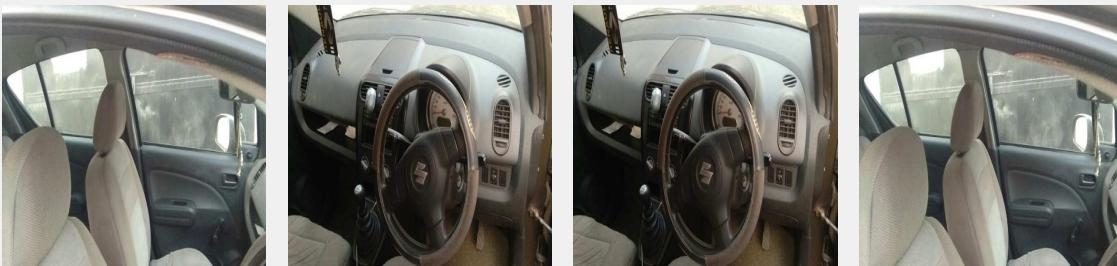
IMAGES

INSPECTION CHECKPOINTS	SCORE(X/10)	REMARKS/COMMENTS	OPTIONAL SPEND EST. (RS)
DOOR PANEL	7	GOOD	0
DOOR HINGES	7	GOOD	0
CARPET & FLOOR MAT	7	BETTER	0
SEAT & SEAT BELT	7	GOOD	0
DASHBOARD & INSTRUMENT PANEL	7	GOOD	0
HORN	7	GOOD	0
SPEAKERS & MUSIC SYSTEM	7	WORKING	0
HANDBRAKE	7	SAFE	0
STEERING-MOUNTED CONTROLS	7	GOOD	0
PEDALS	7	SAFE	0
CENTRAL LOCK	6	GOOD	0
A/C VENTS & HEATER	7	GOOD	0
CUP HOLDERS	6	GOOD	0
NAVIGATION (NO)	10		0
ODOMETER	7	GOOD	0
POWER WINDOWS (YES - FRONT ONLY)	7	GOOD	0
HAZARD LIGHT	7	SAFE	0

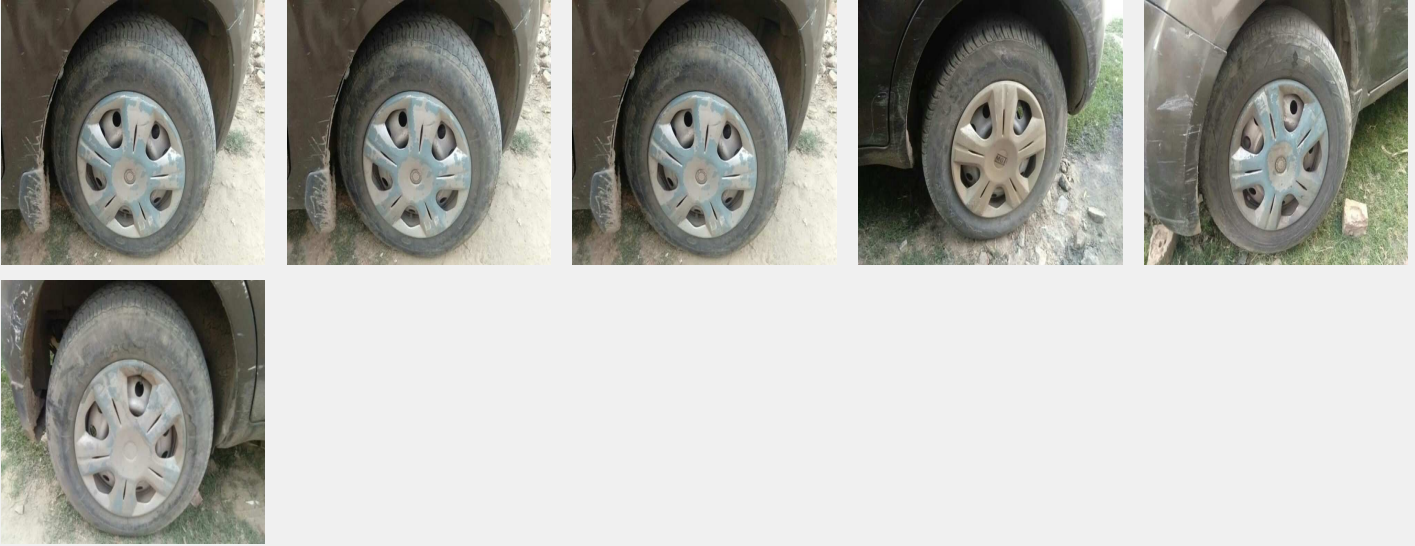
IMAGES

INSPECTION CHECKPOINTS	SCORE(X/10)	REMARKS/COMMENTS	OPTIONAL SPEND EST. (RS)
TYRES	7	GOOD	0
SPARE TYRE (NO)	10		0
WHEEL ASSEMBLY (ALLOY RIM)	7	GOOD	0

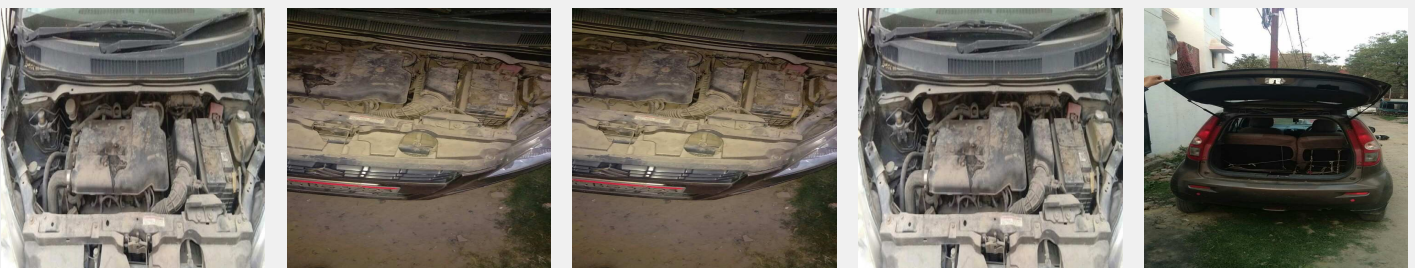
INSPECTION CHECKPOINTS	SCORE(X/10)	REMARKS/COMMENTS	OPTIONAL SPEND EST. (RS)
LH APRON	6	GOOD	0
RADIATOR	6	GOOD	0
WIRING	6	WORKING	0
BATTERY	7	GOOD	0
BRAKE FLUID LEVEL	7	ABOVE AVRAGE	0
ENGINE OIL	7	GOOD	0
COOLANT LEVEL	7	SAFE	0
BRAKE & COOLANT HOSE PIPES	6	GOOD	0
UNDERCARRIAGE	7	GOOD	0
EXHAUST SYSTEM	8	SAFE	0
RH APRON	5	NOT GOOD	5000

NEED ATTENTION

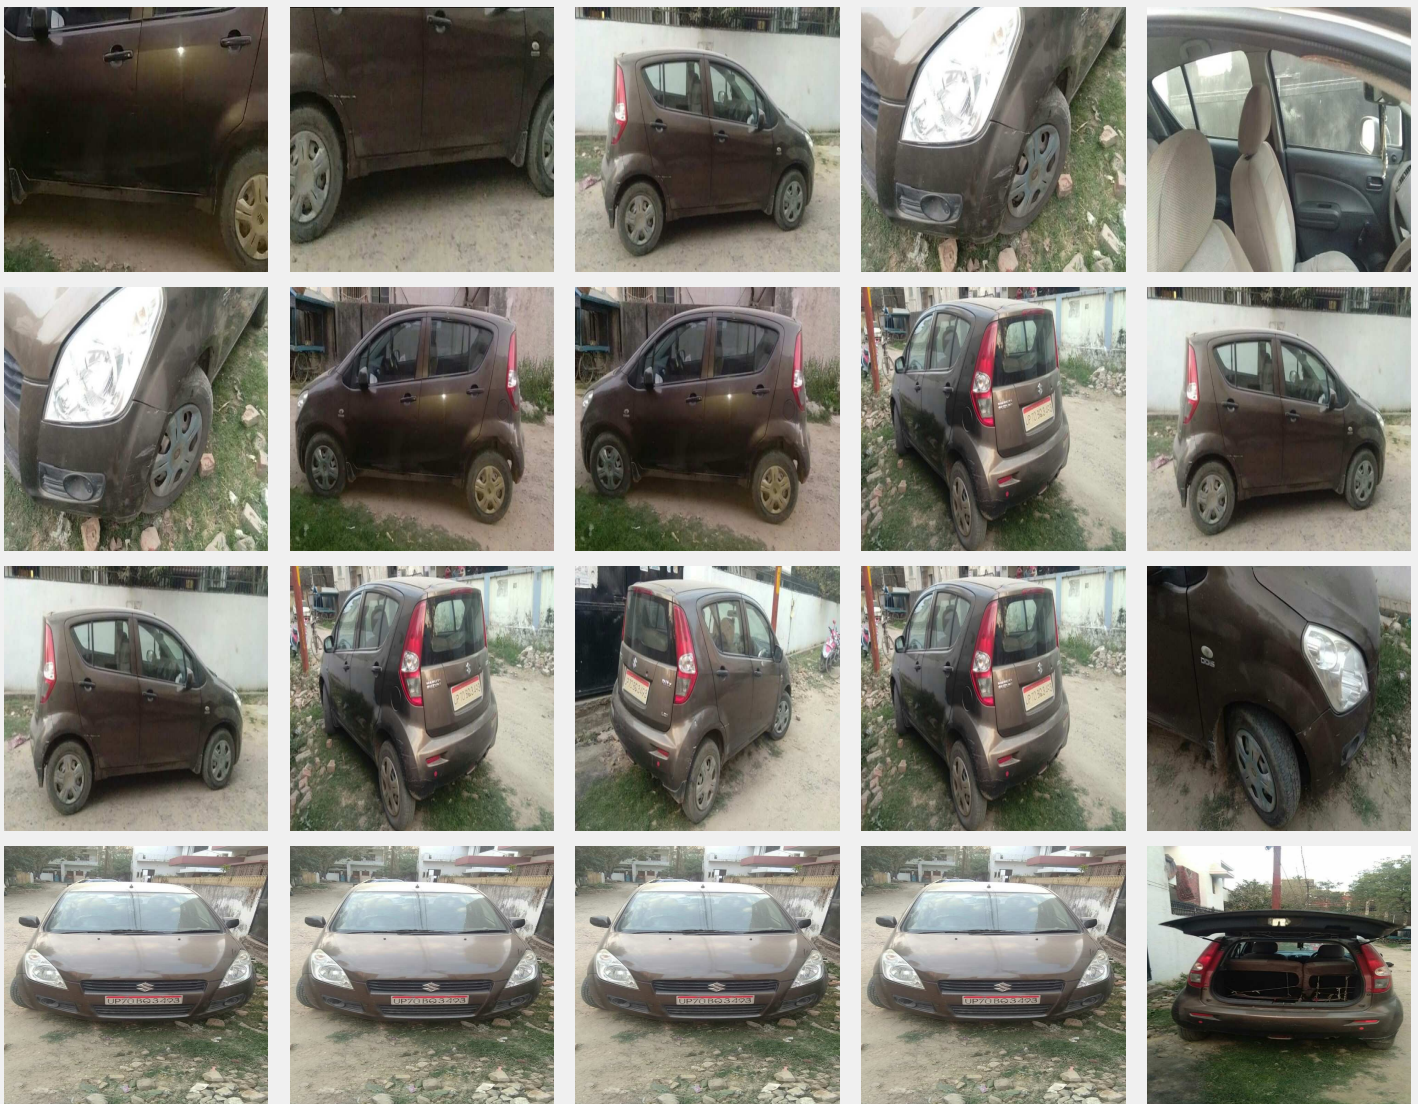
IMAGES

INSPECTION CHECKPOINTS	SCORE(X/10)	REMARKS/COMMENTS	OPTIONAL SPEND EST. (RS)
RH FRONT DOOR	7	SAFE	0
RH FENDER	7	GOOD	0
BODY RUST	7	NO RUST	0
ROOF (REGULAR)	7	GOOD	0
PAINT CONDITION	8	GOOD	0
