ECO INSPECTION CERTIFICATE

Order ID : 47480

121 Points Vehicle Inspection Certificate

Suzuki Intruder SP 150CC, 2018

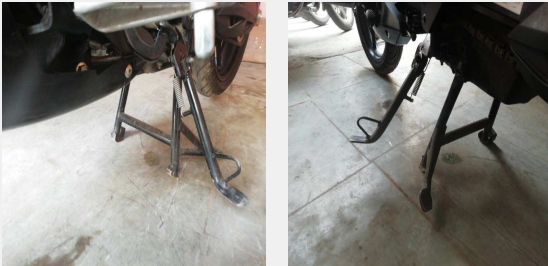
INSPECTION CHECKPOINTS	SCORE(X/10)	REMARKS/COMMENTS	OPTIONAL SPEND EST. (RS)
CENTRE STAND CONDITION	7	GOOD CONDITION	0
CENTRE STAND RETENTION	7	GOOD RETENTION	0
SIDE STAND CONDITION	7	GOOD CONDITION	0
SIDE STAND RETENTION	7	GOOD RETENTION	0

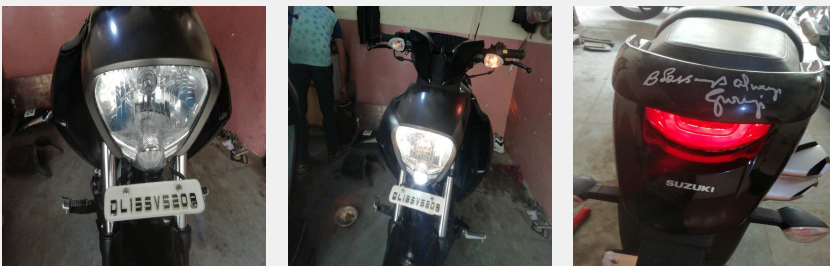
LIGHT

INSPECTION CHECKPOINTS	SCORE(X/10)	REMARKS/COMMENTS	OPTIONAL SPEND EST. (RS)
BATTERY CONDITION	7	WORKING PROPERLY	0
BATTERY VENT TUBE	6	AVERAGE CONDITION	0
HEADLAMP CONDITION	7	GOOD CONDITION	0
TAILLAMP/BRAKELAMP CONDITION	7	GOOD CONDITION	0
TAILLAMP/BRAKELAMP OPERATION	7	WORKING PROPERLY	0
TURN SIGNALS OPERATION FRONT LEFT	7	WORKING PROPERLY	0
TURN SIGNALS OPERATION FRONT RIGHT	7	WORKING PROPERLY	0
TURN SIGNALS OPERATION REAR LEFT	7	WORKING PROPERLY	0
TURN SIGNALS OPERATION REAR RIGHT	7	WORKING PROPERLY	0
SWITCHES OPERATION	7	WORKING PROPERLY	0
LENSES & REFLECTORS CONDITION	6	AVERAGE CONDITION	0
WIRING CONDITION	7	GOOD CONDITION	0
WIRING ROUTING	7	GOOD CONDITION	0
MIRRORS CONDITION	4	NOT AVAILABLE NEW REQUIRED	1000
MIRRORS AIM	0	NA	0
