ECO INSPECTION CERTIFICATE

Order ID : 44848

121 Points Vehicle Inspection Certificate

Tata Indica DLE, 2004

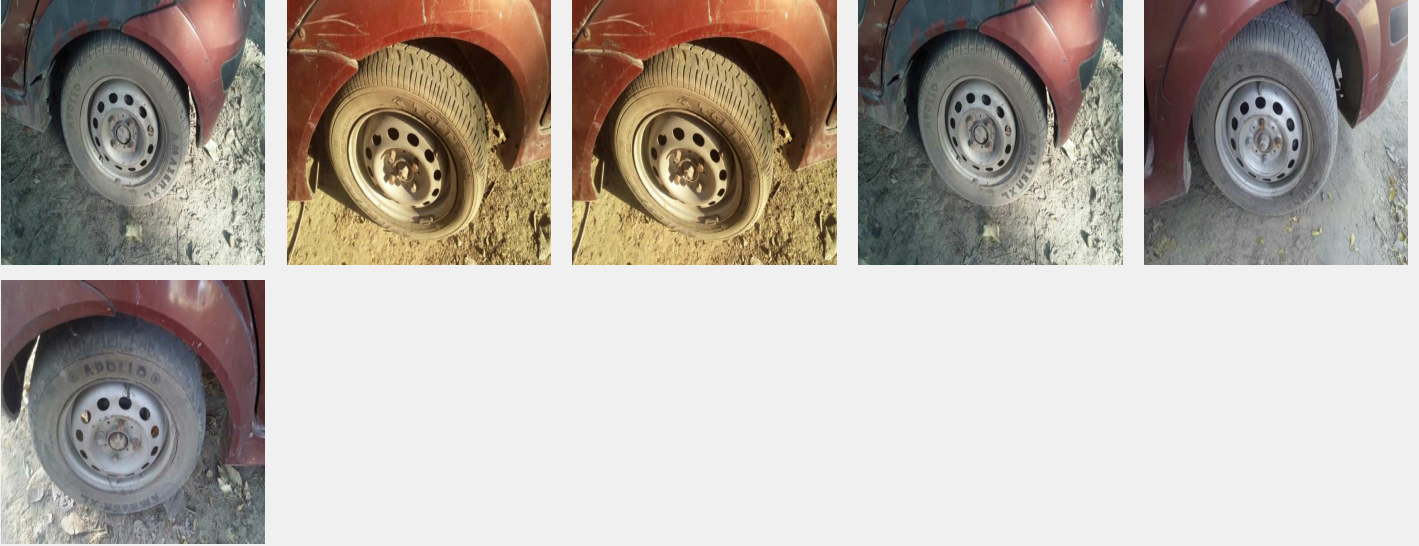
IMAGES

INSPECTION CHECKPOINTS	SCORE(X/10)	REMARKS/COMMENTS	OPTIONAL SPEND EST. (RS)
TYRES	6	OK	0
SPARE TYRE (NO)	10		0
WHEEL ASSEMBLY (ALLOY RIM)	6	SAFE	0

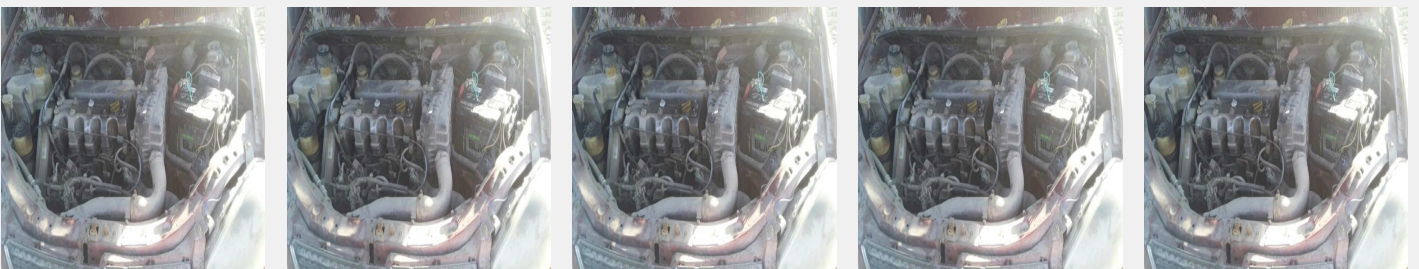
IMAGES

INSPECTION CHECKPOINTS	SCORE(X/10)	REMARKS/COMMENTS	OPTIONAL SPEND EST. (RS)
LH APRON	7	GOOD	0
RH APRON	7	GOOD	0
RADIATOR	6	SAFE	0
WIRING	7	GOOD	0
BATTERY	6	OK	0
BRAKE FLUID LEVEL	6	OK	0
ENGINE OIL	7	GOOD	0
COOLANT LEVEL	6	ABOVE AVERAGE	0
BRAKE & COOLANT HOSE PIPES	6	SAFE	0
UNDERCARRIAGE	7	BETTER	0
EXHAUST SYSTEM	6	BETTER	0

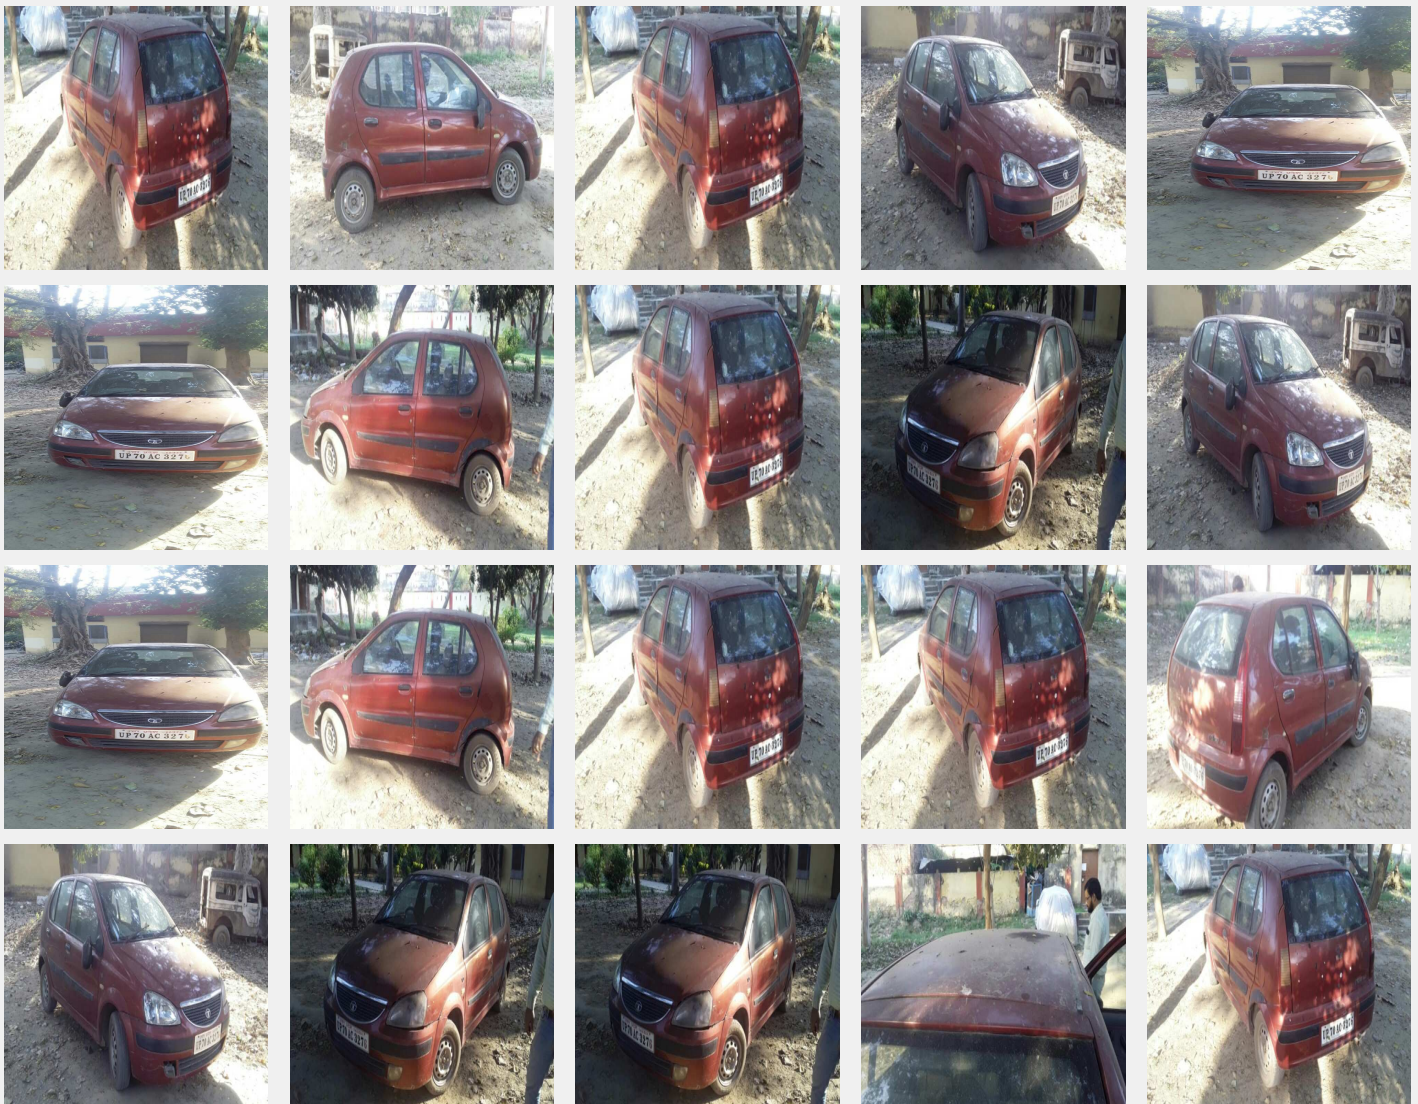
IMAGES

INSPECTION CHECKPOINTS	SCORE(X/10)	REMARKS/COMMENTS	OPTIONAL SPEND EST. (RS)
ROOF (REGULAR)	7	SMOOTH	0
PAINT CONDITION	6	OK	0
FOG LAMPS	5	DAMAGE	1000
SIDE VIEW MIRRORS	4	DAMAGE	2000
RH QUARTER PANEL	5	DAMAGE	1500

**NEED ATTENTION**

average
