ECO INSPECTION CERTIFICATE

Order ID : 47894

121 Points Vehicle Inspection Certificate

Toyota Qualis 2.4 DFS, 2003

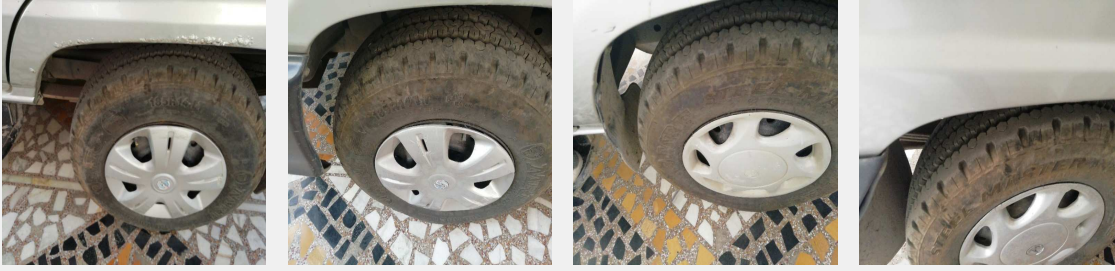
IMAGES

INSPECTION CHECKPOINTS	SCORE(X/10)	REMARKS/COMMENTS	OPTIONAL SPEND EST. (RS)
TYRES	6		0
SPARE TYRE (YES)	6		0
WHEEL ASSEMBLY (STEEL RIM)	6		0

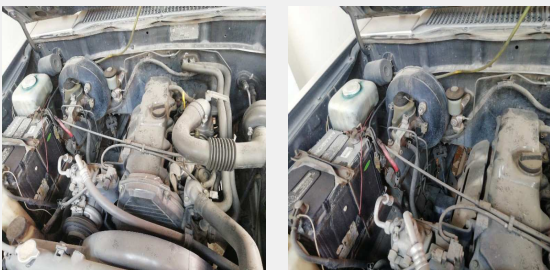
IMAGES

INSPECTION CHECKPOINTS	SCORE(X/10)	REMARKS/COMMENTS	OPTIONAL SPEND EST. (RS)
LH APRON	6		0
RH APRON	7		0
RADIATOR	6		0
WIRING	6		0
BATTERY	6		0
BRAKE FLUID LEVEL	7		0
ENGINE OIL	7		0
COOLANT LEVEL	7		0
BRAKE & COOLANT HOSE PIPES	6		0
UNDERCARRIAGE	6		0
EXHAUST SYSTEM	6		0
