ECO INSPECTION CERTIFICATE

Order ID : 50161

121 Points Vehicle Inspection Certificate

Mahindra Kuv100 Nxt K4 PLUS 6 STR, 2018

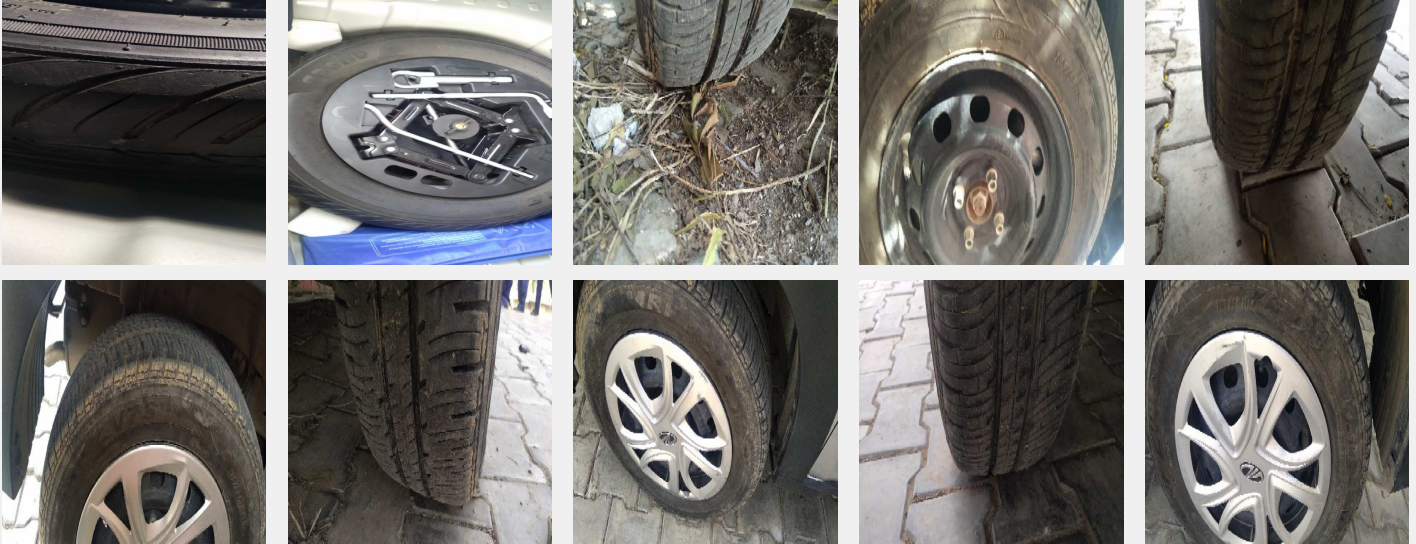
INSPECTION CHECKPOINTS	SCORE(X/10)	REMARKS/COMMENTS	OPTIONAL SPEND EST. (RS)
TYRES	7	GOOD CONDITION	0
SPARE TYRE (YES)	7	GOOD CONDITION	0
WHEEL ASSEMBLY (STEEL RIM)	7	GOOD CONDITION	0

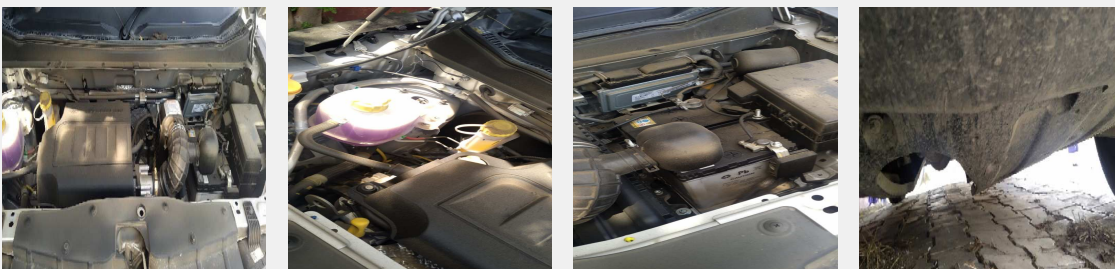
INSPECTION CHECKPOINTS	SCORE(X/10)	REMARKS/COMMENTS	OPTIONAL SPEND EST. (RS)
LH APRON	7	GOOD CONDITION	0
RH APRON	7	GOOD CONDITION	0
RADIATOR	7	GOOD CONDITION	0
WIRING	7	GOOD CONDITION	0
BATTERY	7	GOOD CONDITION	0
BRAKE FLUID LEVEL	7	MAX	0
ENGINE OIL	7	MAX	0
COOLANT LEVEL	7	MAX	0
BRAKE & COOLANT HOSE PIPES	7	GOOD CONDITION	0
UNDERCARRIAGE	7	GOOD CONDITION	0
EXHAUST SYSTEM	7	GOOD CONDITION	0

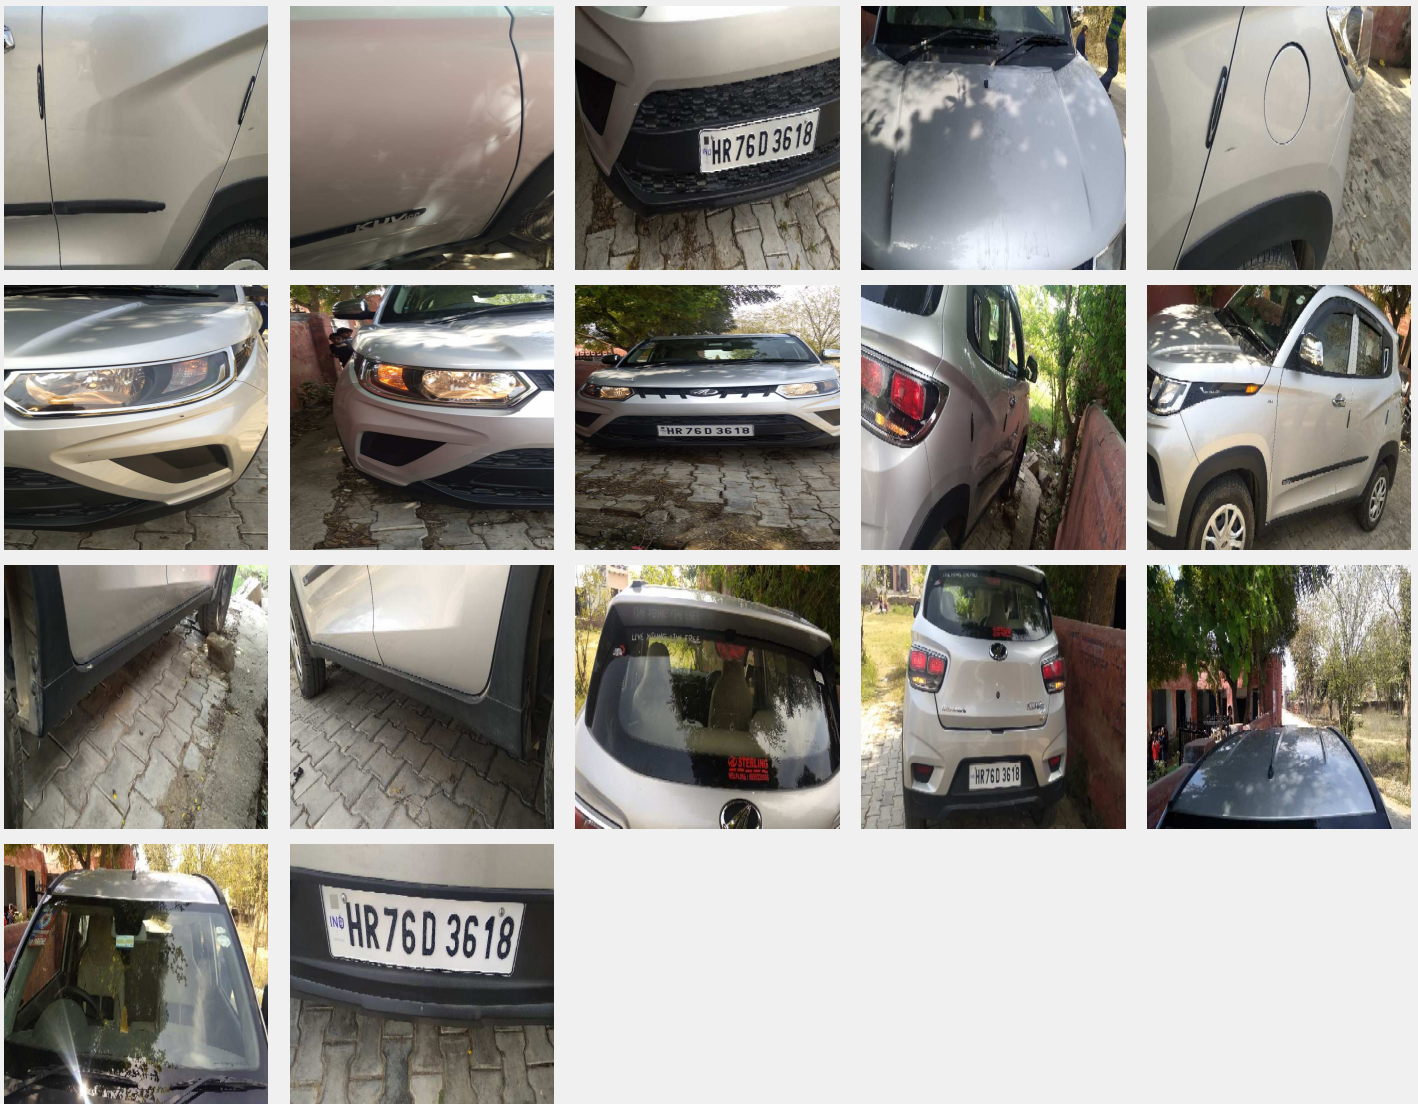
INSPECTION CHECKPOINTS	SCORE(X/10)	REMARKS/COMMENTS	OPTIONAL SPEND EST. (RS)
LICENSE PLATE	7	GOOD CONDITION	0
FRONT BUMPER	6	MINOR SCRATCHES	1000
HEAD LIGHTS	7	GOOD CONDITION	0
GRILLE	7	GOOD CONDITION	0
TURN SIGNAL	7	GOOD CONDITION	0
HOOD	6	MINOR DENT AND SCRATCHES	1000
PILLAR	7	GOOD CONDITION	0
FRONT WINDSHIELD	7	GOOD VISIBILITY	0
SIDE VIEW MIRRORS	7	GOOD CONDITION	0
LH FENDER	7	GOOD CONDITION	0
LH FRONT DOOR	7	GOOD CONDITION	0
LH REAR DOOR	6	MINOR SCRATCHES	1000
LH RUNNING BOARD	7	GOOD CONDITION	0
LH QUARTER PANEL	6	MINOR DENT	1000
FUEL LID	7	GOOD CONDITION	0
REAR WINDSHIELD	7	GOOD VISIBILITY	0
REAR BUMPER	7	GOOD CONDITION	0
TRUNK LID/TAIL GATE	7	GOOD CONDITION	0
LUGGAGE COMPARTMENT LIGHT	7	GOOD CONDITION	0
RH QUARTER PANEL	7	GOOD CONDITION	0
RH RUNNING BOARD	7	GOOD CONDITION	0
RH REAR DOOR	7	GOOD CONDITION	0
RH FRONT DOOR	6	MINOR DENT	1000
RH FENDER	7	GOOD CONDITION	0

INSPECTION CHECKPOINTS	SCORE(X/10)	REMARKS/COMMENTS	OPTIONAL SPEND EST. (RS)
BODY RUST	7	GOOD CONDITION	0
ROOF (REGULAR)	7	GOOD CONDITION	0
PAINT CONDITION	7	GOOD CONDITION	0
FOG LAMPS	0	NOT AVAILABLE	0
TAIL LIGHT	5	NEED TO REPLACE	3000

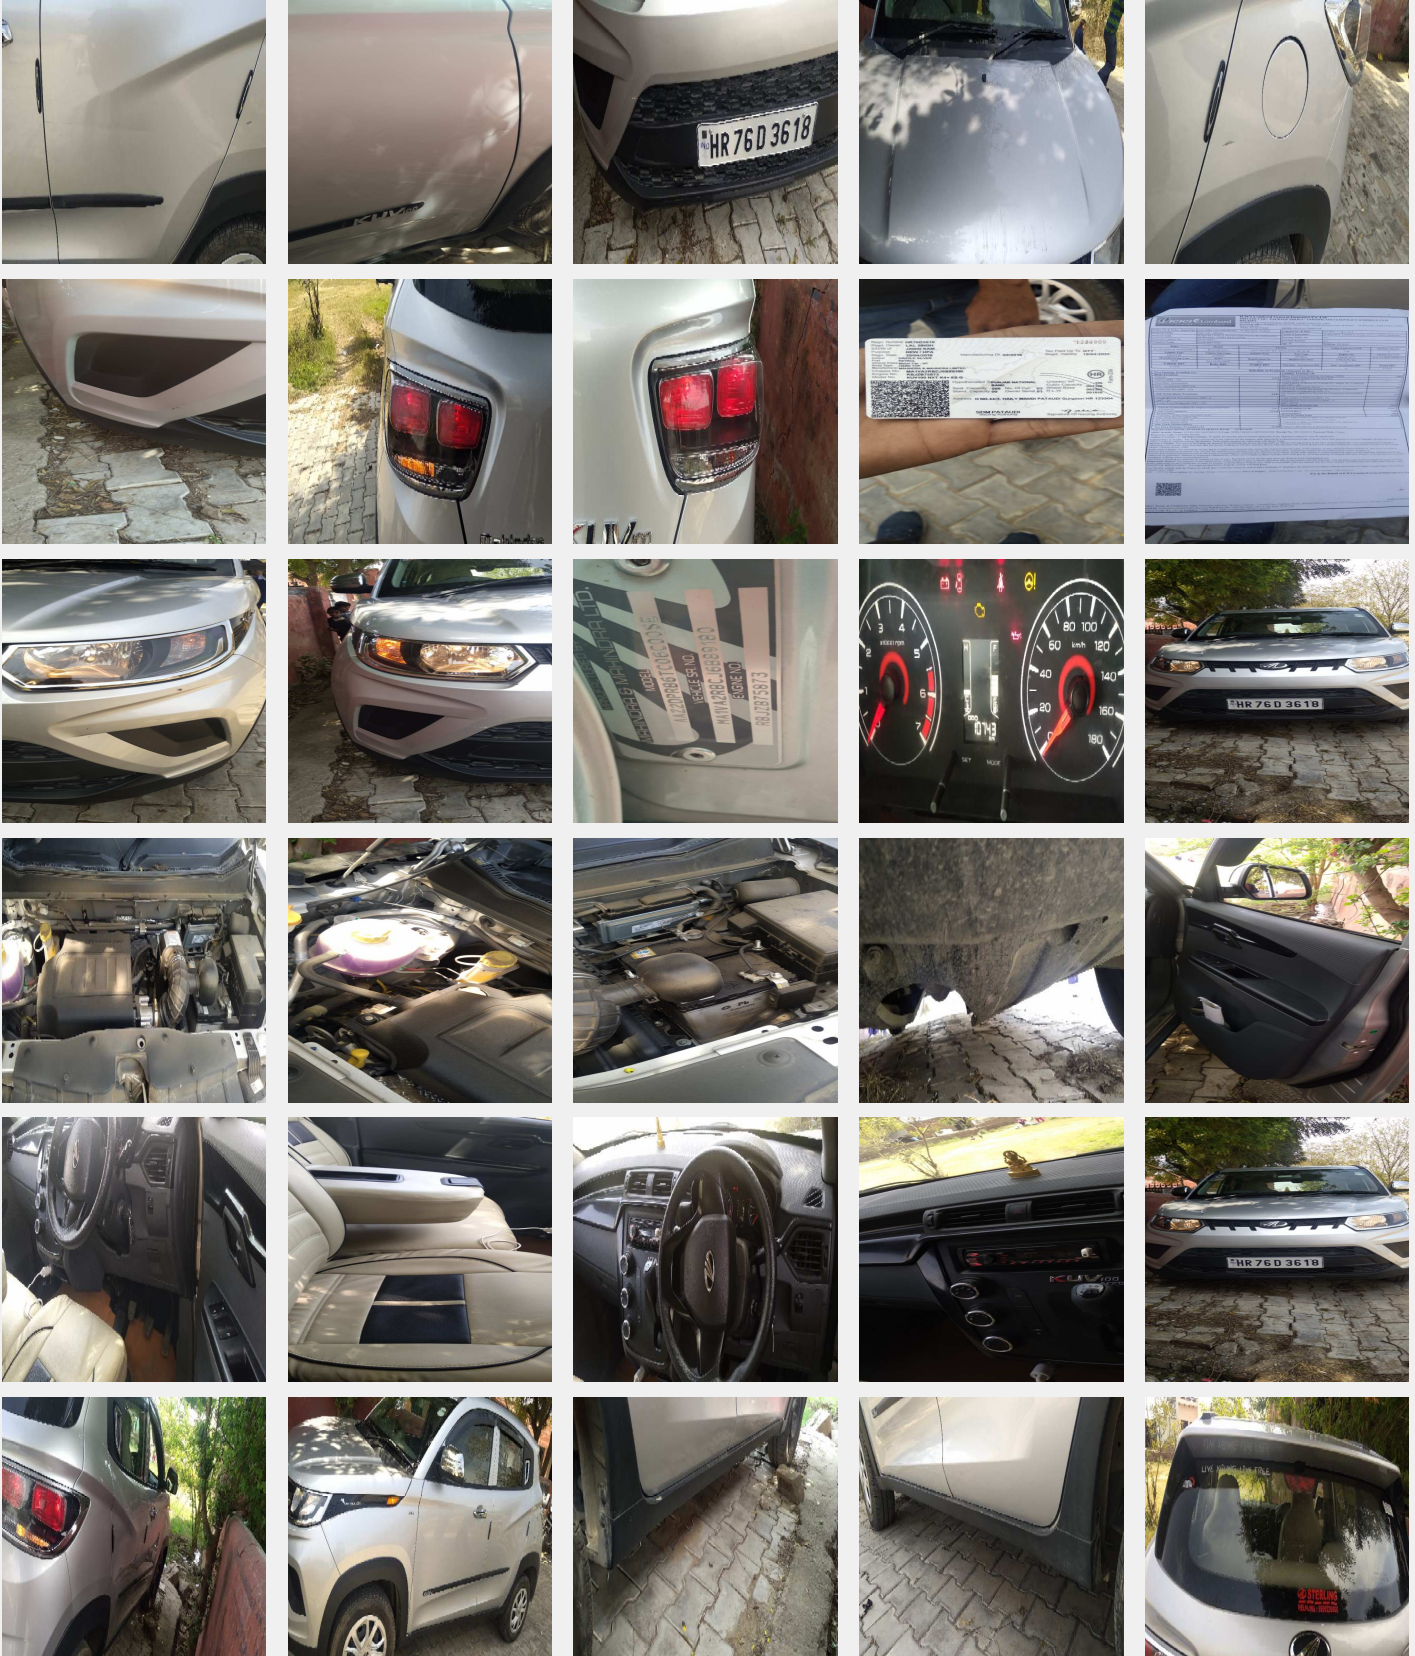
minor scratches and dent
