# ECO INSPECTION CERTIFICATE

Order ID : 49668

121 Points Vehicle Inspection Certificate

## Tata Indica Vista AQUA TDI BS-III, 2010

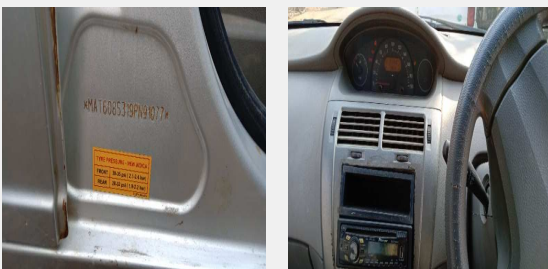
## IMAGES

INSPECTION CHECKPOINTS	SCORE(X/10)	REMARKS/COMMENTS	OPTIONAL SPEND EST. (RS)
STEERING PERFORMANCE	6		0
BRAKE PERFORMANCE	6		0
CLUTCH PERFORMANCE	6		0
ENGINE NOISE	6		0
IGNITION SYSTEM	6		0
SUSPENSION PERFORMANCE	6		0
SUSPENSION FRONT SHOCKS	6		0
SUSPENSION REAR SHOCKS	6		0
TRANSMISSION ENGAGE	6		0
CRUISE CONTROL (NO)	10		0
REAR PARKING SENSORS (NO)	10		0
REAR VIEW CAMERA (NO)	10		0

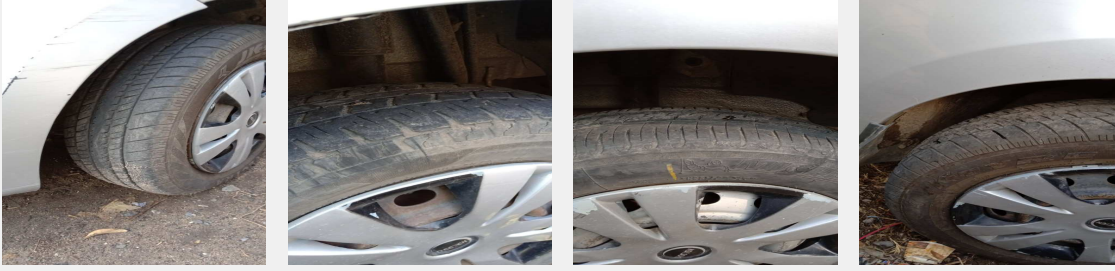
IMAGES

INSPECTION CHECKPOINTS	SCORE(X/10)	REMARKS/COMMENTS	OPTIONAL SPEND EST. (RS)
TYRES	6		0
SPARE TYRE (YES)	6		0
WHEEL ASSEMBLY (STEEL RIM)	6		0

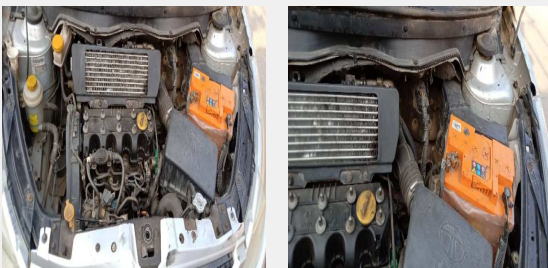
IMAGES

INSPECTION CHECKPOINTS	SCORE(X/10)	REMARKS/COMMENTS	OPTIONAL SPEND EST. (RS)
LH APRON	6		0
RH APRON	6		0
RADIATOR	6		0
WIRING	6		0
BATTERY	6		0
BRAKE FLUID LEVEL	6		0
ENGINE OIL	6		0
COOLANT LEVEL	6		0
BRAKE & COOLANT HOSE PIPES	6		0
UNDERCARRIAGE	6		0
EXHAUST SYSTEM	6		0
