ECO INSPECTION CERTIFICATE

Order ID : 46521

121 Points Vehicle Inspection Certificate

Maruti Suzuki Swift VDI, 2012

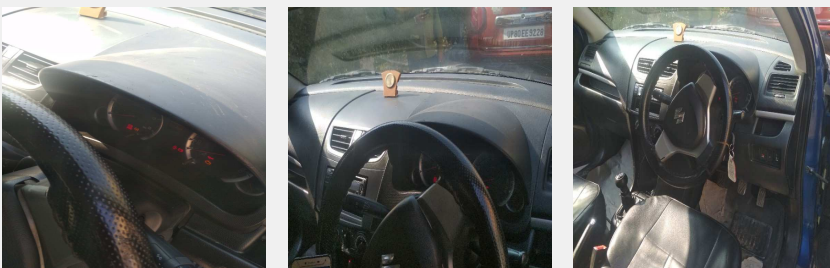
IMAGES

INSPECTION CHECKPOINTS	SCORE(X/10)	REMARKS/COMMENTS	OPTIONAL SPEND EST. (RS)
DOOR PANEL	8	SCRATCHES ON DASHBOARD	0
DOOR HINGES	9		0
CARPET & FLOOR MAT	7		0
SEAT & SEAT BELT	8		0
DASHBOARD & INSTRUMENT PANEL	8		0
HORN	8		0
SPEAKERS & MUSIC SYSTEM	9		0
HANDBRAKE	9		0
STEERING-MOUNTED CONTROLS	9		0
PEDALS	9		0
CENTRAL LOCK	9		0
A/C VENTS & HEATER	9		0
CUP HOLDERS	8		0
NAVIGATION (NO)	10		0
ODOMETER	9		0
POWER WINDOWS (YES)	9	REAR RIGHT POWER WINDOW NOT WORKING PROPERLY	1000
HAZARD LIGHT	9		0

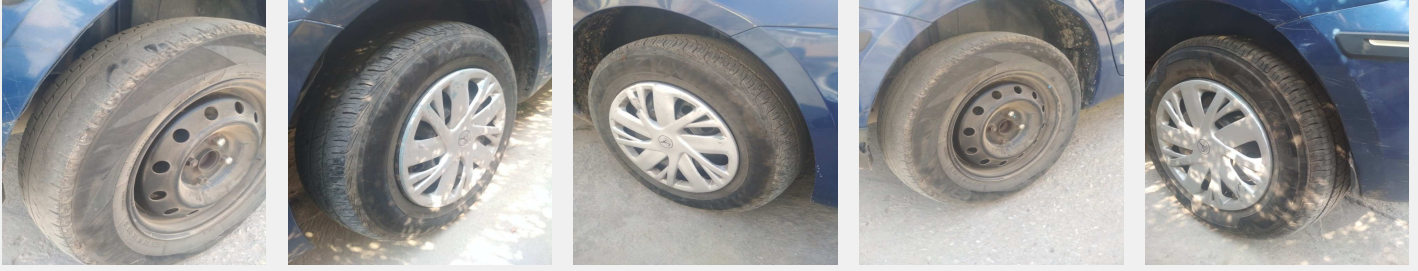
IMAGES

INSPECTION CHECKPOINTS	SCORE(X/10)	REMARKS/COMMENTS	OPTIONAL SPEND EST. (RS)
TYRES	7	ONE TYRE HAVING ONE SIDED WEAR AND SPARE WHEEL DAMAGED	0
SPARE TYRE (NO)	10		0
WHEEL ASSEMBLY (STEEL RIM)	8		0
