ECO INSPECTION CERTIFICATE

Order ID : 50846

121 Points Vehicle Inspection Certificate

Maruti Suzuki Alto 800 Lx, 2016

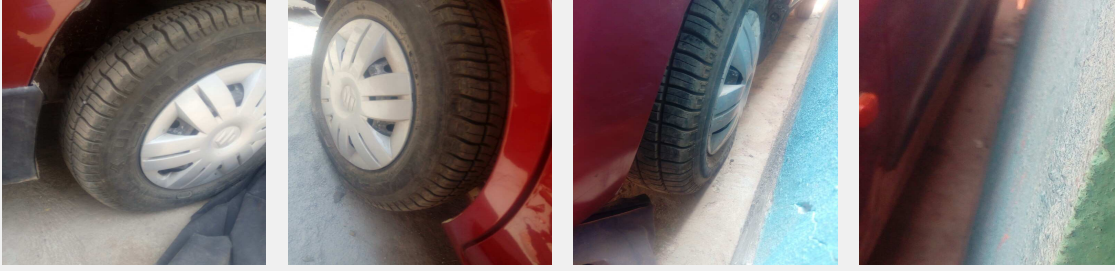
INSPECTION CHECKPOINTS	SCORE(X/10)	REMARKS/COMMENTS	OPTIONAL SPEND EST. (RS)
TYRES	7		0
SPARE TYRE (YES)	7		0
WHEEL ASSEMBLY (STEEL RIM)	8		0

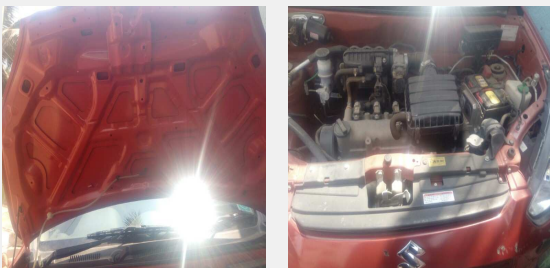
HOOD

INSPECTION CHECKPOINTS	SCORE(X/10)	REMARKS/COMMENTS	OPTIONAL SPEND EST. (RS)
LH APRON	7		0
RH APRON	8		0
RADIATOR	7		0
WIRING	8		0
BATTERY	8		0
BRAKE FLUID LEVEL	7		0
ENGINE OIL	6		0
COOLANT LEVEL	7		0
BRAKE & COOLANT HOSE PIPES	7		0
UNDERCARRIAGE	7		0
EXHAUST SYSTEM	7		0

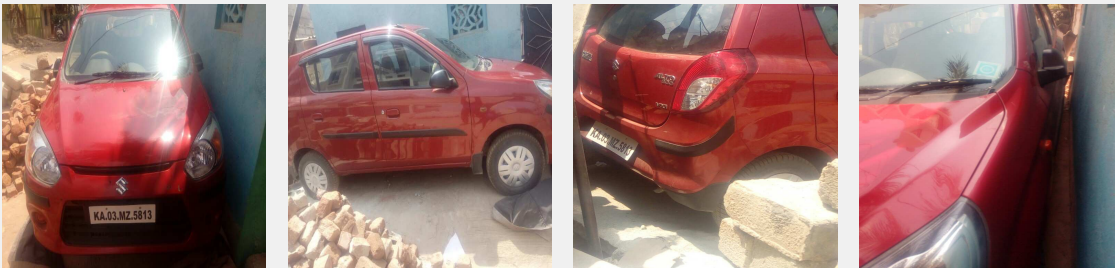
EXTERIOR (CONTINUED)

INSPECTION CHECKPOINTS	SCORE(X/10)	REMARKS/COMMENTS	OPTIONAL SPEND EST. (RS)
RH FRONT DOOR	7		0
RH FENDER	7		0
BODY RUST	8		0
ROOF (REGULAR)	7		0
PAINT CONDITION	7		0
