ECO INSPECTION CERTIFICATE

Order ID : 49266

121 Points Vehicle Inspection Certificate

Bajaj Platina 125CC, 2009

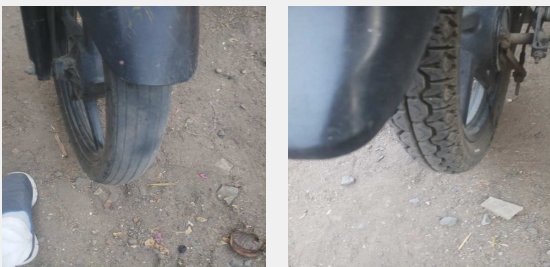
IMAGES

INSPECTION CHECKPOINTS	SCORE(X/10)	REMARKS/COMMENTS	OPTIONAL SPEND EST. (RS)
REAR TYRE CONDITION & AIR PRESSURE	6		0
WHEEL SPOKES FRONT	6		0
WHEEL SPOKES REAR	6		0
WHEEL RIM FRONT	7		0
WHEEL RIM REAR	7		0
WHEEL BEARINGS FRONT	7		0
WHEEL BEARINGS REAR	7		0
WHEEL SEALS FRONT	6		0
WHEEL SEALS REAR	6		0
BRAKE FUNCTION FRONT	7		0
BRAKE FUNCTION REAR	7		0
BRAKES CONDITION FRONT	7		0
BRAKES CONDITION REAR	6		0
FRONT TYRE CONDITION & AIR PRESSURE	0	NEW	1200
